Cisco RF Gateway 1 Software Release 6.02.01 Release Note

Cisco RF Gateway 1 (RFGW-1) software Version 6.02.01 contains several improvements from Release 6.01.07. This release also includes new features.

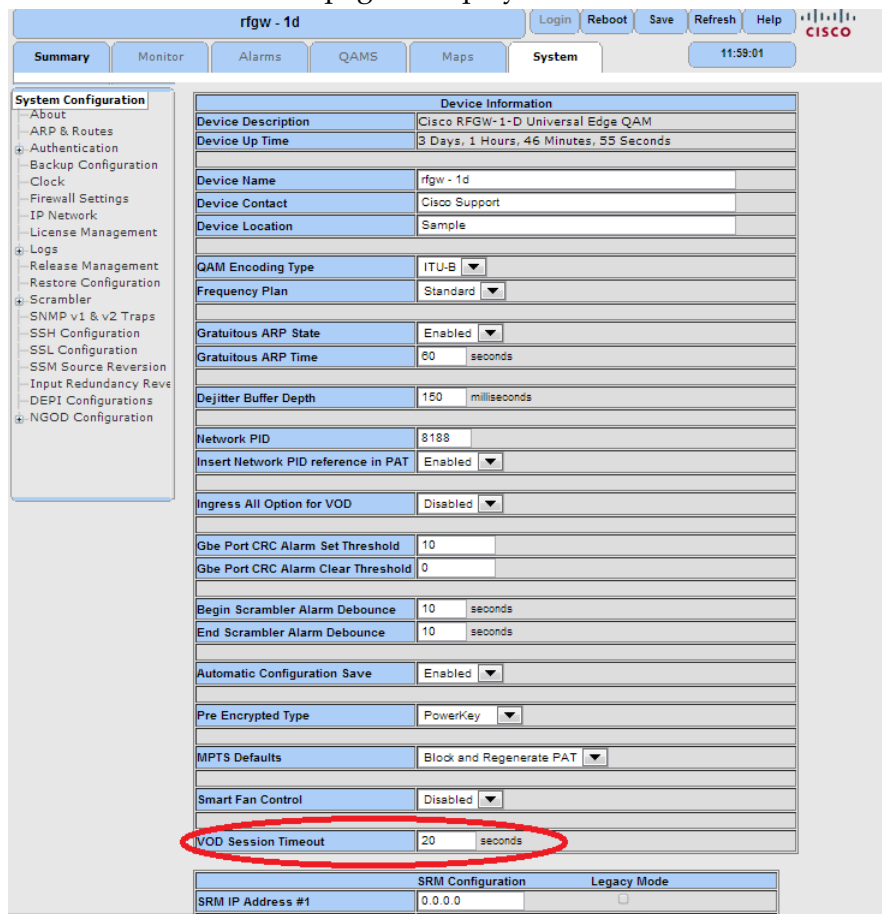
- 1 Choose **System > System Configuration**.

The Device Information page is displayed, as shown in the following example.

- 2 Edit the value (in seconds) in the **VOD Session Timeout** field as needed.
- 3 Click **Apply** and then click **Save**.
