Cisco DSAN System Troubleshooting Guide

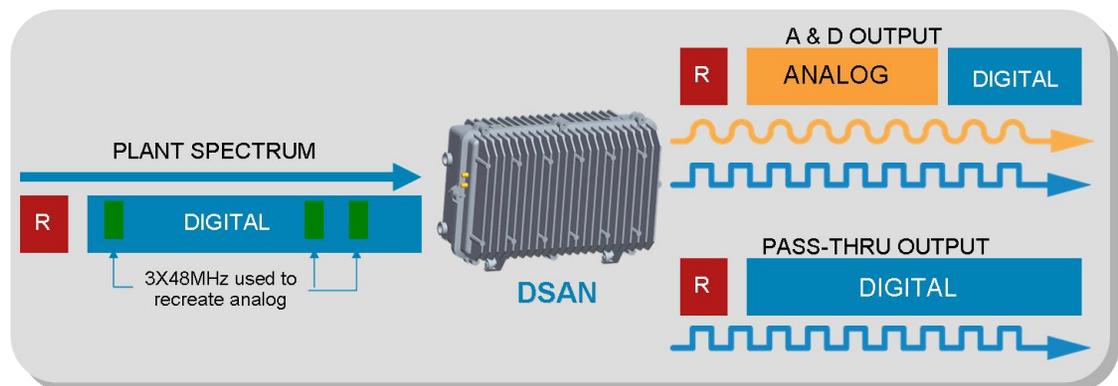
The DSAN is a device that converts a pure digital plant spectrum to a combined spectrum containing both digital and analog output, as shown in the following illustration.

The analog output is recreated from portions of the digital plant spectrum, and occupies the 54-to-552 MHz frequency range designated for CATV analog channels. The combined digital output (564 MHz to 1 GHz) is available for use by compatible receiving equipment such as a set-top box, EMTA, or cable modem.

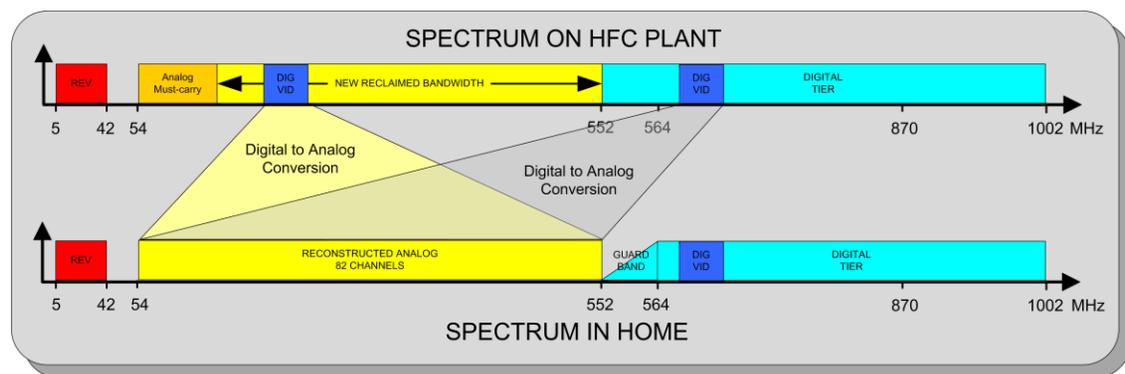
The following illustration shows an example of the regeneration process for an analog spectrum of 54 to 552 MHz that is reconstructed from a portion of the digital tier, which can span from 54 to 1002 MHz.

As shown above, a 12 MHz guard band is provided in the DSAN output spectrum between the reconstructed analog and the low end of the digital tier. A dedicated "brick wall" high-pass filter in the DSAN creates this guard band, which is needed to isolate the recreated analog channels from existing channels on the plant.

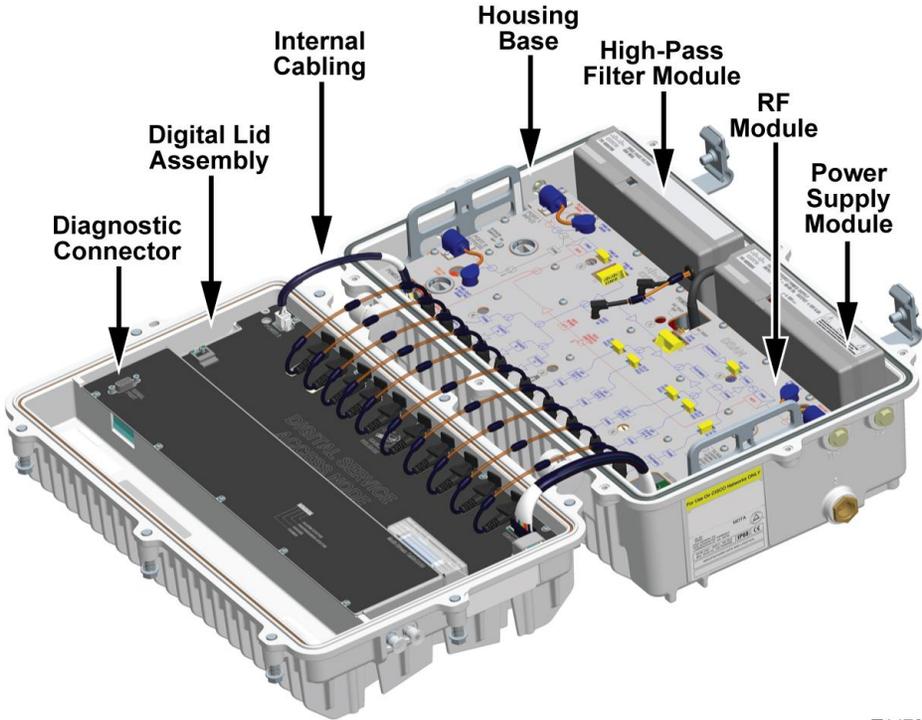
T14731

The DSAN system unit includes the following main internal components.

Component	Description
Housing base	Houses the high-pass filter, power supply, and RF module
RF module	Houses the RF tuners and upconverters and handles input and output signal routing
Power supply module	Converts coax line power to DC
Digital lid assembly	Houses the digital board
High pass filter module	Isolates regenerated analog from existing plant carriers
Internal cabling	1 power cable, 10 RF cables, 1 digital control cable
Diagnostic connector	Used for local management and troubleshooting

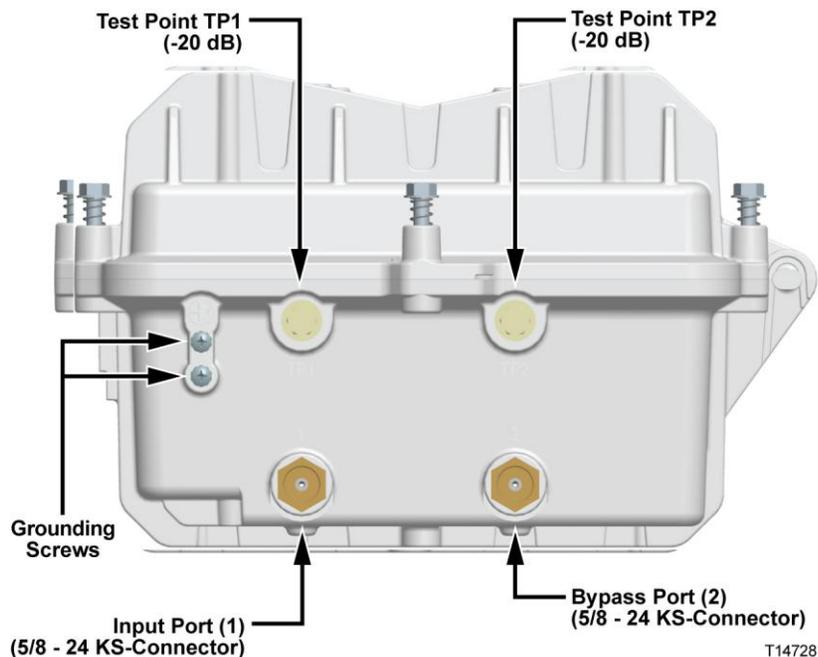
The left side of the enclosure contains the following connectors:

- Input port (Port 1)
- Bypass Output port (Port 2)
- Input forward path test point TP1 (-20 dB)
- Bypass Output forward path test point TP2 (-20 dB)

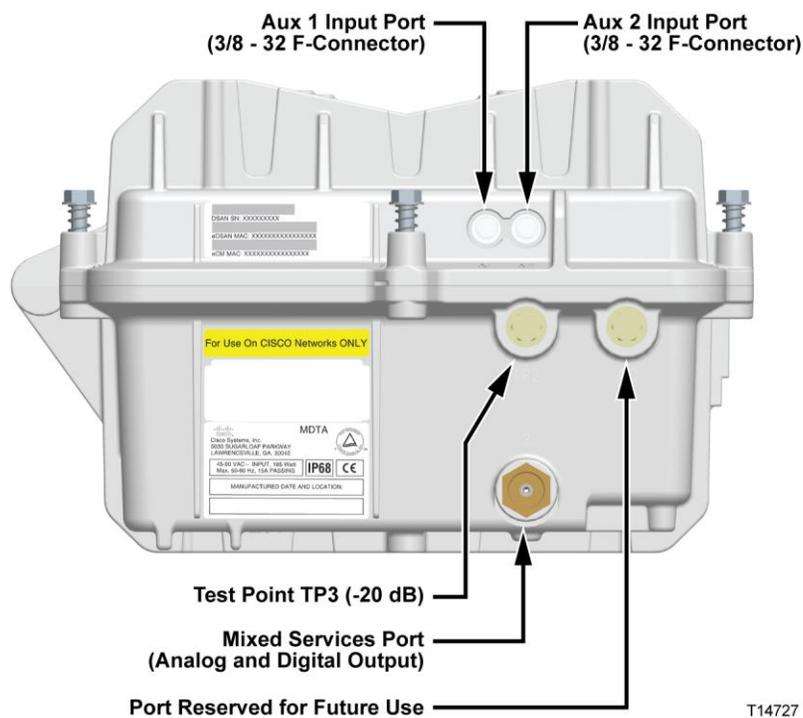
The right (product label) side of the DSAN enclosure contains the following connectors:

- Mixed Services output port (Port 3)
- Mixed Services output forward path test point TP3 (-20 dB)
- Aux 1 Input port
- Aux 2 Input port

An additional port next to the Mixed Services output port is reserved for possible future use.

Product labels are attached to the right side of the DSAN lid and base, as shown in the preceding illustration. These labels provide the following information.

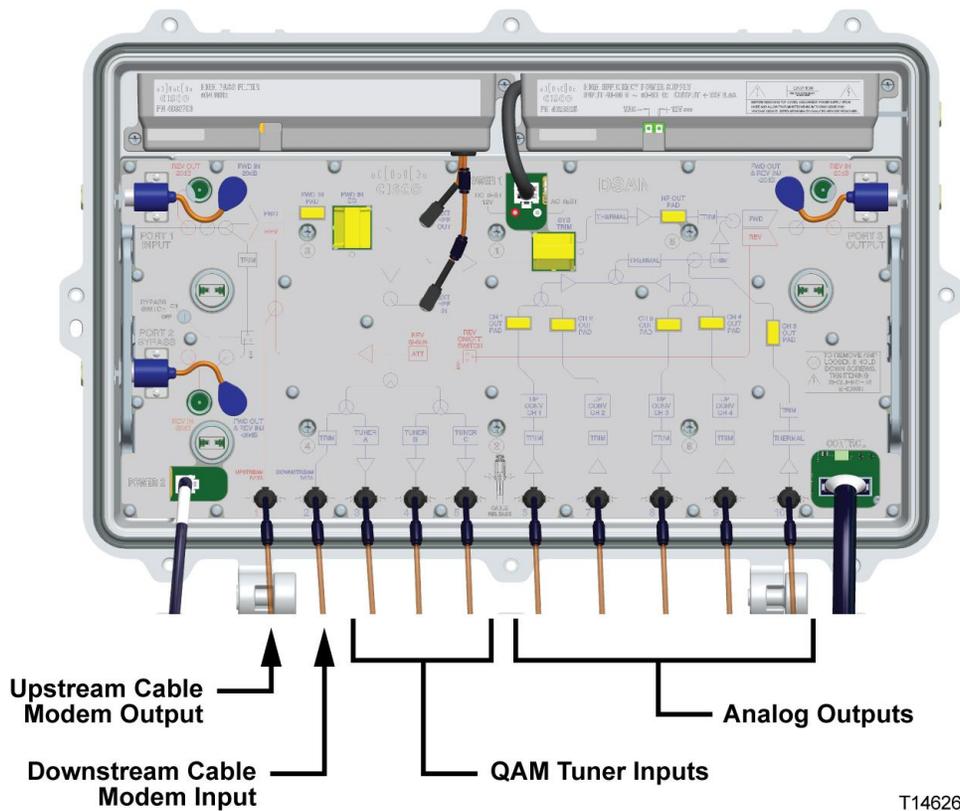
The DSAN receives quadrature amplitude modulated (QAM) MPEG-2 encoded video and AC3 encoded audio, and generates up to 82 NTSC video with BTSC audio channels between 54 MHz and 552 MHz.

All DSAN configurations have one coaxial input sourced from the service provider headend. The DSAN can tune up to three 48 MHz bands residing in the 88 MHz to 1 GHz spectrum. Residing within this 48 MHz band are eight contiguous 6 MHz QAM channels. Each QAM channel may contain up to 15 MPEG-2 video channels.

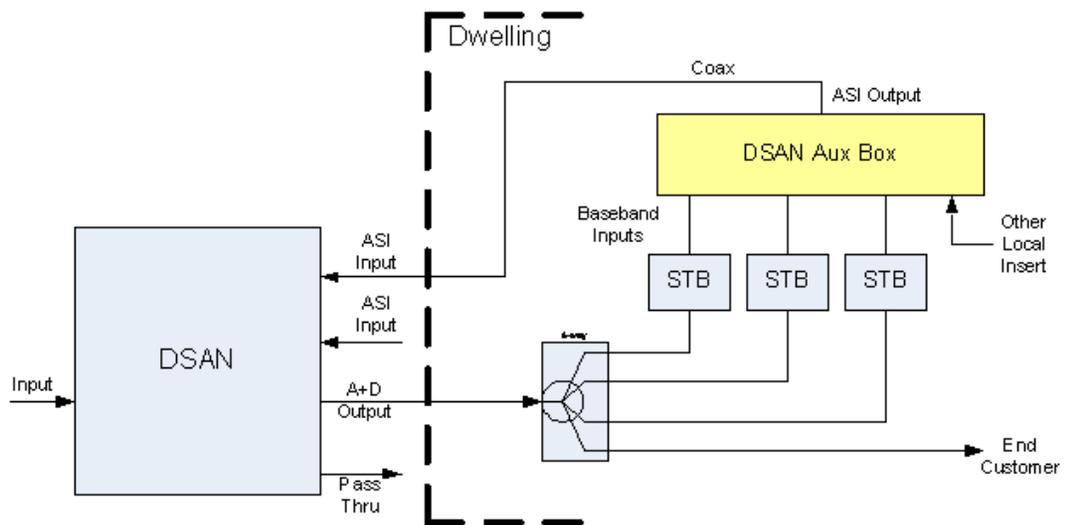
The DSAN Auxiliary Input Box (DAXI) is a compatible external product that converts up to four analog video channels to digital format for distribution via the DSAN.

The DAXI provides baseband video and audio conversion to MPEG-2 Transport Stream. The output is carried over one ASI channel to the DSAN ASI input. The content that the DAXI converts can come from up to four external sources such as a set-top box, DVD player, analog security camera, or character generator.

The DAXI is a stand-alone product targeted for indoor applications. It is simple to install and requires no maintenance or remote management. It can be mounted on a rack, a wall, or a shelf.

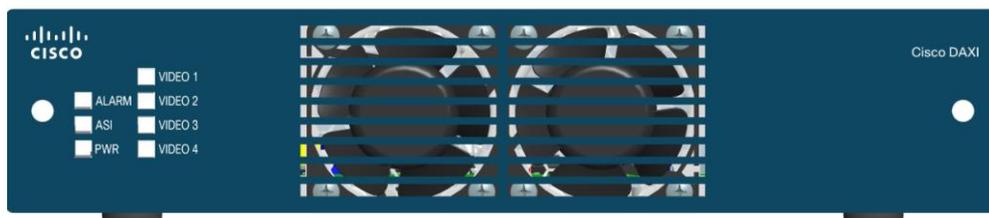
DAXI Front Panel

The DAXI accepts four analog baseband audio and video composite signal inputs, and provides one ASI output. The DAXI front panel has LEDs to show status on the four video inputs, the ASI output, the input power, and general Alarm status.

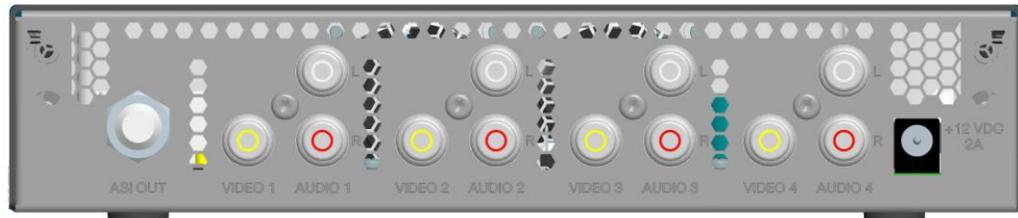
DAXI Back Panel

The DAXI accepts four analog baseband video composite signals over female RCA connectors, and their corresponding analog stereo baseband audio signals over female RCA connectors. On the data path side, it provides one standard ASI output on a female F connector. The DAXI is powered by 12 VDC via an external power supply converter.

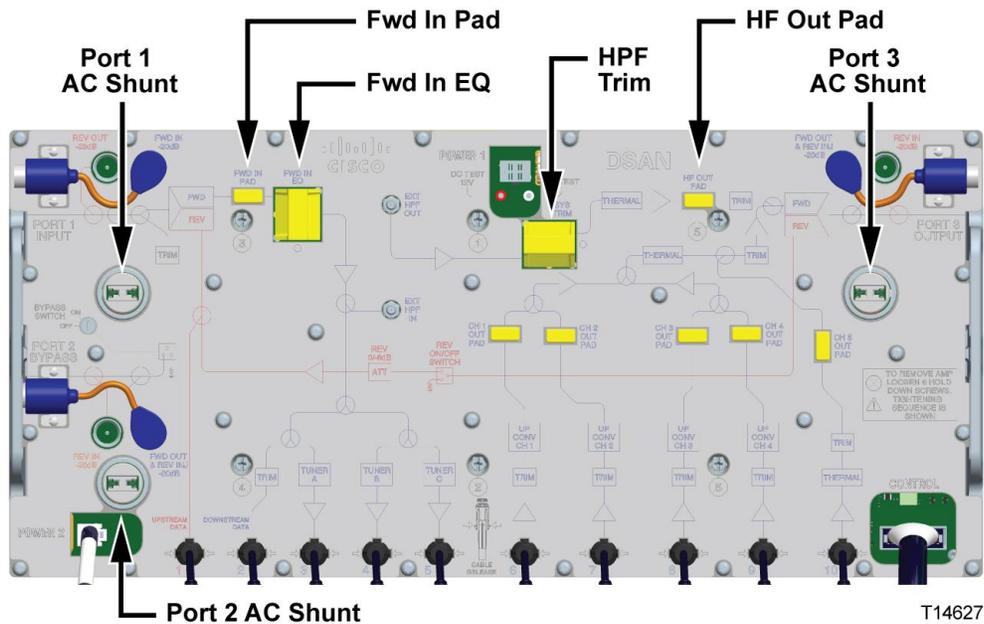
The DSAN can receive line power at 40 - 90 VAC through *any one* of its three KS ports - Port 1, Port 2, or Port 3, as shown in the following illustration.

Determine which port will accept power, and **install one shunt** at the appropriate location.

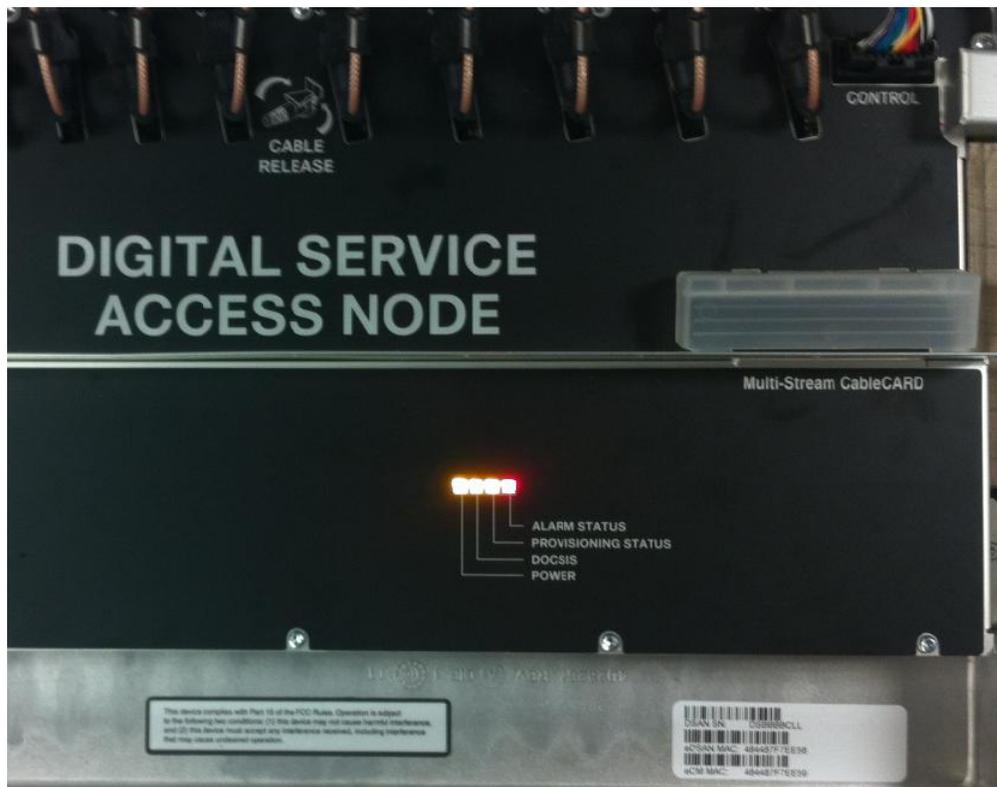
After connecting the plant coax to the DSAN Input port and applying power to the unit, open the DSAN housing and verify that the power LED on the digital board is illuminated, as shown in the following illustration.

- Use a digital multimeter (DMM) to check for the correct incoming AC or DC voltages.
- If incoming AC or DC voltage is not correct, check for power at the test lugs on the power supply module.
- If the power supply tests OK, probe the RF module itself for power. If power is not reaching the RF module, check for a loose or broken cable.

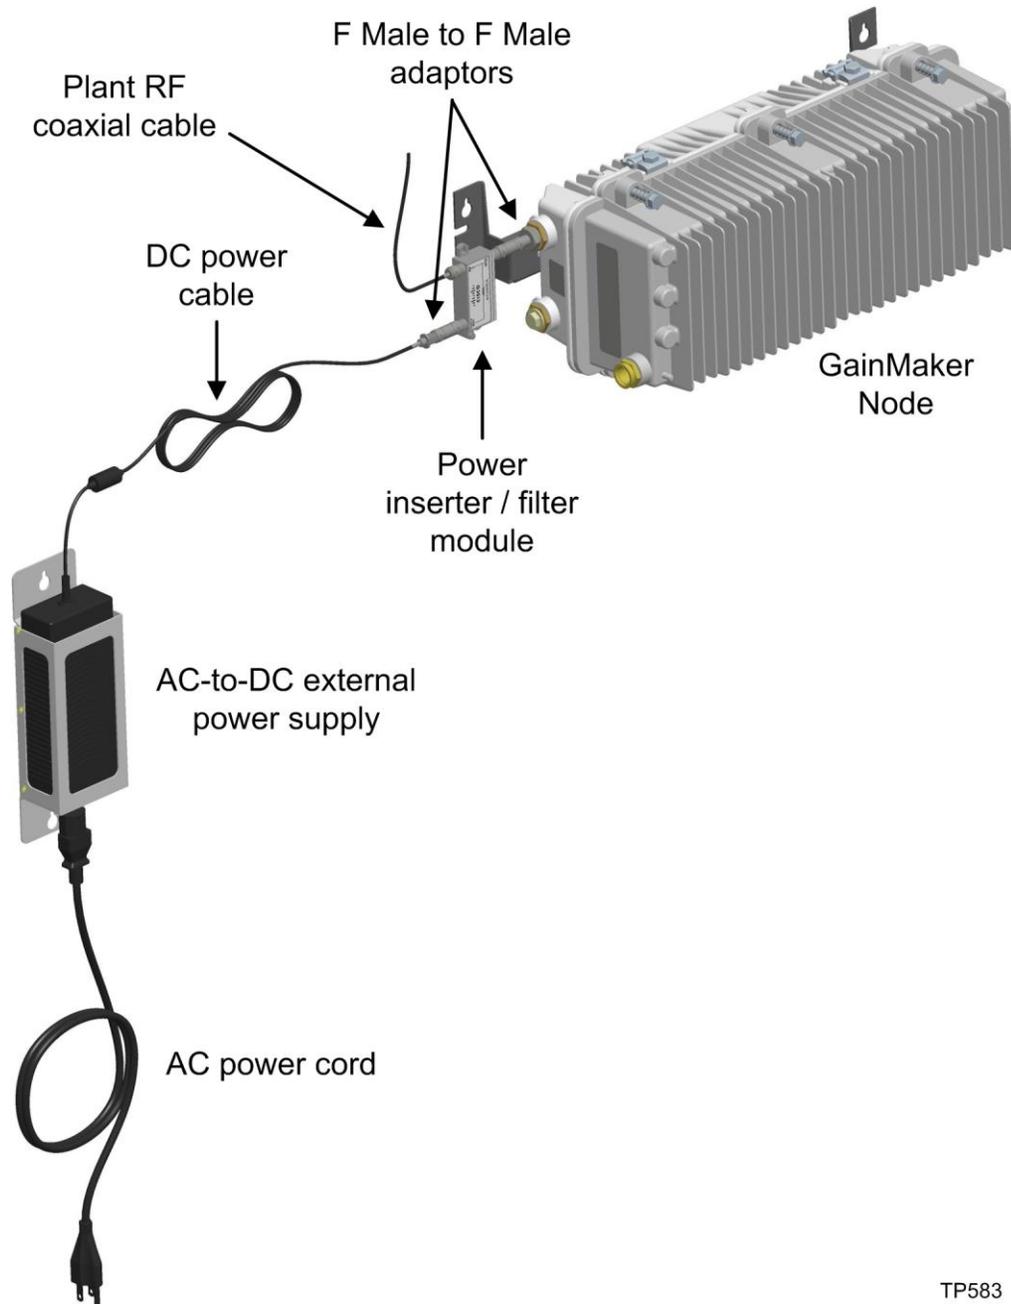
TP583

Connect the Mains Power Supply as shown in the following illustration. (Substitute the DSAN for the GainMaker in the picture.)

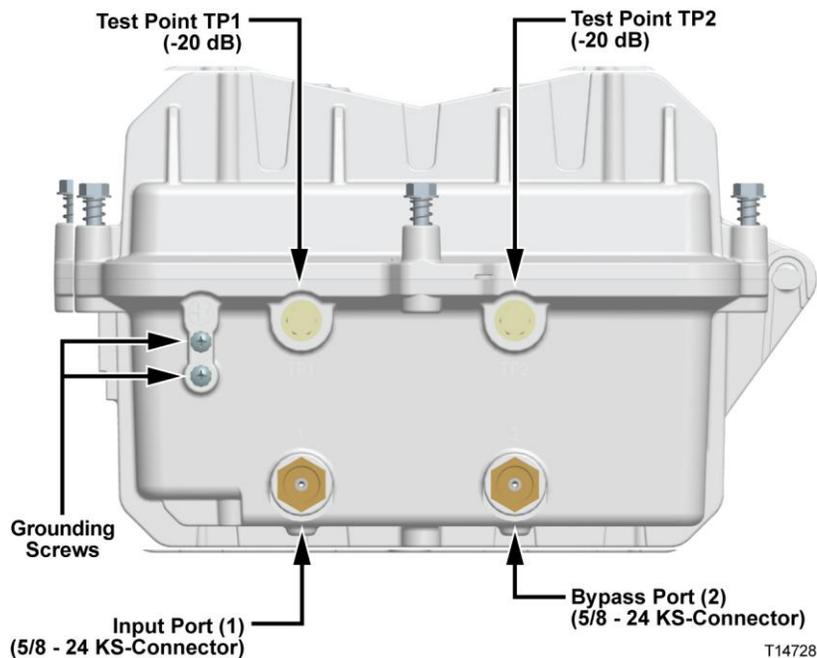
- 1 Connect the cable plan to the Input port (Port 1) on the DSAN unit.
- 2 Connect the test equipment to the Input port test point (FWD IN -20dB TP) on the DSAN unit.

- 3 Measure the signal levels at the lowest frequency and highest frequencies specified in the system design.
- 4 Adjust the FWD IN EQ to flatten the frequency spectrum. Adjust the FWD IN PAD to adjust the level of the input signals.

Note: A FWD IN PAD value of 1 dB and a FWD IN EQ value of 0 dB give the proper setup for a flat input spectrum with digital signal levels at +4 dBmV (analog channels are + 10 dBmV, or 6 dB higher than digital). Changes in the FWD IN PAD and FWD IN EQ values will not change the measured results at the FWD IN -20 dB test point because this test point is located ahead of the input accessories.

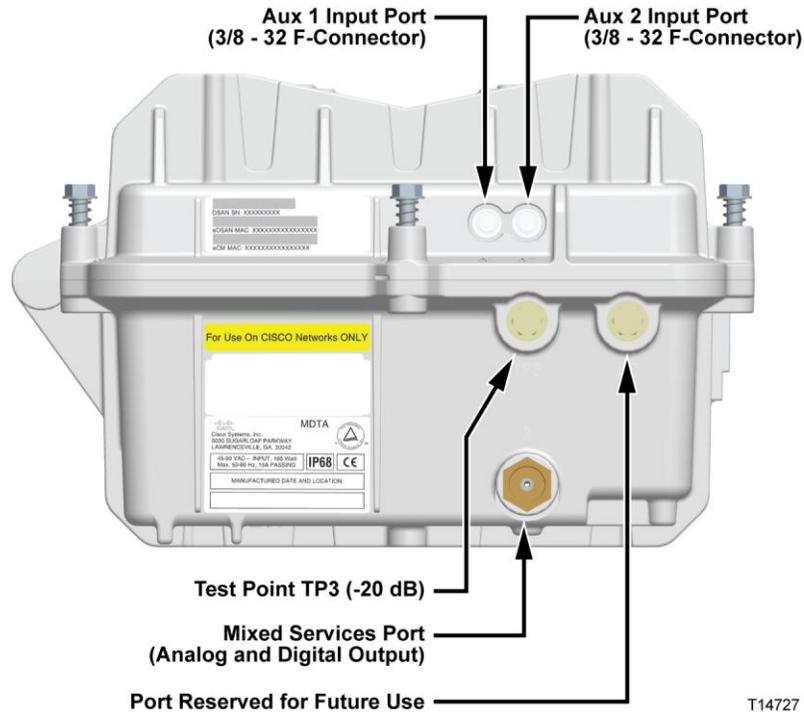
- 5 Connect the test probe to the Mixed Services output port (Port 3) test point (FWD OUT -20 dB TP3).

After power is applied, the DSAN takes about 4 minutes to boot completely. No analog channels are present at this step until the unit has booted completely.

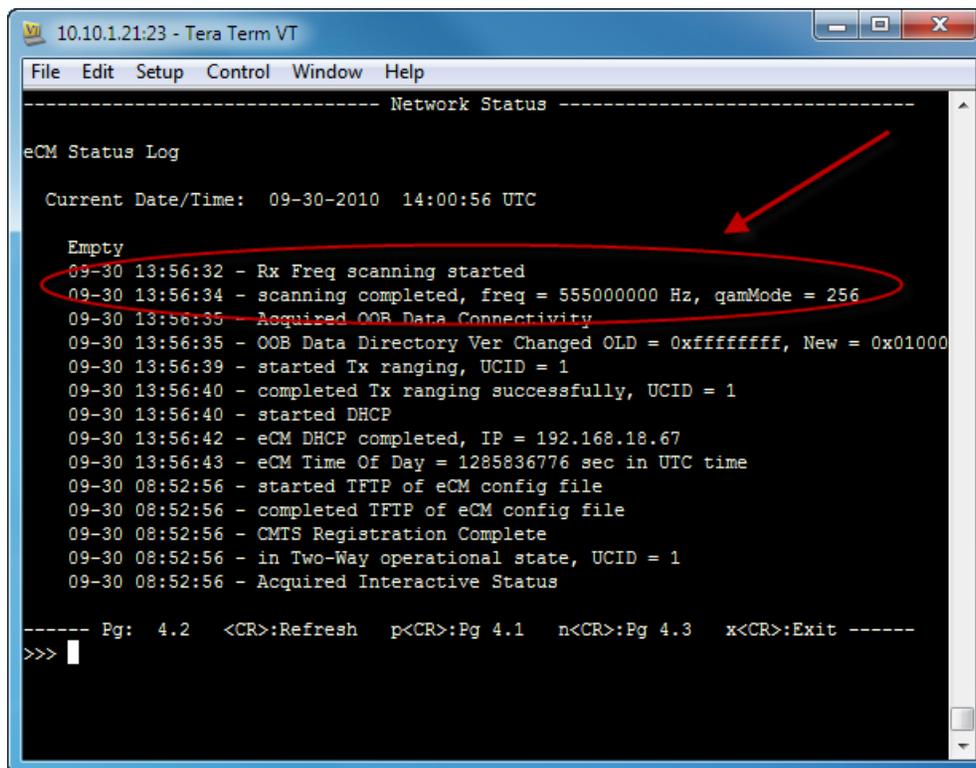
Review CLI diag page 4.2 to confirm that frequency scanning completed successfully.

```
10.10.1.21:23 - Tera Term VT
File Edit Setup Control Window Help
----- Network Status -----
eCM Status Log
Current Date/Time: 09-30-2010 14:00:56 UTC
Empty
09-30 13:56:32 - Rx Freq scanning started
09-30 13:56:34 - scanning completed, freq = 555000000 Hz, qamMode = 256
09-30 13:56:35 - Acquired OOB Data Connectivity
09-30 13:56:35 - OOB Data Directory Ver Changed OLD = 0xffffffff, New = 0x01000
09-30 13:56:39 - started Tx ranging, UCID = 1
09-30 13:56:40 - completed Tx ranging successfully, UCID = 1
09-30 13:56:40 - started DHCP
09-30 13:56:42 - eCM DHCP completed, IP = 192.168.18.67
09-30 13:56:43 - eCM Time Of Day = 1285836776 sec in UTC time
09-30 08:52:56 - started TFTP of eCM config file
09-30 08:52:56 - completed TFTP of eCM config file
09-30 08:52:56 - CMTS Registration Complete
09-30 08:52:56 - in Two-Way operational state, UCID = 1
09-30 08:52:56 - Acquired Interactive Status
----- Pg: 4.2 <CR>:Refresh p<CR>:Pg 4.1 n<CR>:Pg 4.3 x<CR>:Exit -----

Note: If the Cisco CA client ID is not specified in the DCD, the eCM will continue to search for a CMTS downstream channel that has it. This error is indicated by a "downstream scanning completed" message on diag page 4.0 but a "Rx freq scanning failed" message on diag page 4.2 If this error occurs, contact your CMTS administrator for assistance.

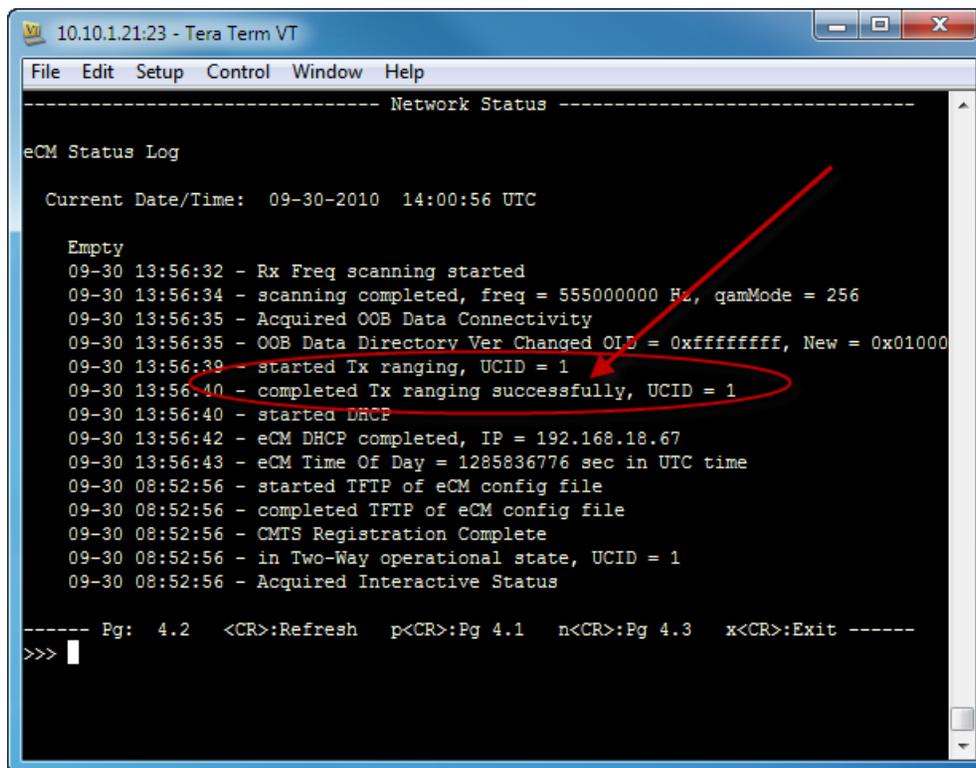
Successful completion of upstream ranging is reported on CLI diag page 4.2, as shown in the following example.

```
10.10.1.21:23 - Tera Term VT
File Edit Setup Control Window Help
----- Network Status -----
eCM Status Log
Current Date/Time: 09-30-2010 14:00:56 UTC
Empty
09-30 13:56:32 - Rx Freq scanning started
09-30 13:56:34 - scanning completed, freq = 555000000 Hz, qamMode = 256
09-30 13:56:35 - Acquired OOB Data Connectivity
09-30 13:56:35 - OOB Data Directory Ver Changed OID = 0xffffffff, New = 0x01000
09-30 13:56:39 - started Tx ranging, UCID = 1
09-30 13:56:40 - completed Tx ranging successfully, UCID = 1
09-30 13:56:40 - started DHCP
09-30 13:56:42 - eCM DHCP completed, IP = 192.168.18.67
09-30 13:56:43 - eCM Time Of Day = 1285836776 sec in UTC time
09-30 08:52:56 - started TFTP of eCM config file
09-30 08:52:56 - completed TFTP of eCM config file
09-30 08:52:56 - CMTS Registration Complete
09-30 08:52:56 - in Two-Way operational state, UCID = 1
09-30 08:52:56 - Acquired Interactive Status
----- Pg: 4.2 <CR>:Refresh p<CR>:Pg 4.1 n<CR>:Pg 4.3 x<CR>:Exit -----

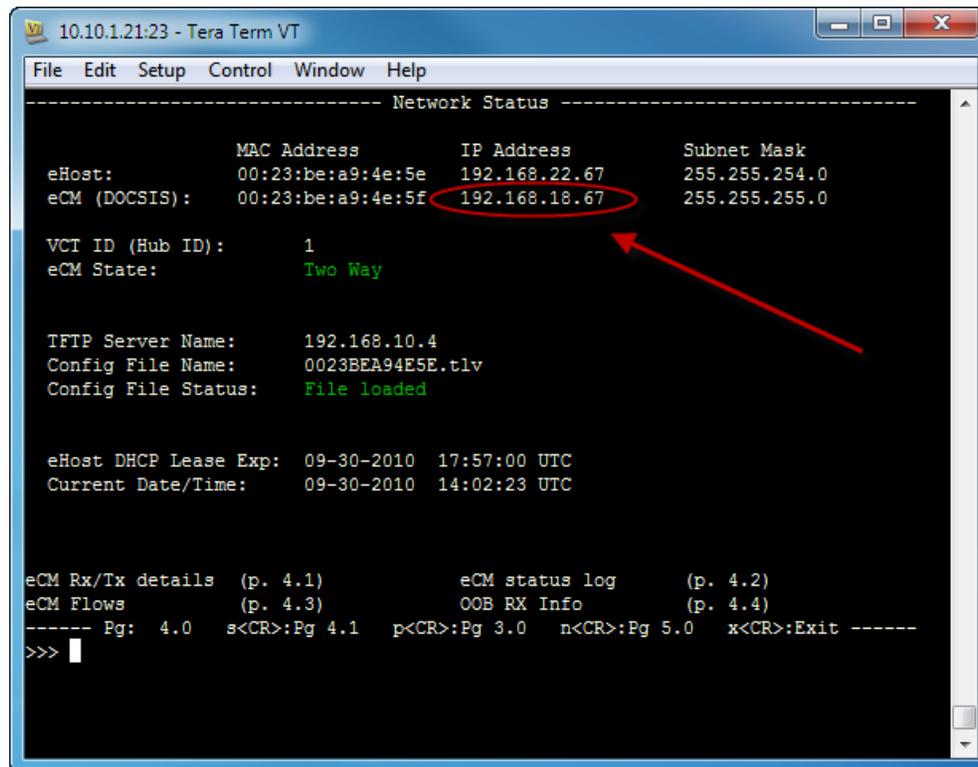
After ranging has succeeded, the eCM tries to obtain an IP address using DHCP. You can verify the IP address on CLI diag page 4.0, as shown in the following example.

10.10.1.21:23 - Tera Term VT
File Edit Setup Control Window Help
----- Network Status -----
eHost:          MAC Address      IP Address      Subnet Mask
eCM (DOCSIS):  00:23:be:a9:4e:5e  192.168.22.67  255.255.254.0
                00:23:be:a9:4e:5f  192.168.18.67  255.255.255.0

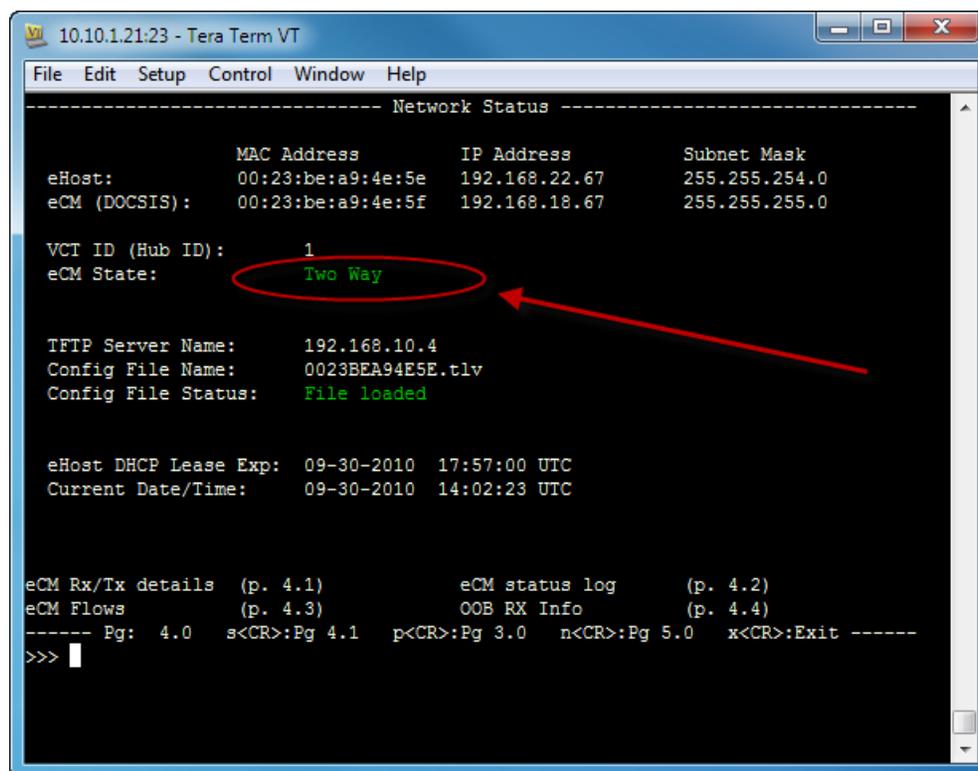
Once an IP address is established, the eCM will enter two-way operation. Two-way operation is reported on CLI diag page 4.0, as shown in the following example.

```
10.10.1.21:23 - Tera Term VT
File Edit Setup Control Window Help
----- Network Status -----
eHost:          MAC Address      IP Address      Subnet Mask
eHost:          00:23:be:a9:4e:5e    192.168.22.67   255.255.254.0
eCM (DOCSIS):   00:23:be:a9:4e:5f    192.168.18.67   255.255.255.0

VCT ID (Hub ID): 1
eCM State:       Two Way

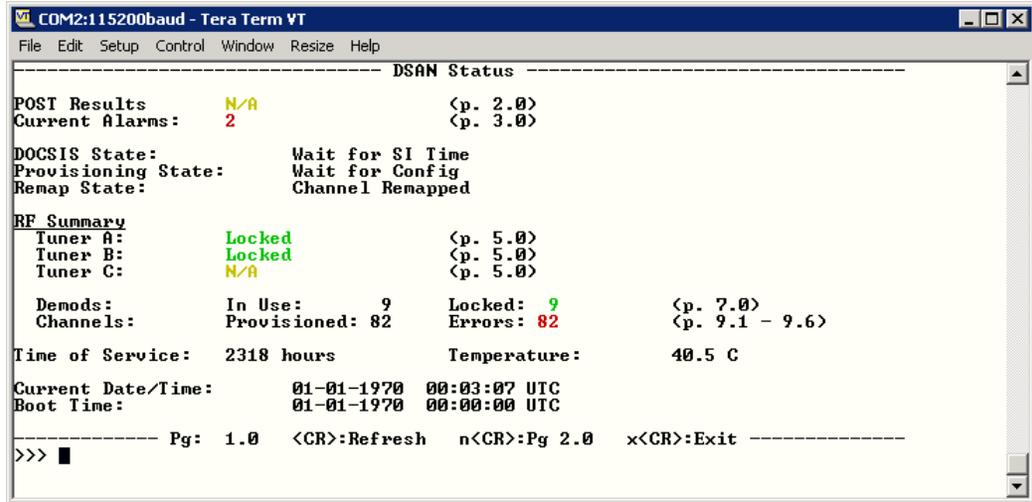
- 1 Check CLI diag page 1 to see if the SI time is available from the DNCS. If not, the DOCSIS State will report as Wait for SI time, as shown in the following example.

```
COM2:115200baud - Tera Term VT
File Edit Setup Control Window Resize Help
----- DSAN Status -----
POST Results      N/A                <p. 2.0>
Current Alarms:   2                  <p. 3.0>
DOCSIS State:     Wait for SI Time
Provisioning State: Wait for Config
Remap State:      Channel Remapped
RF Summary
Tuner A:          Locked                <p. 5.0>
Tuner B:          Locked                <p. 5.0>
Tuner C:          N/A                  <p. 5.0>
Demods:           In Use: 9             Locked: 9                <p. 7.0>
Channels:         Provisioned: 82       Errors: 82              <p. 9.1 - 9.6>
Time of Service:  2318 hours           Temperature: 40.5 C
Current Date/Time: 01-01-1970 00:03:07 UTC
Boot Time:        01-01-1970 00:00:00 UTC
----- Pg: 1.0  <CR>:Refresh  n<CR>:Pg 2.0  x<CR>:Exit -----
>>>
```

It may be that the SI process is not running and SI data is not available. Verify the status of the SI process with your DNCS administrator.

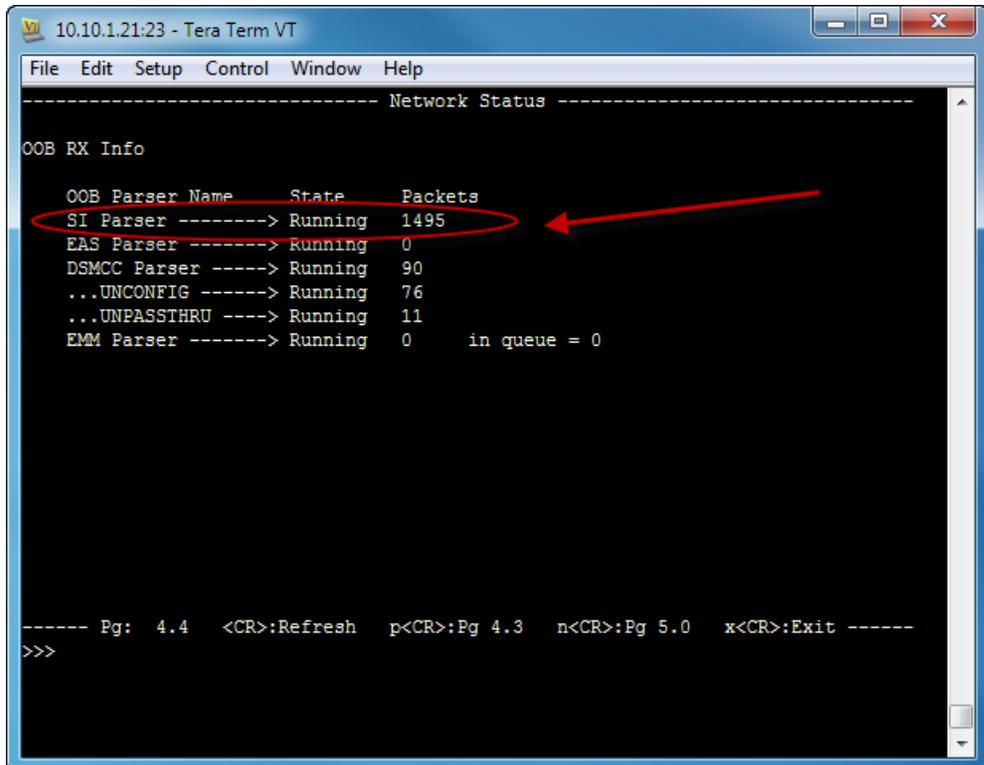
- 2 Check CLI diag page 4.4 to verify that the SI parser counter is incrementing, as shown in the following example.

```
10.10.1.21:23 - Tera Term VT
File Edit Setup Control Window Help
----- Network Status -----
OOB RX Info
OOB Parser Name  State  Packets
SI Parser -----> Running 1495
EAS Parser -----> Running  0
DSMCC Parser -----> Running  90
...UNCONFIG -----> Running  76
...UNPASSTHRU -----> Running  11
EMM Parser -----> Running  0   in queue = 0
----- Pg: 4.4  <CR>:Refresh  p<CR>:Pg 4.3  n<CR>:Pg 5.0  x<CR>:Exit -----
>>>
```

If the SI parser counter is not incrementing, SI data is not available in the eCM SCTE-65 OOB SI tunnel. In this case:

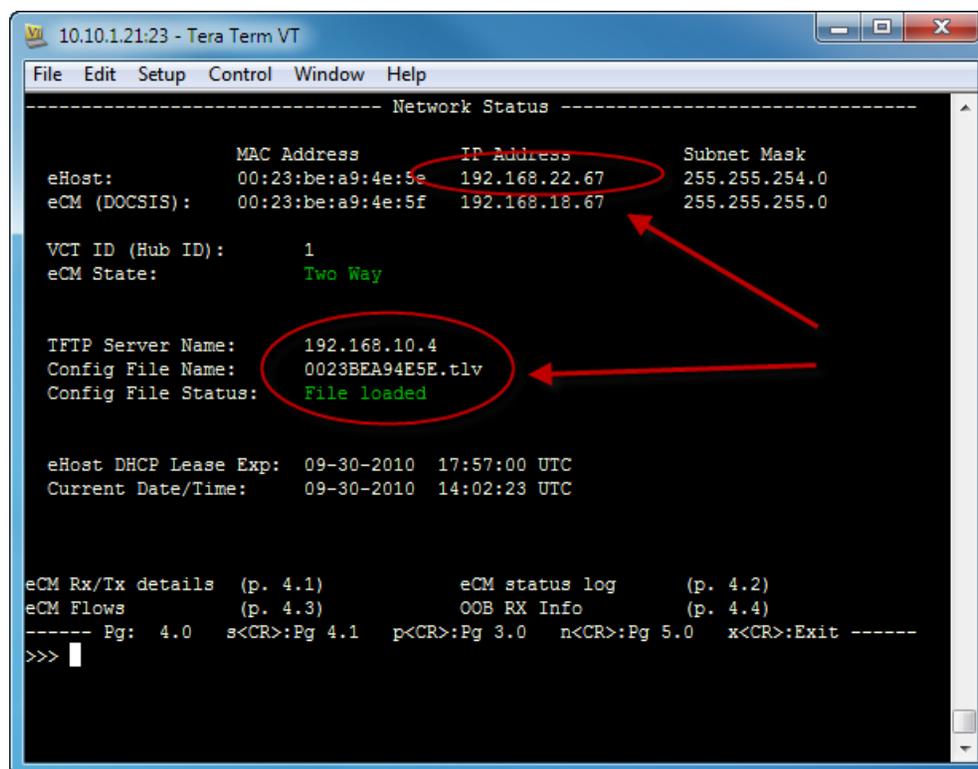
After receiving system time, the eHost obtains an IP address using DHCP. You can verify receipt of the IP address on CLI diag page 4.0, as shown in the following example.

```
10.10.1.21:23 - Tera Term VT
File Edit Setup Control Window Help
----- Network Status -----
eHost:          MAC Address      IP Address      Subnet Mask
eHost:          00:23:be:a9:4e:5e    192.168.22.67   255.255.254.0
eCM (DOCSIS):   00:23:be:a9:4e:5f    192.168.18.67   255.255.255.0

VCT ID (Hub ID): 1
eCM State:      Two Way

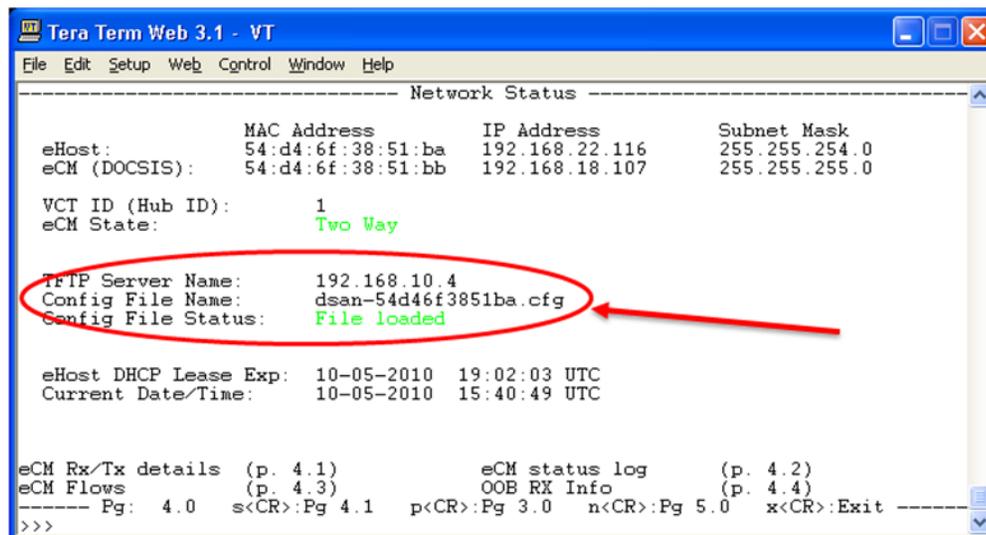
You can check the status of the configuration file on CLI diag page 4.0, as shown in the following example.

```
Tera Term Web 3.1 - VT
File Edit Setup Web Control Window Help
----- Network Status -----
eHost:          MAC Address      IP Address      Subnet Mask
eHost:          54:d4:6f:38:51:ba  192.168.22.116  255.255.254.0
eCM (DOCSIS):   54:d4:6f:38:51:bb  192.168.18.107  255.255.255.0

VCT ID (Hub ID): 1
eCM State:      Two Way

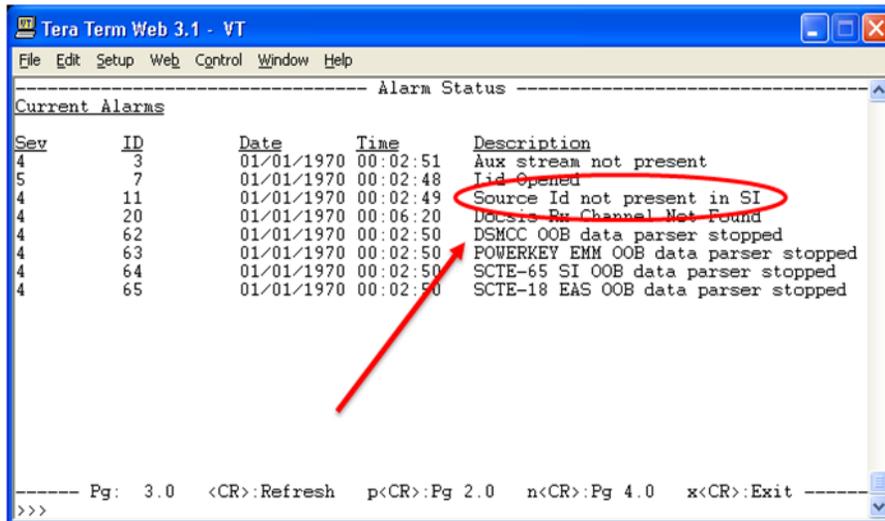
This alarm is triggered when the QAM mode is unknown, or when the source ID is not present in the SI. This alarm appears in the CLI diag pages as shown in the following example.

```
Tera Term Web 3.1 - VT
File Edit Setup Web Control Window Help
----- Alarm Status -----
Current Alarms
Sev  ID      Date      Time      Description
4    3        01/01/1970 00:02:51  Aux stream not present
5    7        01/01/1970 00:02:48  Lid Opened
4    11       01/01/1970 00:02:49  Source Id not present in SI
4    20       01/01/1970 00:06:20  Dotsis Rx Channel Not Found
4    62       01/01/1970 00:02:50  DSMCC OOB data parser stopped
4    63       01/01/1970 00:02:50  POWERKEY EMM OOB data parser stopped
4    64       01/01/1970 00:02:50  SCTE-65 SI OOB data parser stopped
4    65       01/01/1970 00:02:50  SCTE-18 EAS OOB data parser stopped

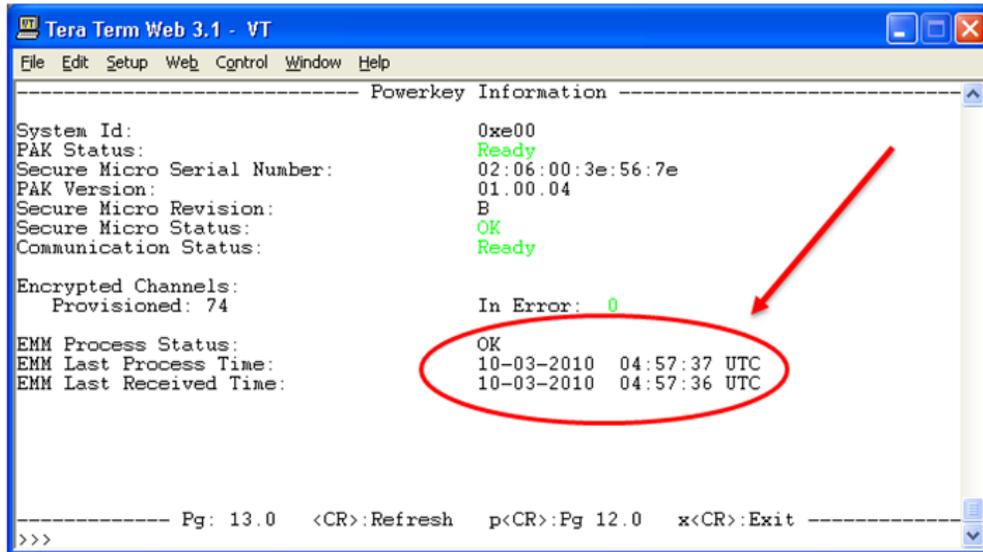
If the EMM has expired, send an “Instant Hit” to the unit as shown in the following example.

```
Tera Term Web 3.1 - VT
File Edit Setup Web Control Window Help
----- Powerkey Information -----
System Id:                                0xe00
PAK Status:                               Ready
Secure Micro Serial Number:              02:06:00:3e:56:7e
PAK Version:                             01.00.04
Secure Micro Revision:                   B
Secure Micro Status:                     OK
Communication Status:                    Ready

Encrypted Channels:
  Provisioned: 74

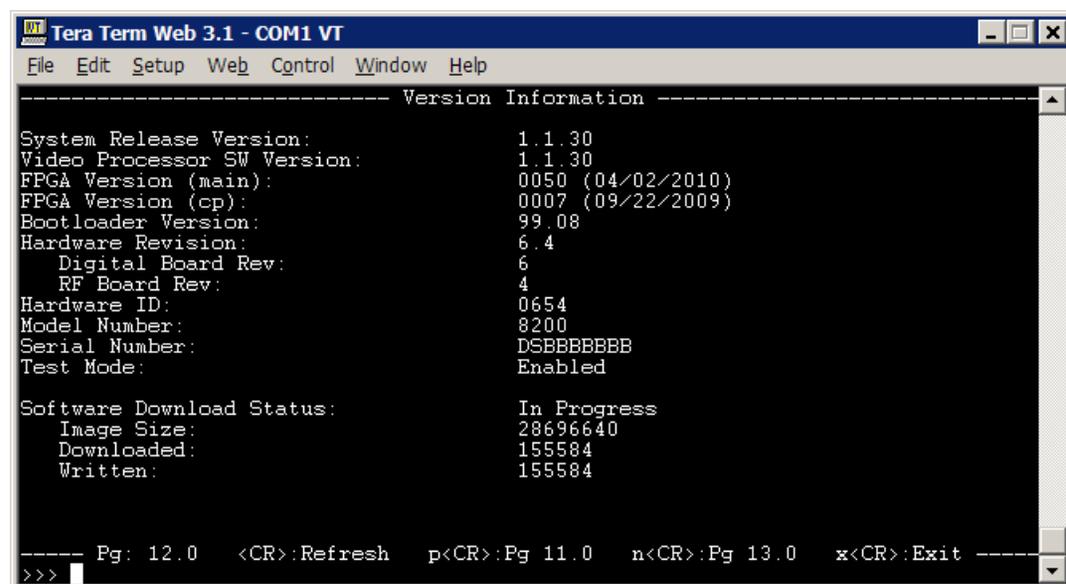
To perform additional monitoring of the download and upgrade, open a CLI session and observe CLI diag page 12.0. This page displays the current download status, and while a download is in progress, also displays the byte count.

```
Tera Term Web 3.1 - COM1 VT
File Edit Setup Web Control Window Help
----- Version Information -----
System Release Version:      1.1.30
Video Processor SW Version:  1.1.30
FPGA Version (main):        0050 (04/02/2010)
FPGA Version (cp):          0007 (09/22/2009)
Bootloader Version:         99.08
Hardware Revision:          6.4
  Digital Board Rev:         6
  RF Board Rev:              4
Hardware ID:                 0654
Model Number:                8200
Serial Number:               DSB888888
Test Mode:                   Enabled

Software Download Status:    In Progress
Image Size:                  28696640
Downloaded:                  155584
Written:                     155584
