Configure In-Service Software Upgrade on Cisco Nexus 9000 and 3100 Series Switches

Overview

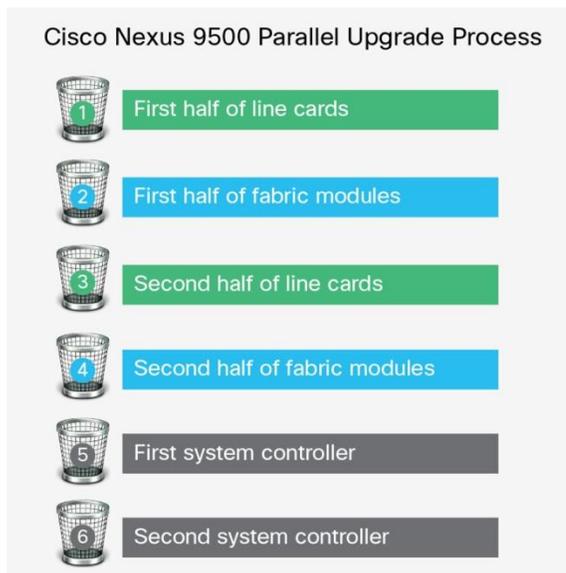
Figure 1. Nexus 9500 Parallel Upgrade Process

Note: The minimum requirement for a modular Cisco Nexus 9000 Series Switch undergoing ISSU is two supervisors, two system controllers and two fabric modules. The Cisco Nexus 9400 linecards can have a partially connected fabric module. In this case, if only two fabric modules are used with the 9400 linecards, the fabric modules should not be in slots 21 and 25. They should be in slots 22, 23, 24, or 26. This allows for the system to maintain high availability during ISSU.
