ILMI Address Registration Problems: %LANE-3-NOREGILMI

Document ID: 10450

This document explains how to troubleshoot Interim Local Management Interface (ILMI) address registration problems on Cisco devices when using LAN emulation (LANE).

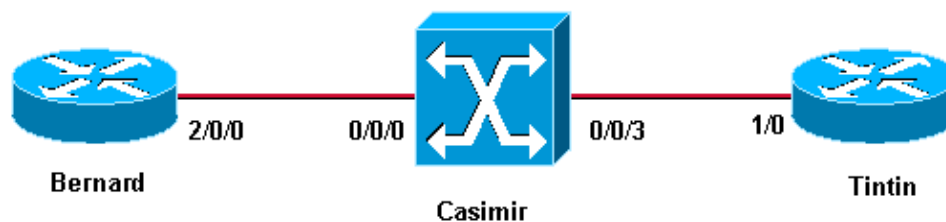
Network Diagram

This setup illustrates the problem:

This setup uses:

- Bernard is a Cisco 7500 router running Cisco IOS® software release 12.1(4).
- Casimir is a LightStream 1010 running Cisco IOS software release 12.0(13)W5(19b)
- Tintin is a Cisco 7000 router running Cisco IOS software release 11.2(22)P.

Note: The configuration used here does not give the best LANE performances; it is simply being used for illustration. For design recommendations regarding LANE services, refer to the LANE Design Recommendations.
