Configure Leaf or Spine Replacement in ACI

This document describes how to replace a leaf or spine switch in the Application Centric Infrastructure (ACI) fabric.

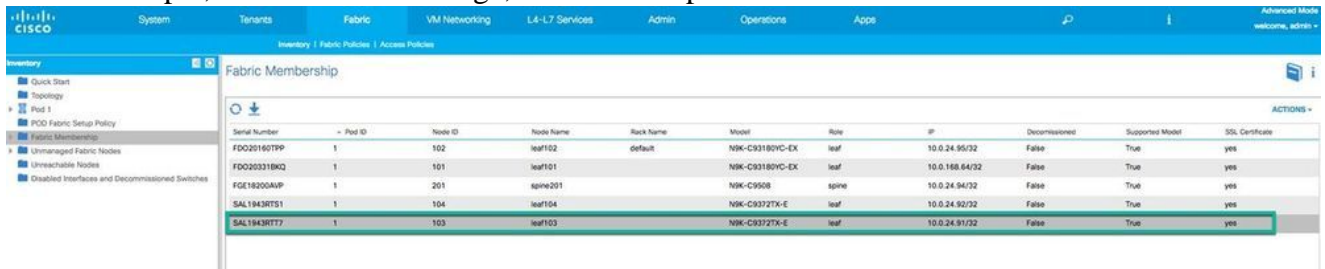
1. In the ACI GUI, navigate to **Fabric > Inventory > Fabric Membership** and identify the switch to be replaced. In this example, as shown in the image, leaf 103 is replaced.

Serial Number	Pod ID	Node ID	Node Name	Rack Name	Model	Role	IP	Decommissioned	Supported Model	SSL Certificate
FDO20160T9P	1	102	leaf102	default	N9K-C93180YC-EX	leaf	10.0.24.95/32	False	True	yes
FDO203318KQ	1	101	leaf101		N9K-C93180YC-EX	leaf	10.0.168.64/32	False	True	yes
FGE18200ANP	1	201	spine201		N9K-C9508	spine	10.0.24.94/32	False	True	yes
SAL1943RTS1	1	104	leaf104		N9K-C9372TX-E	leaf	10.0.24.92/32	False	True	yes
SAL1943RT7	1	103	leaf103		N9K-C9372TX-E	leaf	10.0.24.91/32	False	True	yes

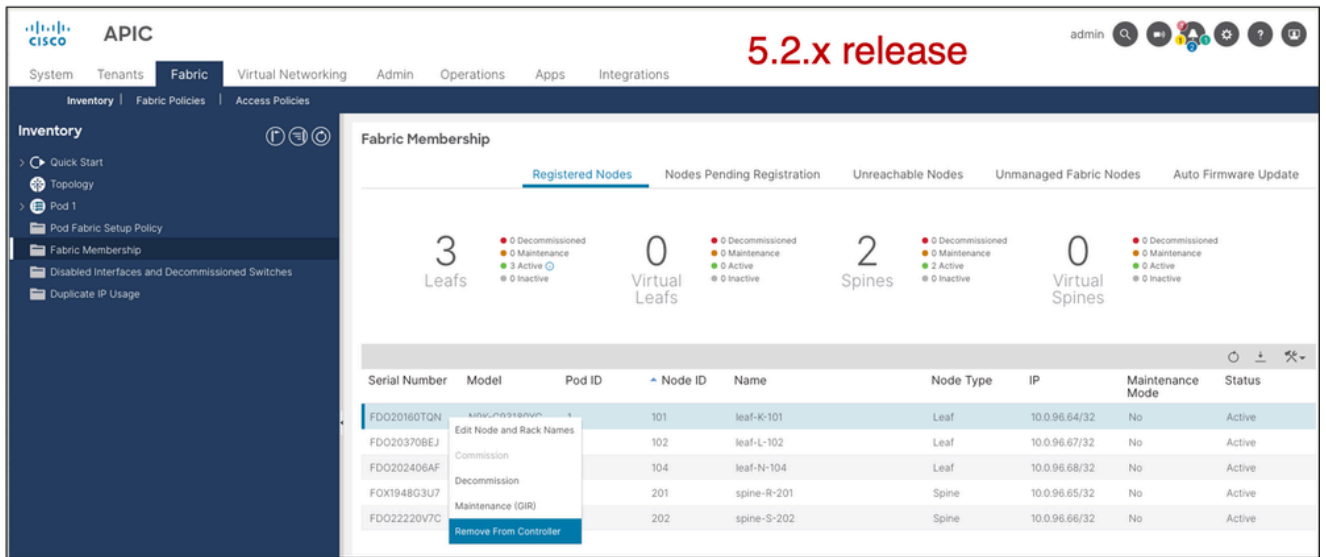
On later releases the GUI option might show up differently. Select **Remove From Controller** for switch replacement on 5.x. On 6.0.x, select **Decommission** and then click **Decommission & Remove** to proceed with the switch removal.

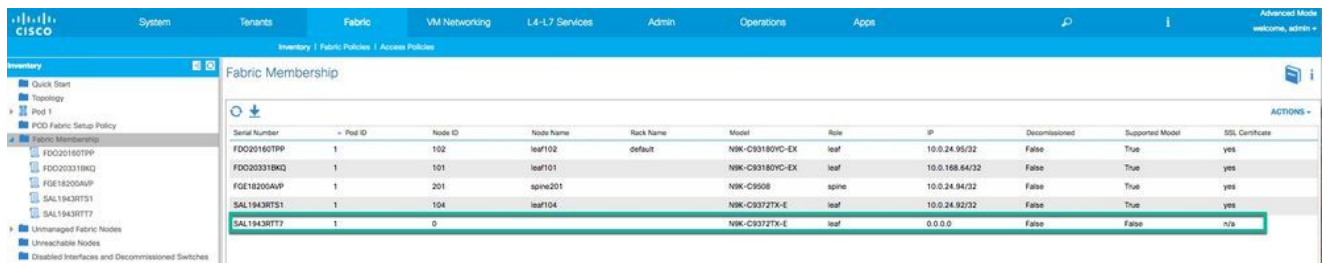
1. Power on the new switch and connect the new switch to the fabric.
2. Navigate back to **GUI > Fabric > Inventory > Fabric Membership** and look for a new switch which does not have an IP address assigned (0.0.0.0) and no node ID assigned, as shown in the image. Cross verify the switch with its serial number.

Serial Number	Pod ID	Node ID	Node Name	Rack Name	Model	Role	IP	Decommissioned	Supported Model	SSL Certificate
FDO201607PP	1	102	leaf102	default	N9K-C93180YC-EX	leaf	10.0.24.95/32	False	True	yes
FDO203318KQ	1	101	leaf101	default	N9K-C93180YC-EX	leaf	10.0.168.64/32	False	True	yes
FGE18200AVP	1	201	spine201	default	N9K-C9508	spine	10.0.24.94/32	False	True	yes
SAL1943RTS1	1	104	leaf104	default	N9K-C9372TX-E	leaf	10.0.24.92/32	False	True	yes
SAL1943RTT7	1	0		default	N9K-C9372TX-E	leaf	0.0.0.0	False	False	n/a

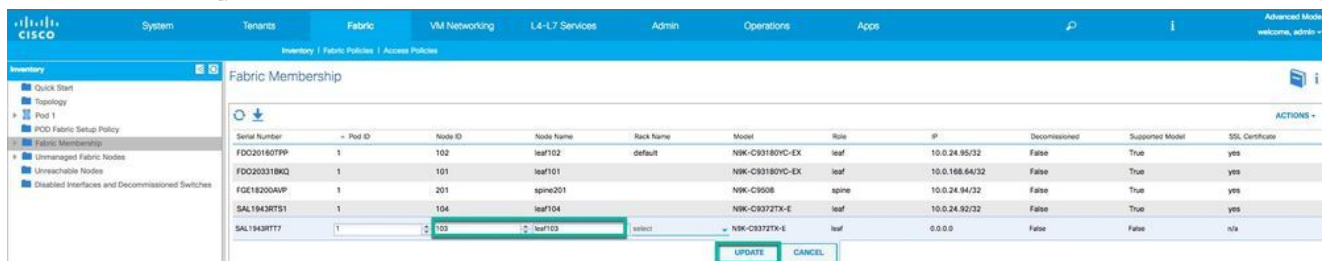
3. As shown in the image, right-click the new switch and from the drop-down list choose **Register Switch**.

Serial Number	Pod ID	Node ID	Node Name	Rack Name	Model	Role	IP	Decommissioned	Supported Model	SSL Certificate
FDO201607PP	1	102	leaf102	default	N9K-C93180YC-EX	leaf	10.0.24.95/32	False	True	yes
FDO203318KQ	1	101	leaf101	default	N9K-C93180YC-EX	leaf	10.0.168.64/32	False	True	yes
FGE18200AVP	1	201	spine201	default	N9K-C9508	spine	10.0.24.94/32	False	True	yes
SAL1943RTS1	1	104	leaf104	default	N9K-C9372TX-E	leaf	10.0.24.92/32	False	True	yes
SAL1943RTT7	1	0		default	N9K-C9372TX-E	leaf	0.0.0.0	False	False	n/a
