Understanding VIP CPU Running at 99% and Rx-Side Buffering

Document ID: 12810

This document explains why the Versatile Interface Processor (VIP) CPU runs at 99%, and what are Rx-side buffers.

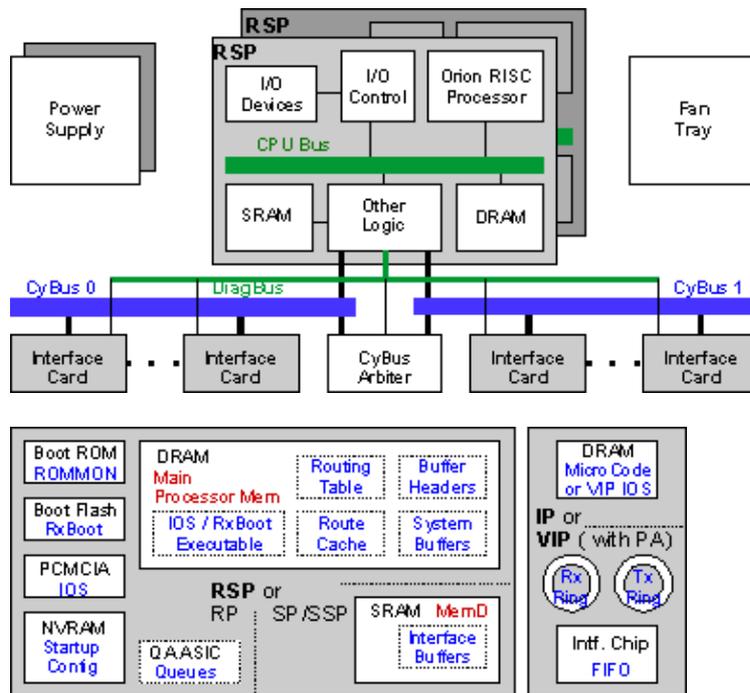
Figure 1 Cisco 7500 Series Architecture

Each interface processor (legacy IP or VIP) has one connection to a high-speed extended system bus called a CyBus. Route/Switch Processors (RSPs) are connected to two CyBuses (see Figure 1).

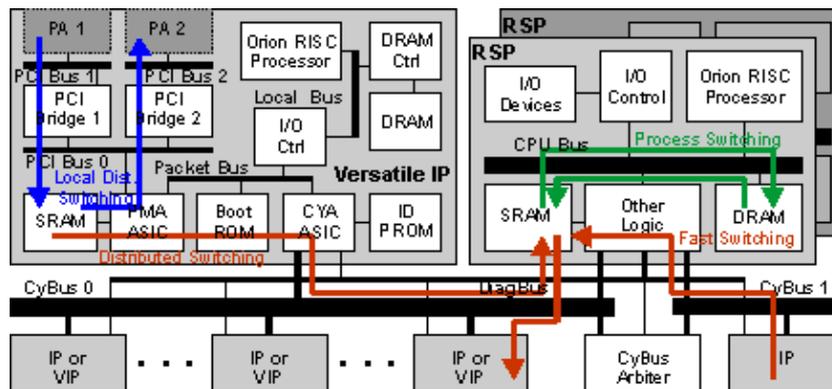
Figure 2 Packet Flow

On a VIP, packet memory contains packet buffers (particles) used for packets received from or sent to a VIP interface. Figure 2 represents packet flow.

This section focusses on a VIP where distributed switching is enabled, because Rx-side buffering usually occurs when a packet follows this type of switching path. Different scenarios are possible, which are explained here:
