# Troubleshoot EIGRP Convergence Time in Catalyst 8500 Dual-Link Failure Scenarios

This document describes the analysis and processing of EIGRP Convergence Time in Catalyst 8500 Dual-Link Failure Scenarios.

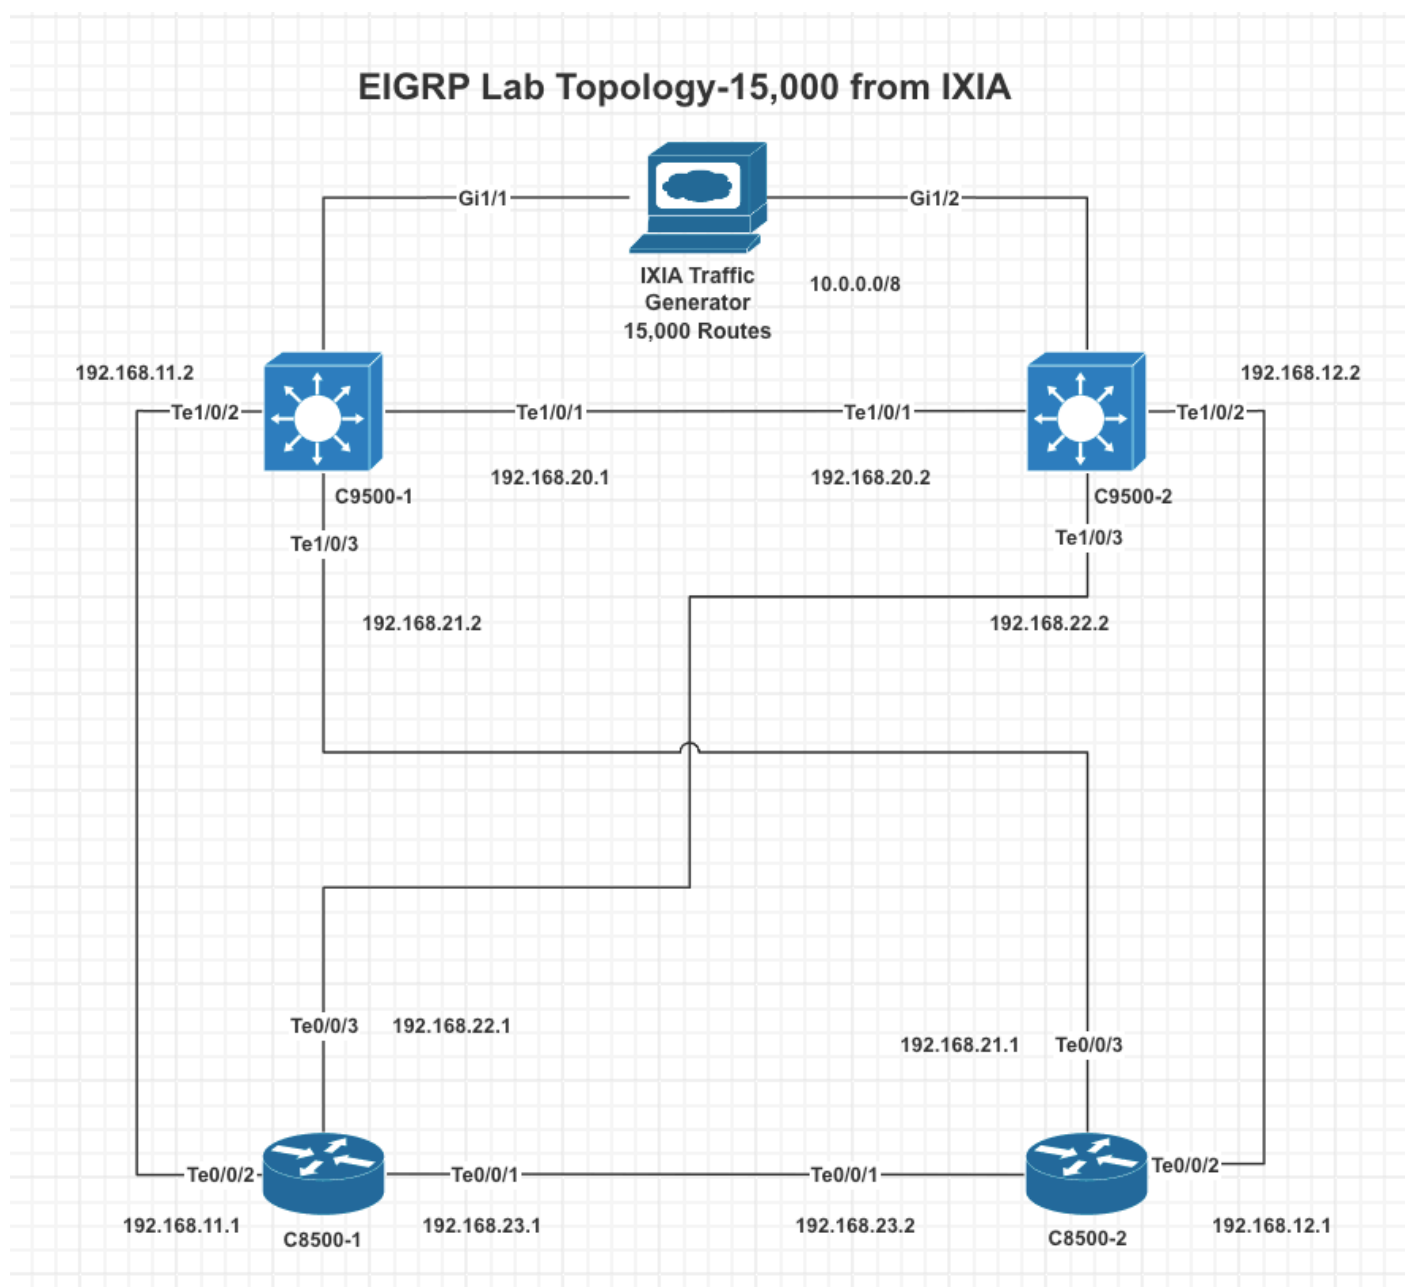
## Topology

The IXIA traffic generator advertised 15,000 routes into the EIGRP domain to simulate a production-scale routing environment.

The issue behavior: After administratively shutting down two EIGRP interfaces simultaneously, one of the routes associated with those interfaces could still be observed in the routing table for a short period. The expected is that all routes learned through the two failed interfaces would disappear immediately after both interfaces were shut down.
