Verify and Troubleshoot Basic NAT Operations

This document describes how to troubleshoot IP connectivity problems in a NAT environment.

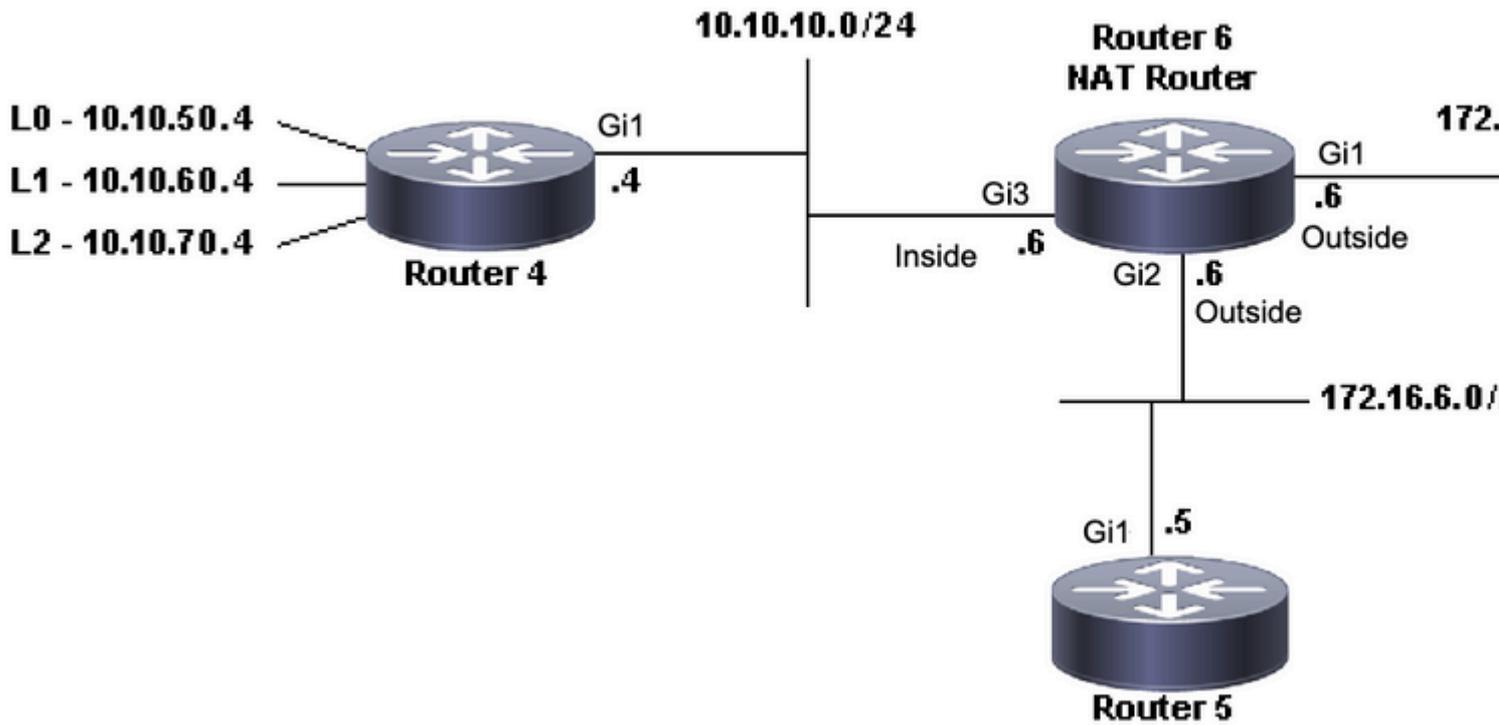
In this first scenario, Router 4 can ping Router 5 (172.16.6.5) but not Router 7 (172.16.11.7):

NAT Topology

After adding the missing route in the NAT Router, the ping is now successful:
