# Understanding EtherChannel Inconsistency Detection

Document ID: 20625

This document provides information on EtherChannel inconsistency and how it is detected in Cisco Catalyst switches.

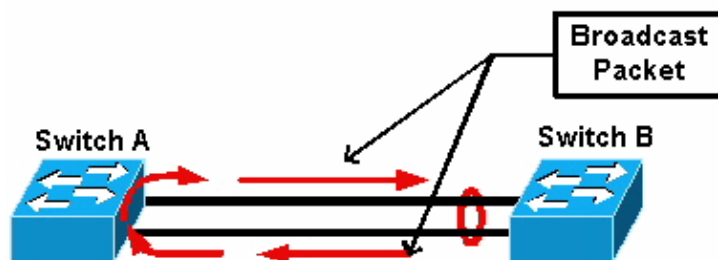
This diagram provides an example:

If switch A has two separate physical links that are not in a channel, and switch B considers those same links to be part of the channel, switch B sends a broadcast or unknown unicast packet to switch A. Since the links are not bundled together as a channel on switch A, the packet is forwarded back to switch B, as seen in the diagram. This causes packet duplication and changes the forwarding table on switch B to point in the wrong direction.

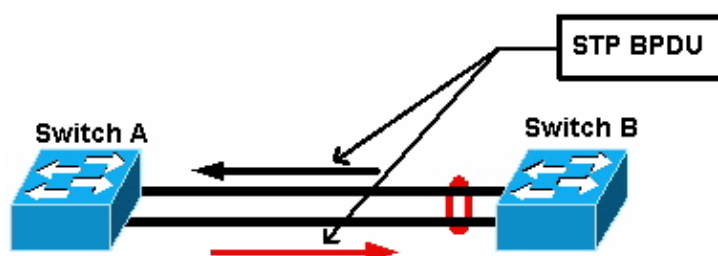
This is not the case if one switch considers the links to be a channel and a neighbor switch considers those links to be separate connections, that is, inconsistent. Consider this example:

In the diagram, switch A does not channel, while switch B channels. Assume that the STP designated port for the channel is on the switch B side. This means that switch B is supposed to send BPDUs. As long as the channel is regarded as a single STP port, only one BPDU is sent for each VLAN on the channel. This BPDU is physically transmitted by one of the links in the channel. Therefore, only one of the ports on switch A receives it. This is represented with a black arrow in the diagram.

After switch A receives the BPDU, the other port on switch A becomes the STP designated port. This is because the port is not bundled as a channel with the port that received the BPDU, and it does not receive BPDUs directly from switch B. As the STP designated port on switch A, it now transmits BPDUs, which are represented by the red arrow in the diagram, back to switch B. Switch B receives BPDUs from switch A, and an inconsistency is detected.
