Replace the ML Series Card for Cisco ONS 15454

Document ID: 66131

This document describes the procedure to replace a Cisco Multi-Layer (ML) Series card for the ONS 15454 platform.

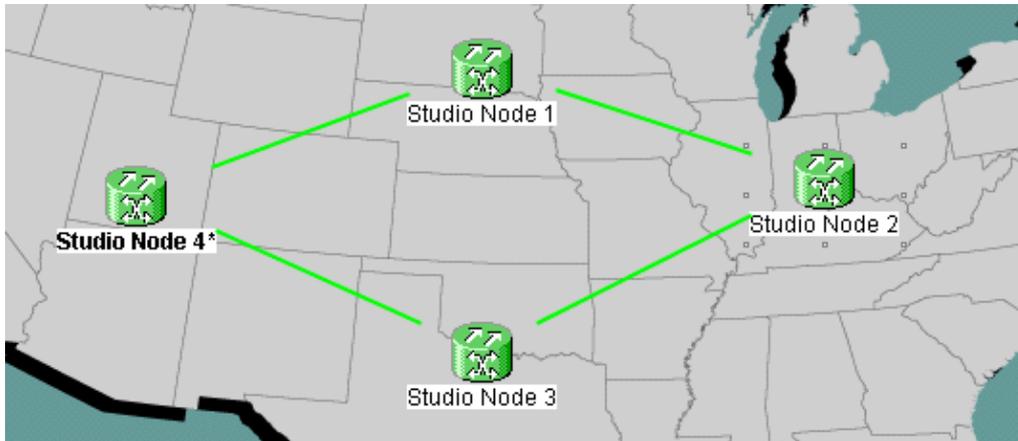
Figure 1 Topology

This document uses a lab setup with four ONS 15454 nodes, namely, Studio Node 1, Studio Node 2, Studio Node 3 and Studio Node 4 (see Figure 1). These four nodes form one OC48 Unidirectional Path Switched

Ring (UPSR).

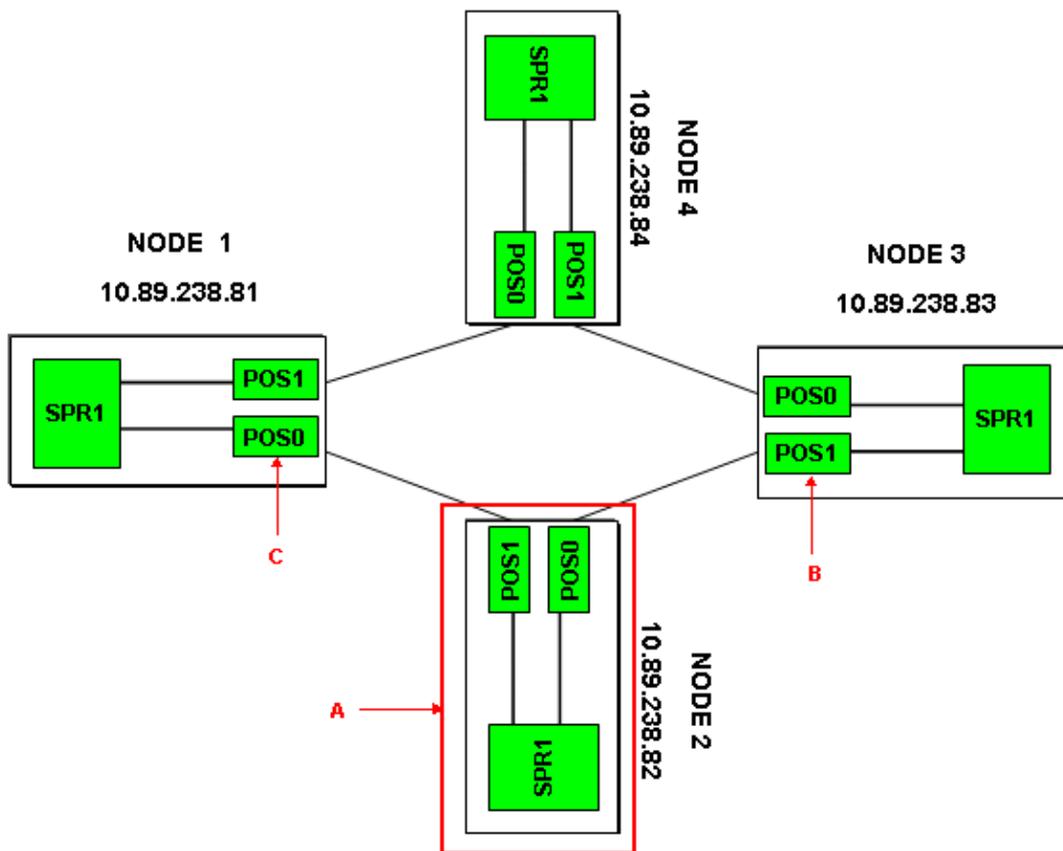
Figure 2 RPR Ring Topology

Each node has one ML 1000 card installed. These four ML cards form one Resilient Packet Ring (RPR). Figure 2 displays the configuration.

This procedure explains how to replace the ML Series card on node 2 with a new card (see arrow A in Figure 2). The two POS interfaces on the two adjacent ML cards are:

- POS 0 on node1 (see arrow C in Figure 2).
- POS 1 on node 3 (see arrow B in Figure 2).

11. Pull out the ML card on node 2 (see arrow A in Figure 2).
12. Insert the replacement ML card on node 2.
13. Wait for the new ML card to become active.
14. Log into the new ML card to verify the IOS configuration. The TCC must download the current IOS configuration to the ML card.
15. Log into the ML card on node 1.
16. Enter the privileged EXEC mode.
17. Open the POS 0 interface. Here is the command:
