Upgrading XC and XCVT Cards to XC10G Cards

Document ID: 21020

This document explains how to upgrade a Cross Connect (XC) or Cross Connect Virtual Tributary (XCVT) card to a Cisco ONS 15454 XC10G card.

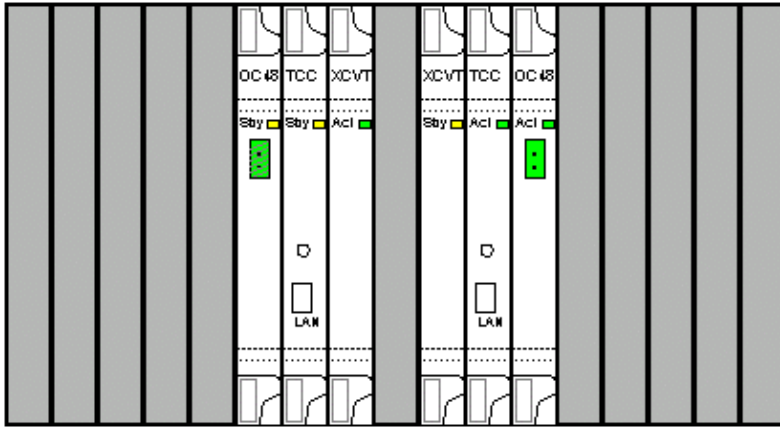
2. Determine the standby XC or XCVT card. The ACT/STBY LED of the standby XC or XCVT card is amber, while the ACT/STBY LED of the active XC or XCVT card is green.

The screenshot shows the CTC interface. On the left, system information is displayed: IP Addr: 10.89.238.122, Booted: 3/6/02 11:01 AM, User: CISCO15, Authority: Superuser. On the right, a card slot diagram is shown with slot 10 highlighted in yellow. Below the diagram is an alarm table.

Alarms										
New	Date	Object	Eqpt Type	Slot	Port	Sev	ST	SA	Cond	Description
<input checked="" type="checkbox"/>	03/06/02 21:29:42 CDT	SLOT-10	XCVT	10		MN	R		IMPROPRM...	Improper Removal

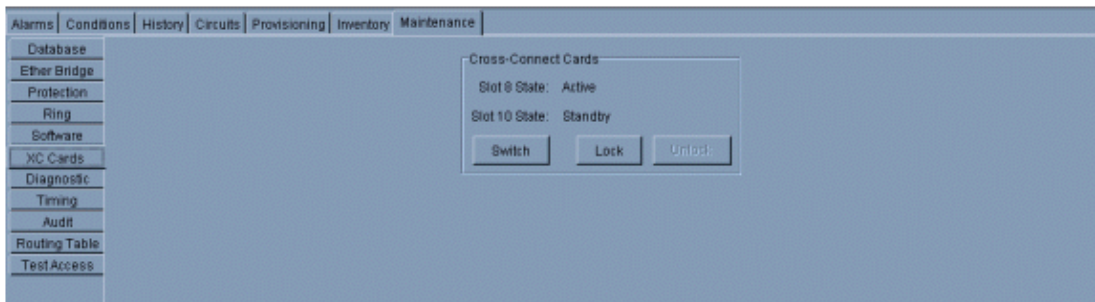
4. Choose the **Maintenance > XC Cards** tabs in the Node view.

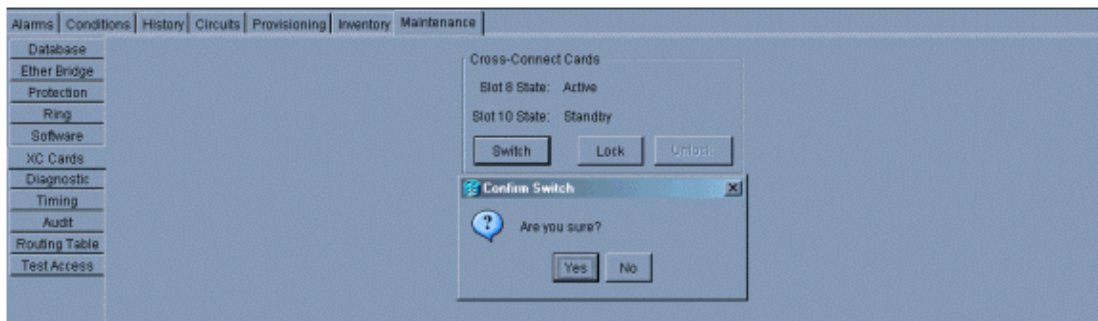
5. Choose **Switch** from the **Cross Connect Cards** menus.
6. Click **Yes** in the Confirm Switch dialog box.

Note: After the active XC or XCVT disengages, the standby slot or first XC10G card becomes active. This causes the ACT/STBY LED on the first XC10G card to change from amber to green.

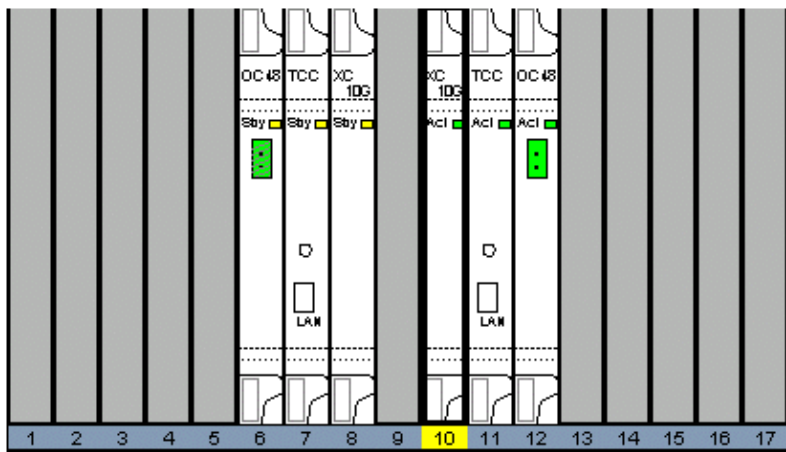
The upgrade is complete when the second XC10G card boots up and becomes the standby XC10G.

Note: CTC shows XCVT cards until the second card fully loads. At this time, both cards in CTC show XC10G.
