# Replacing the Alarm Interface Panel on a Cisco ONS 15454

Document ID: 23153

This document describes how to change the alarm interface panel (AIP) board on a Cisco ONS 15454 shelf.

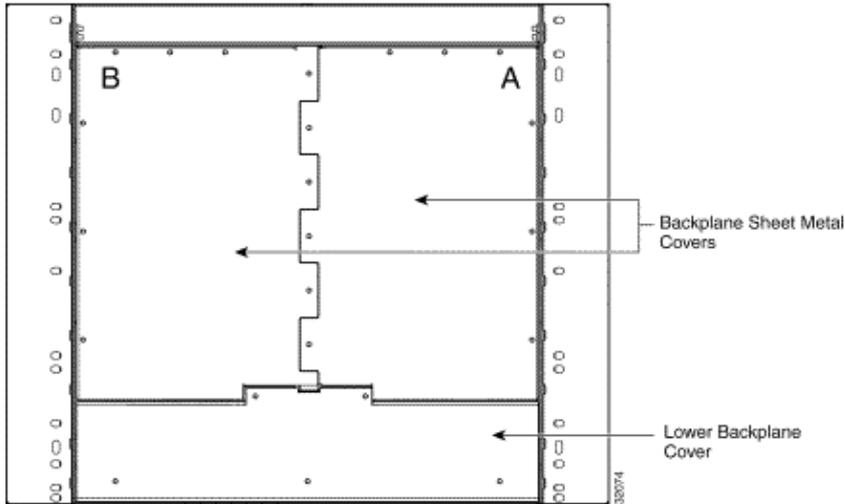
The AIP board is located under lower backplane cover, as shown here:

The lower section of the ONS 15454 backplane is covered by a clear plastic protector, which is held in place by five 6–32 x 1/2 inch screws. Complete these steps to remove this:

- a. Remove the clear plastic cover from the AIP.
  - b. Unscrew the two screws that hold the AIP in place.
  - c. Grip the panel on each side.
  - d. Gently remove the panel from the backplane.
  - e. Remove the fan-tray assembly power cable.
  - f. Attach the fan-tray assembly power cable to the new AIP.
  - g. Place the new AIP on the backplane by plugging the panel into the backplane using the Deutsche Industrie-Norm (DIN) connector.
  - h. Replace the screws that secure the pane to the backplane.
3. Reset both Timing, Communication, and Control Plus (TCC+) cards one at a time.

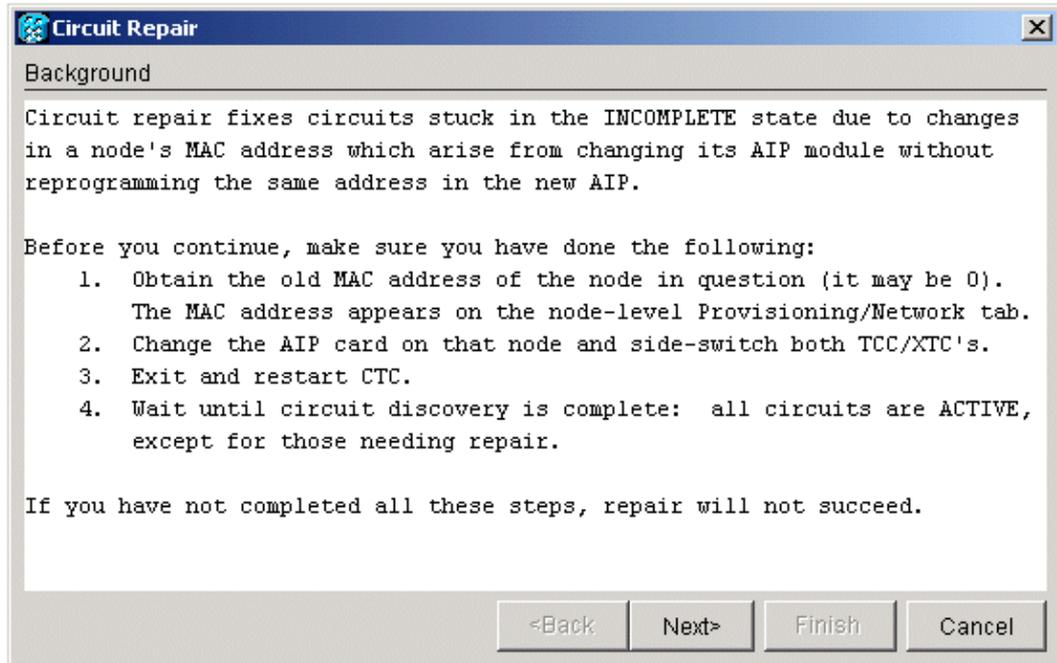
6. Repair the circuits. In the CTC menu, select **Tools > Repair Circuits**. This window displays:

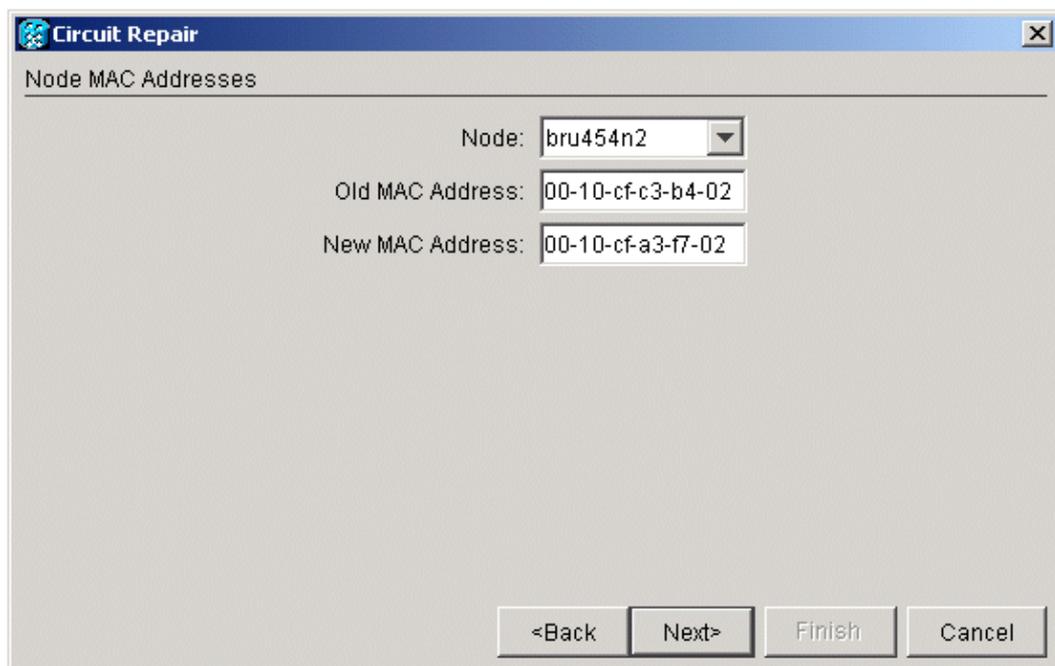
8. Enter the old MAC address (from step 1) and the new MAC address (you can see it in Node view, **Provisioning > Network**) of the new AIP board.

Here is an example:

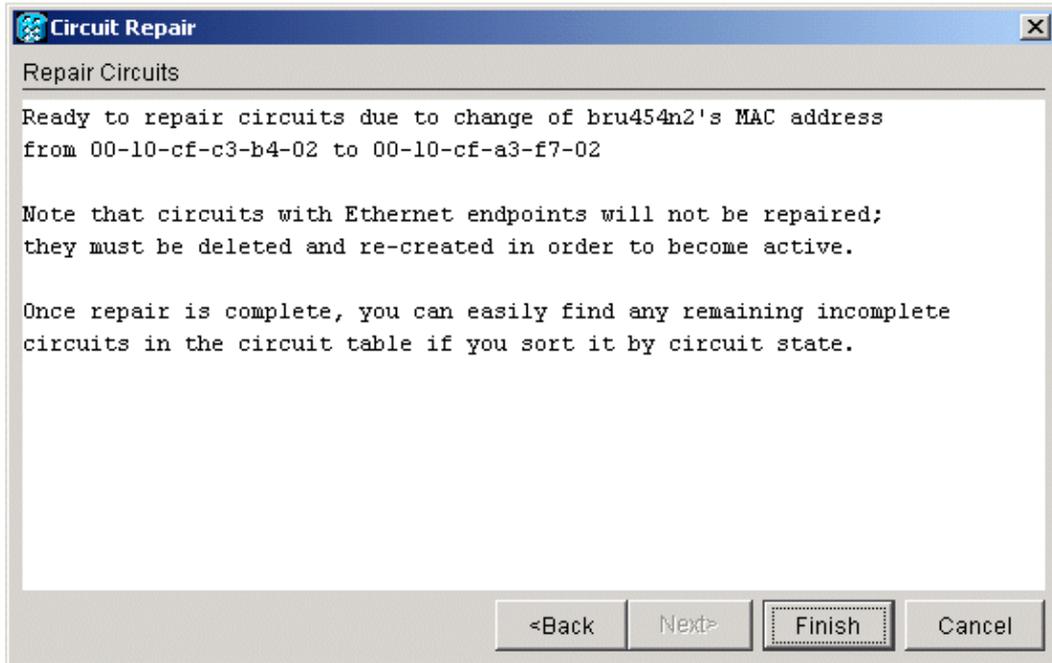
This window displays:

10. Click **Finish** to complete the procedure.
