# Cisco ONS 15454 ML Card Troubleshooting

Document ID: 59863

This document uses a simple test topology to describe how to troubleshoot Multi-Layer (ML) cards on Cisco ONS 15454. The Appendix section provides some basic configuration commands, and detailed topology information.

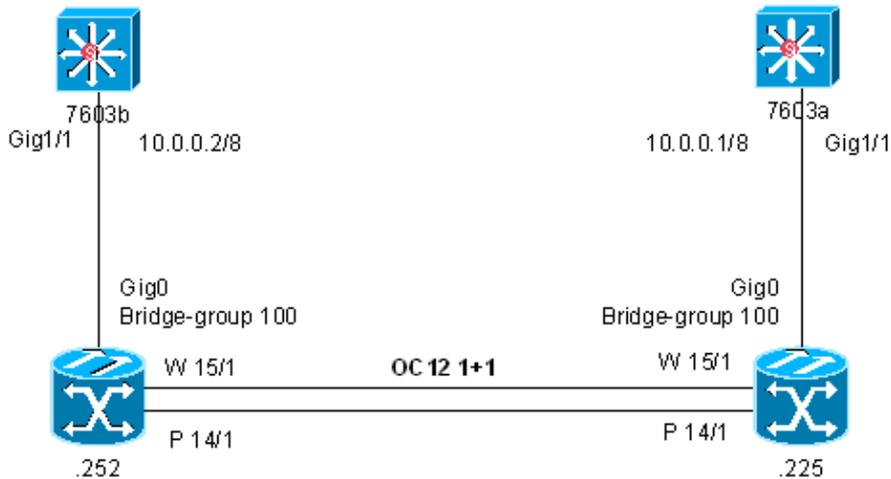
**Figure 1 Test Topology**

Figure 1 represents the test topology:

1. Connect two Cisco 7603 routers to ONS nodes over Gigabit Ethernet, and ensure that both ports on the two routers are on the same IP subnet. Here, each ONS node has one ML1000–2 card in slot 12.
2. Configure a bridge–group 100 for Gig0 and POS0 on both ONS nodes.

3. Disable IP routing on ML cards.
4. Provision OC12 1+1 protection between the two ONS nodes. See Figure 1 for the relevant information.
