# Troubleshooting PSE and NSE Events on POS Interfaces

Document ID: 18932

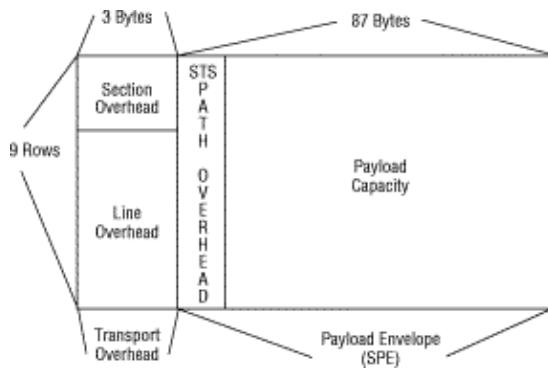
**Figure 1** The Format of an STS-1 Frame

Each Synchronous Transport Signal (STS-1) consists of 810 bytes, which includes 27 bytes for the transport overhead and 783 bytes for the Synchronous Payload Envelope (SPE). The format of an STS-1 frame and the nine rows by 90 columns are illustrated in .

The transport overhead section breaks down into section overhead and line overhead. The line overhead includes the H1 and H2 bytes. The SONET protocol uses these bytes to identify the position of the payload in the SPE portion of the frame. This table illustrates the location of the H1 and H2 bytes:
