# ASR Single Chassis Migration to nV-Edge System Configuration Example

Document ID: 117642

Contributed by Aaron Foss, Sakthi Saravanan Malli Somanathan, and Sam Milstead, Cisco TAC Engineers.

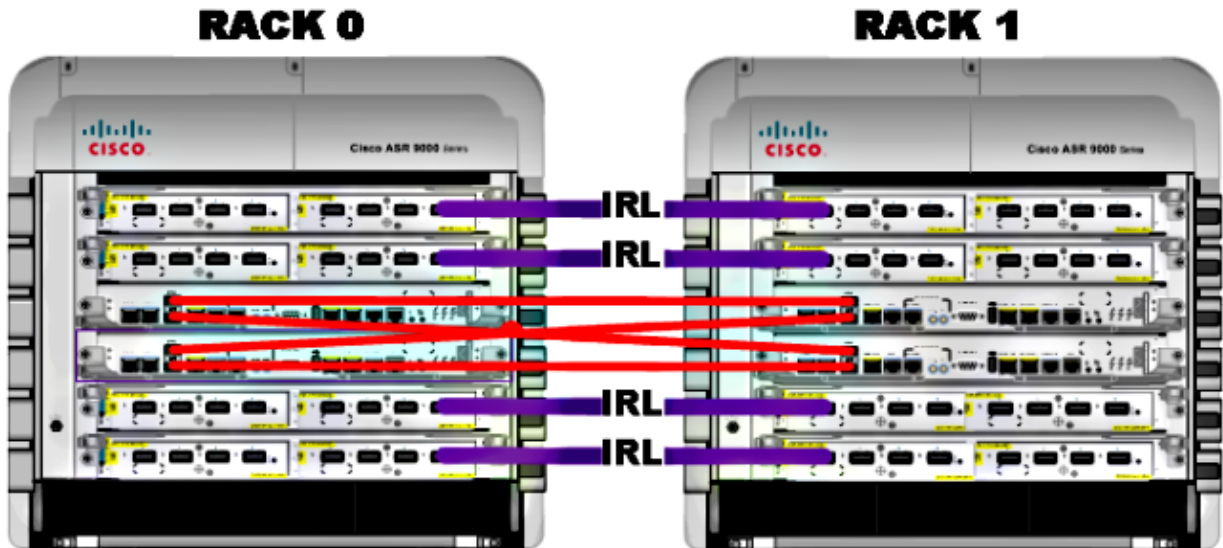
### Network Diagram

The control link or EOBC ports are the control plane connection between the two routers.

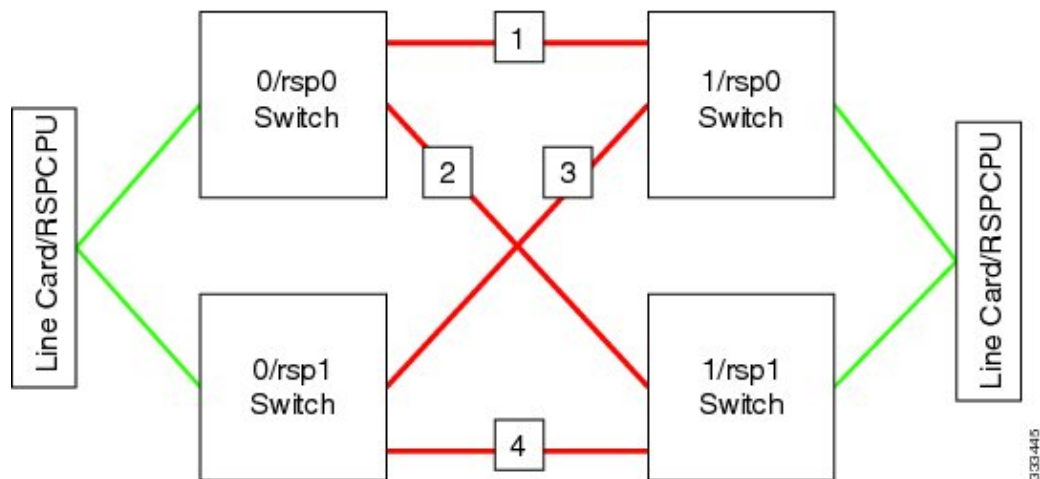
*Note:* The Control links are cross-connected as shown here.

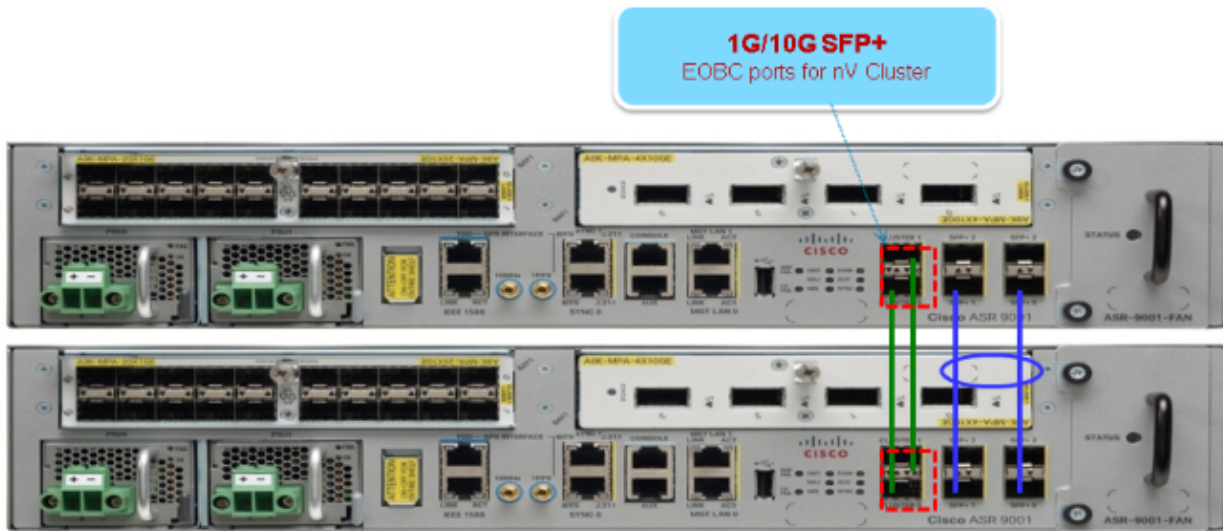
For the 9001, there are two *cluster* ports (pictured in green) that act as the 10G EOBC links. Any 10G port can be used for IRL links including the on-board SFP+ ports (pictured in blue) or a 10G port in a Modular Port Adapter (MPA).
