Parity errors seen on ASR9k

Introduction

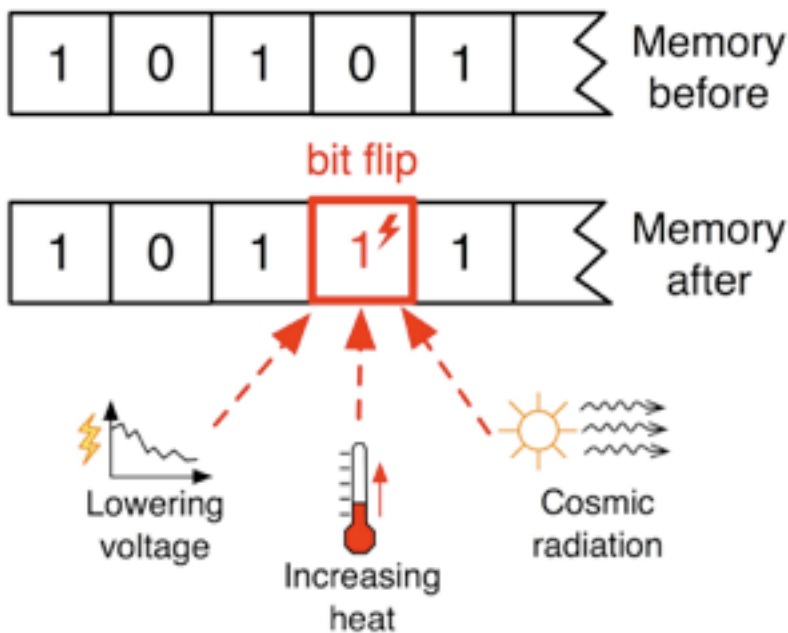
A parity error is a bit flip in memory. In electronics and computing, electrical or magnetic interference from internal or external sources can cause a single bit or memory to spontaneously flip to the opposite state. This event makes the original data bits invalid and is known as a parity error.
