# Parity errors seen on ASR9k

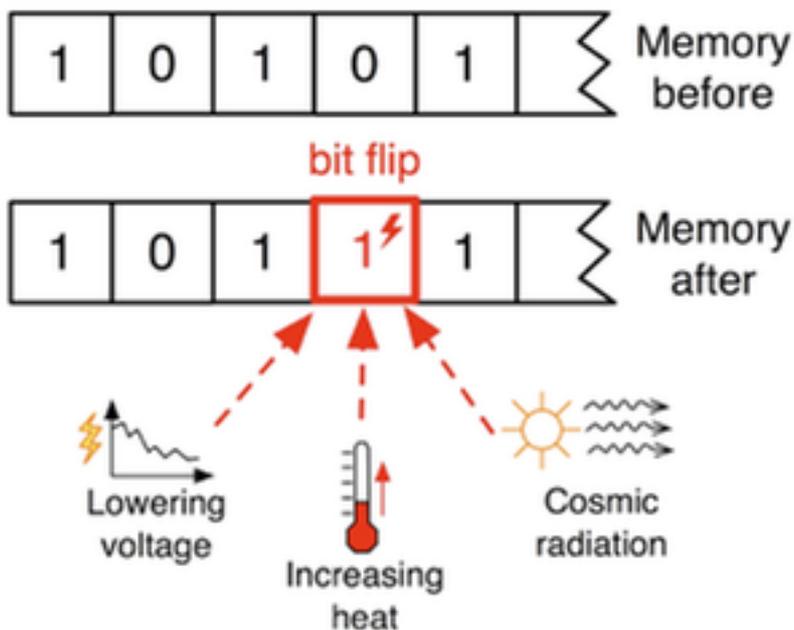
A parity error is a bit flip in memory. In electronics and computing, electrical or magnetic interference from internal or external sources can cause a single bit or memory to spontaneously flip to the opposite state. This event makes the original data bits invalid and is known as a parity error.
