# Troubleshoot FAN Module Failure in ASR 9000

This document describes how to troubleshoot FAN module failure in ASR9k.

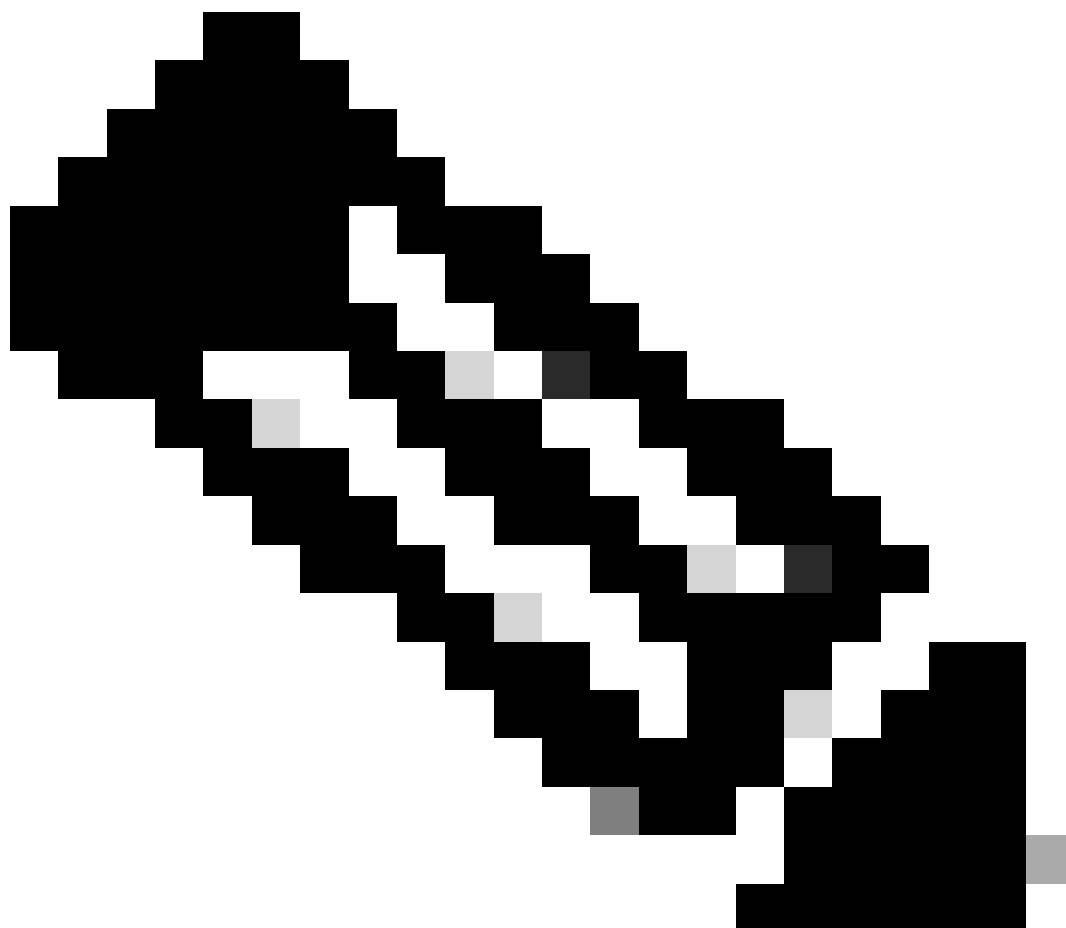
**Note:** If all the FAN Trays are in "OPERATIONAL" , then you can conclude the FAN Tray works fine. Else if any FAN Tray is Non-Operational,it implies FAN Tray is in failed state.

**Step 1.1 Check Plarform Status:** Run this command to identify if it is a FAN Tray failure or ,one or more FAN failure in a FAN Tray.
