Web Interface Not Responding After Firmware Upgrade to Version 1.0.01.18 on RV34x Series Router

RV34x Series

CSCvk05937

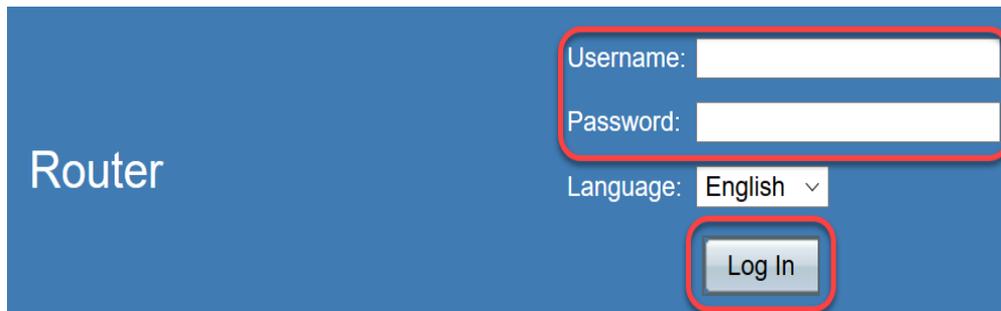
Step 1: Log in to the web-based utility of the router by entering your Username and Password in the fields provided and then click **Log In**.

A screenshot of a web-based utility interface for a router. The background is blue with the word "Router" in white on the left. On the right, there are three input fields: "Username:" with a white text box, "Password:" with a white text box, and "Language:" with a dropdown menu showing "English" and a downward arrow. Below these fields is a "Log In" button. Red rounded rectangles highlight the Username and Password fields, and the Log In button.
