# Hardware Troubleshooting for Catalyst 8540/8510 MSRs and LightStream 1010 ATM Switch: IOS upgrade

Document ID: 21445

## IOS Upgrade

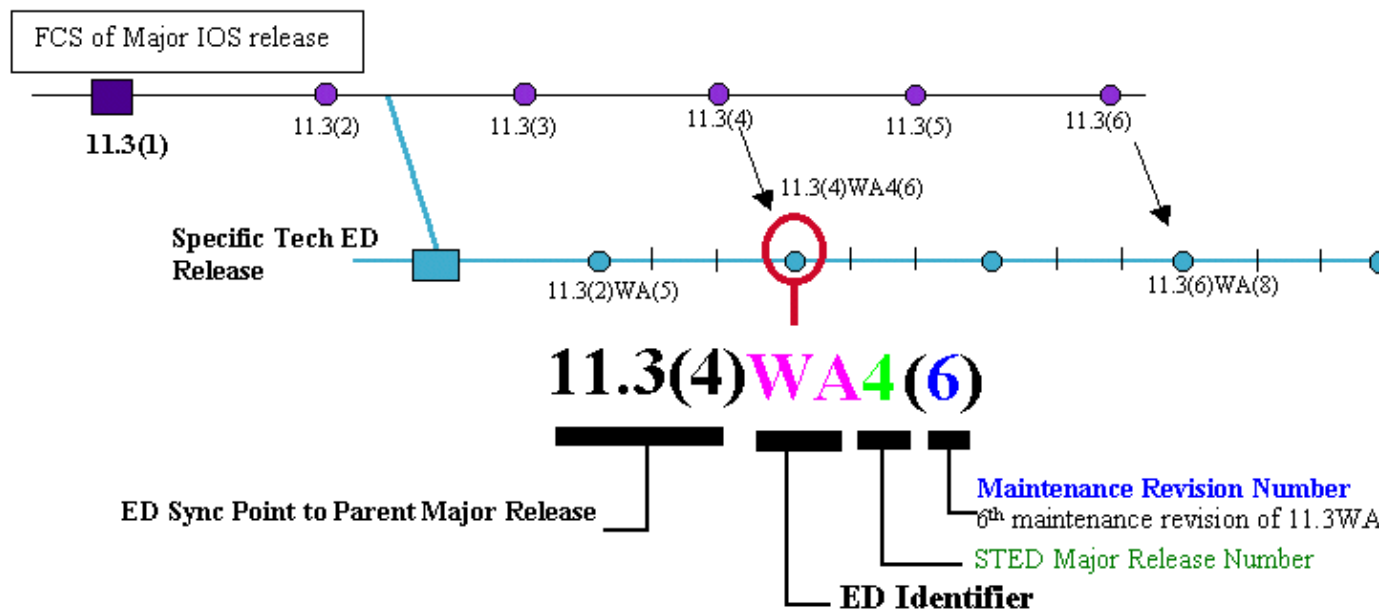
This numbering process applies to Cisco IOS 11.2WA3, 11.3WA4, and 12.0W5 releases. Note that these STEDs do not regularly synchronize to the parent release; however, they always show the synchronize point, indicated by the leading numbers. For example, if the above example was synchronize to 11.3(4a), then the number would have been 11.3(4a)WA4(6)
