# Troubleshoot Layer 3 Interface Configuration Problem in Meraki MS and MX Device

This document describes how to troubleshoot the Layer 3 interface configuration problem in Meraki MS And MX devices.

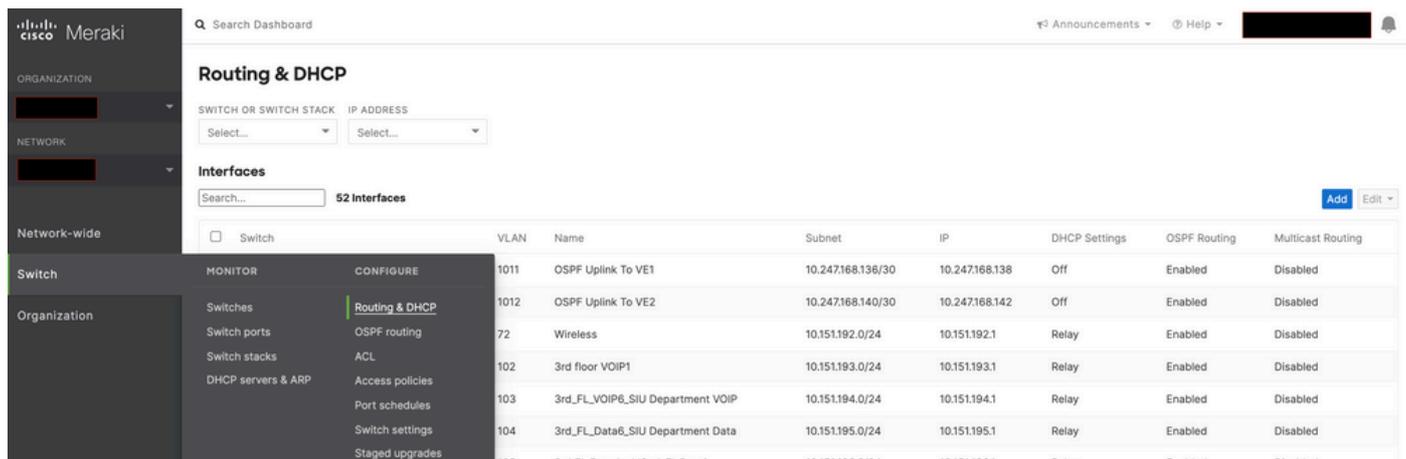
2. Navigate to **Switch > Configure > Routing & DHCP** as shown in the image.
3. In the **Interface** section click **Add** as shown in the image.

Meraki MS Switch Routing & DHCP Setting

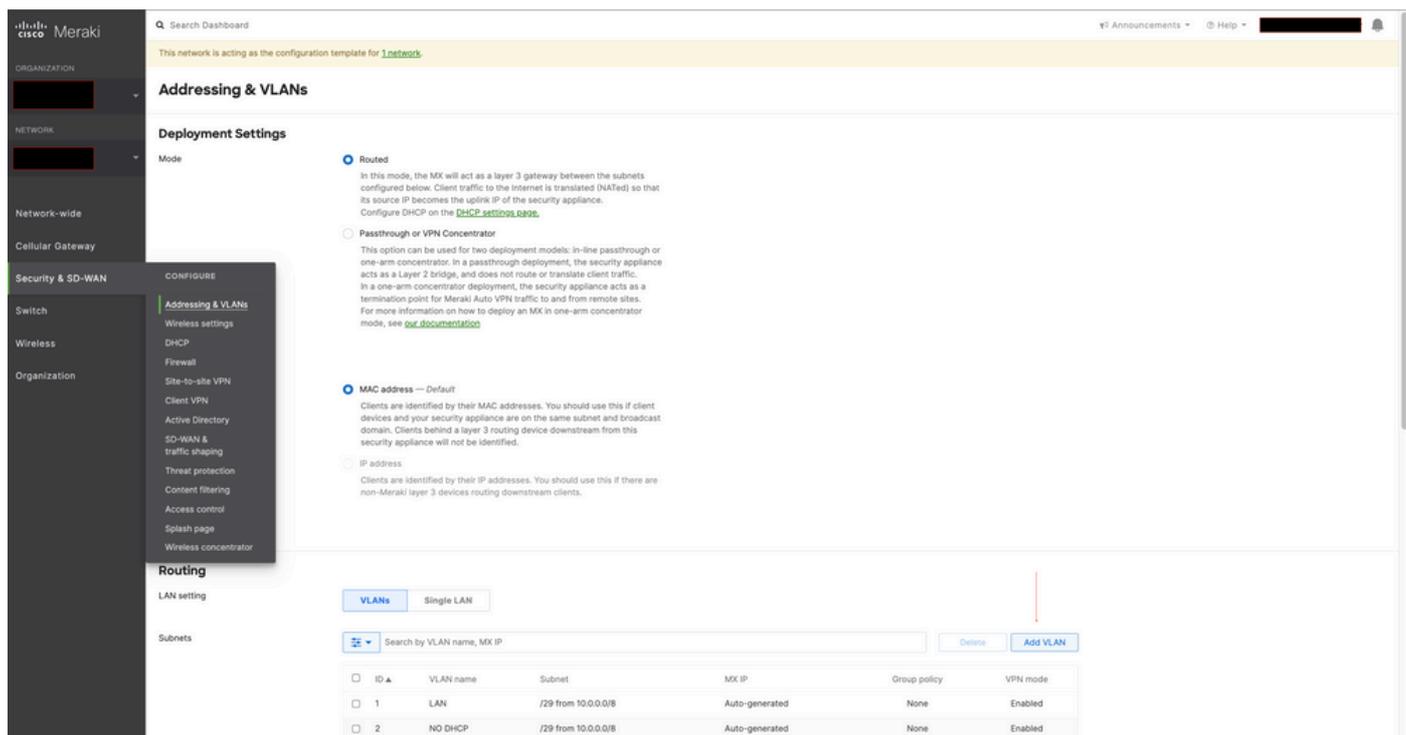
1. Login into the **Meraki** dashboard.
2. Navigate to **Security & SD-WAN > Configure > Addressing & VLANs** as shown in the image.
3. In the **Routing** section click **Add VLAN** as shown in the image.

Meraki MX Security Appliance Routing Setting
