# Troubleshoot COS AP Boot Issues and AP Image Download

This document describes the detailed process of AP Boot Process, AP Upgrade Path, and AP Image Download Methods.

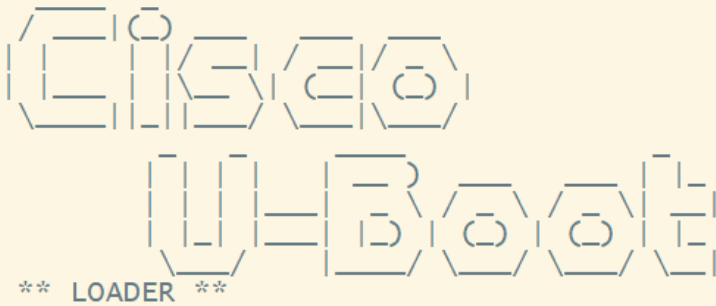
U-Boot Startup Screen

5. Enter U-Boot mode by via the escape (esc) button on your keyboard, you see the option to **Hit ESC to stop autoboot** as seen in the screenshot. This message appears upon reboot of the Access Point while connected to the console port.

Net:    , egiga1, egiga2 [PRIME]
Hit ESC key to stop autoboot:  0
u-boot>>
```
