Monitor and Troubleshoot

Following are some troubleshooting tips for installing and using the Cisco Smart PHY.

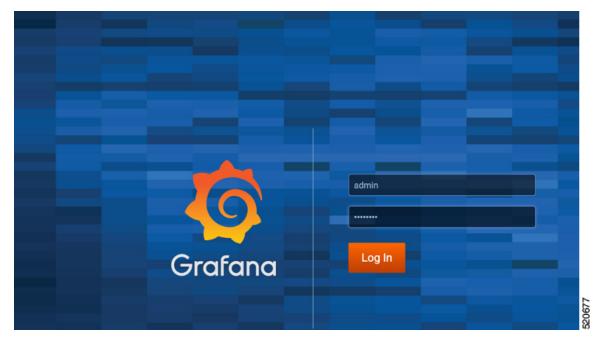
- **Step 1** Access the Grafana dashboard using the following URL: https://grafana.<smartphy-ip>.nip.io/or https://grafana.<fqdn>/
- **Step 2** Log in using the credentials used during the installation.
