Monitor and Troubleshoot

Following are some troubleshooting tips for installing and using the Cisco Smart PHY.

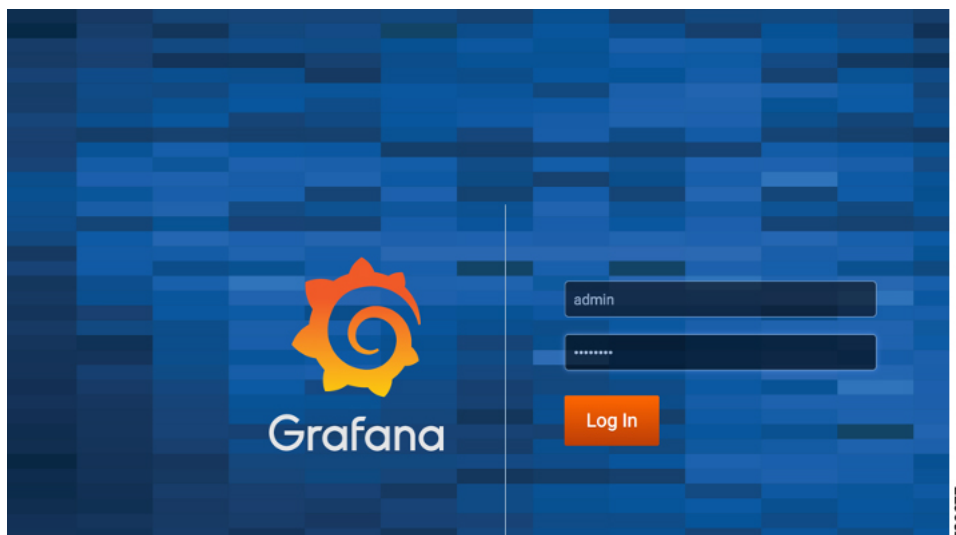
Step 1 Access the Grafana dashboard using the following URL: `https://grafana.<smartphy-ip>.nip.io/` or `https://grafana.<fqdn>/`

Step 2 Log in using the credentials used during the installation.

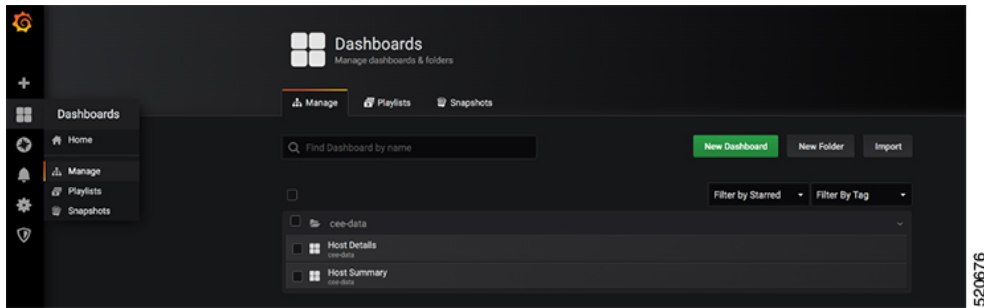
Step 3 Select **Dashboards > Manage**.

Step 4 Click the **cee-data** and then select **Host Details**.

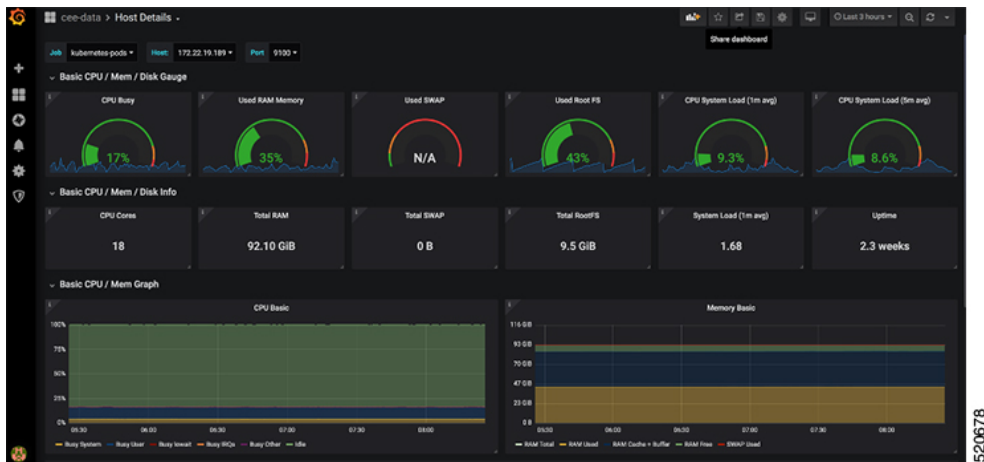
Step 5 To view details of CPU, Memory, or Disk usage, select the **Host** on the top left corner of the screen.

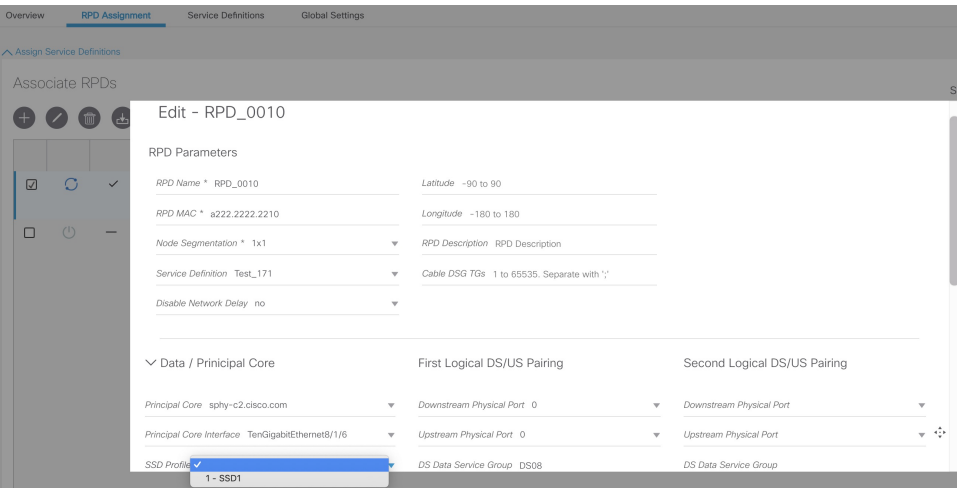
3. Verify the SSD profile ID and the image name in the **Edit** window of the RPD pairing

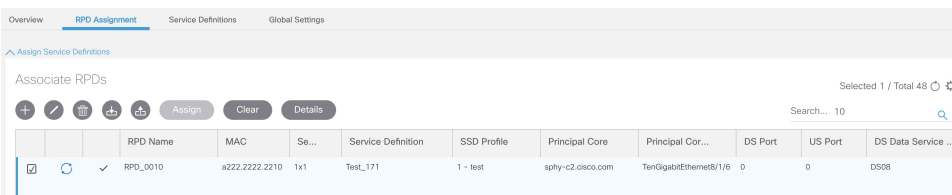
RPD Name	MAC	Se...	Service Definition	SSD Profile	Principal Core	Principal Cor...	DS Port	US Port	DS Data Service ...
RPD_0010	a222.2222.2210	1x1	Test_171	1 - test	sphy-c2.cisco.com	TenGigabitEthernet8/1/6	0	0	DS08
