# Upgrading the Cisco cBR-8 Router System to Cisco IOS XE Gibraltar 16.12.1w

This section contains the upgrade procedures for the Cisco cBR-8 Router System.

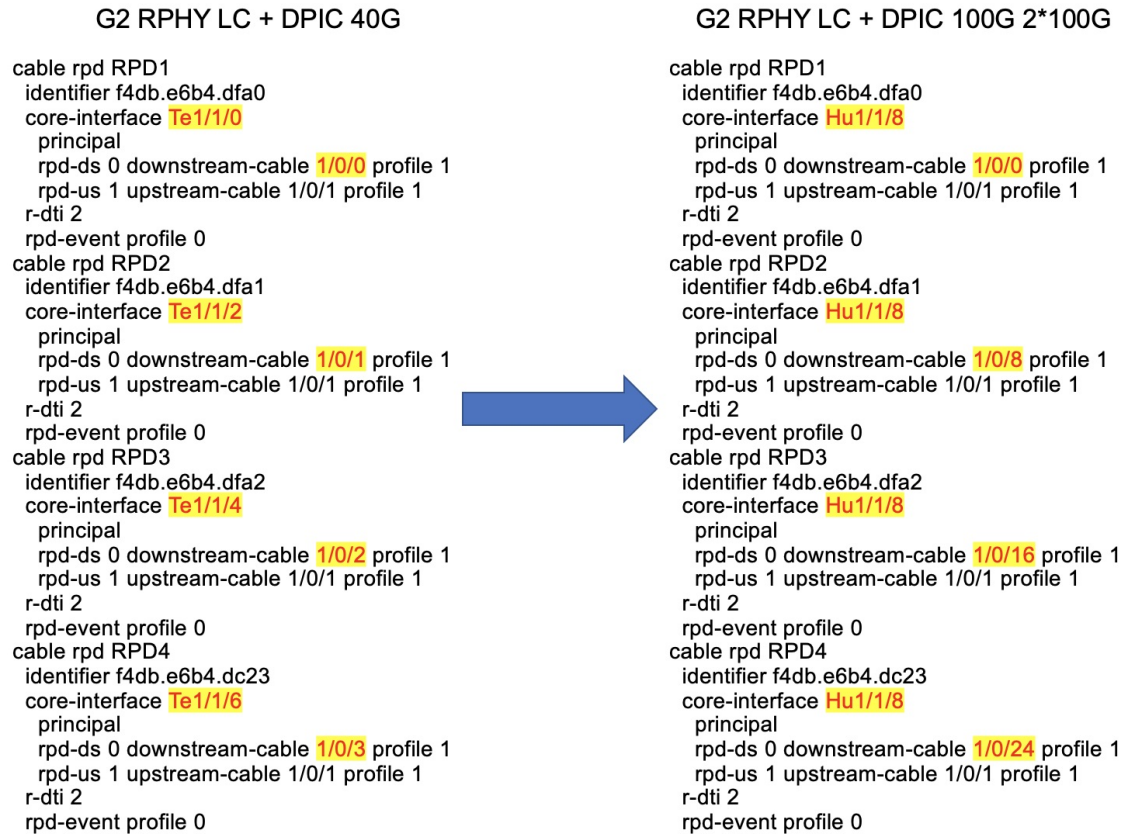
Below is an example of the configuration comparison between G2 RPHY LC + DPIC 40G and G2 RPHY LC + DPIC 100G 2\*100G mode.

For G2 RPHY LC supporting DPIC-100G 2x100G mode, 32 downstream controllers are divided into 4 XFI groups, each XFI group supports 9Gbps data bandwidth at most. The bandwidth restriction is inherited from DPIC 40G design.
