Release Notes for Cisco uBR10012 Universal Broadband Router for Cisco IOS Release 12.2 BC

November 2, 2005

Cisco IOS Release 12.2(15)BC2i

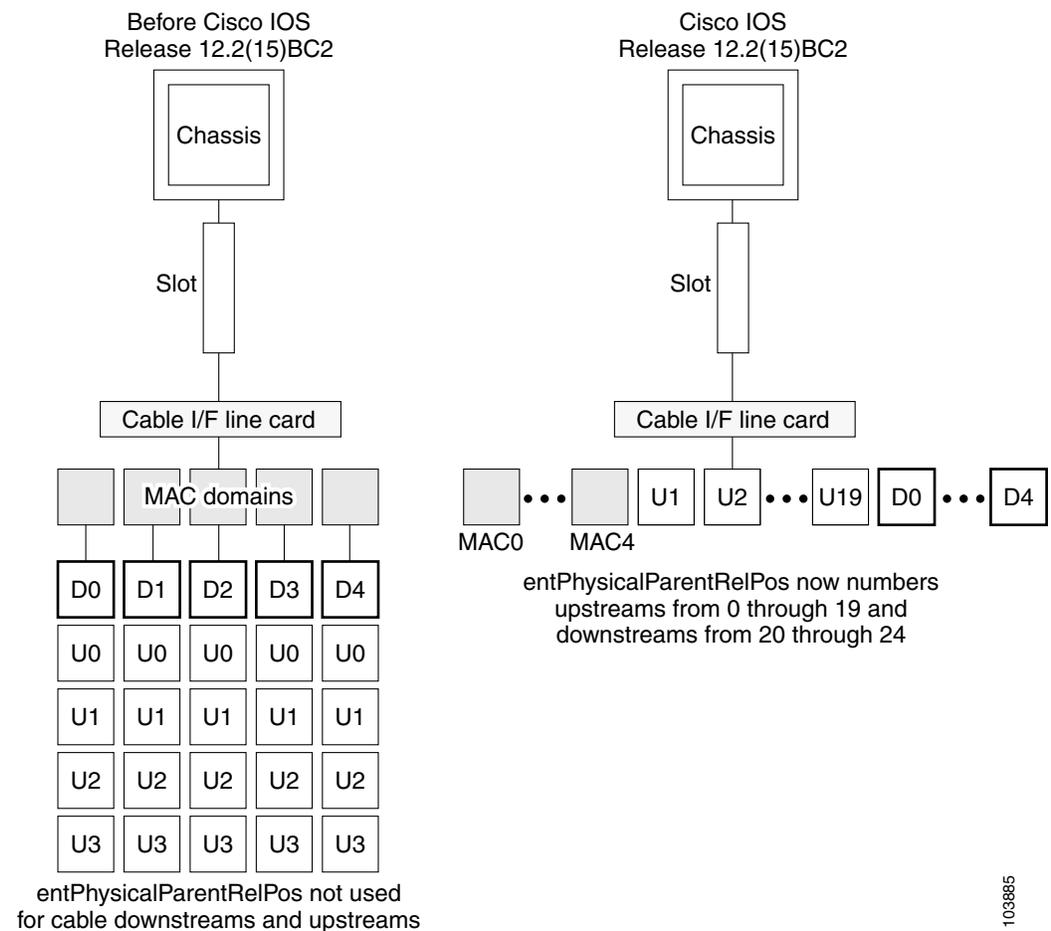
Figure 1 ENTITY-MIB Changes for Virtual Interface Support on Cable Interface Line Cards

Figure 1 shows the difference in how the entPhysicalTable in the ENTITY-MIB organized a Cisco uBR-MC5X20S cable interface line card in previous releases and in Cisco IOS Release 12.2(15)BC2. For consistency, all cable interface line cards use this approach, even if they do not support the Virtual Interfaces feature.

The following are the key points in how the ENTITY-MIB shows the physical relationship of objects when the Virtual Interfaces feature is configured:
