Managing Router Hardware

This chapter describes the concepts and tasks used to manage and configure the hardware components of a router running the Cisco IOS XR software.

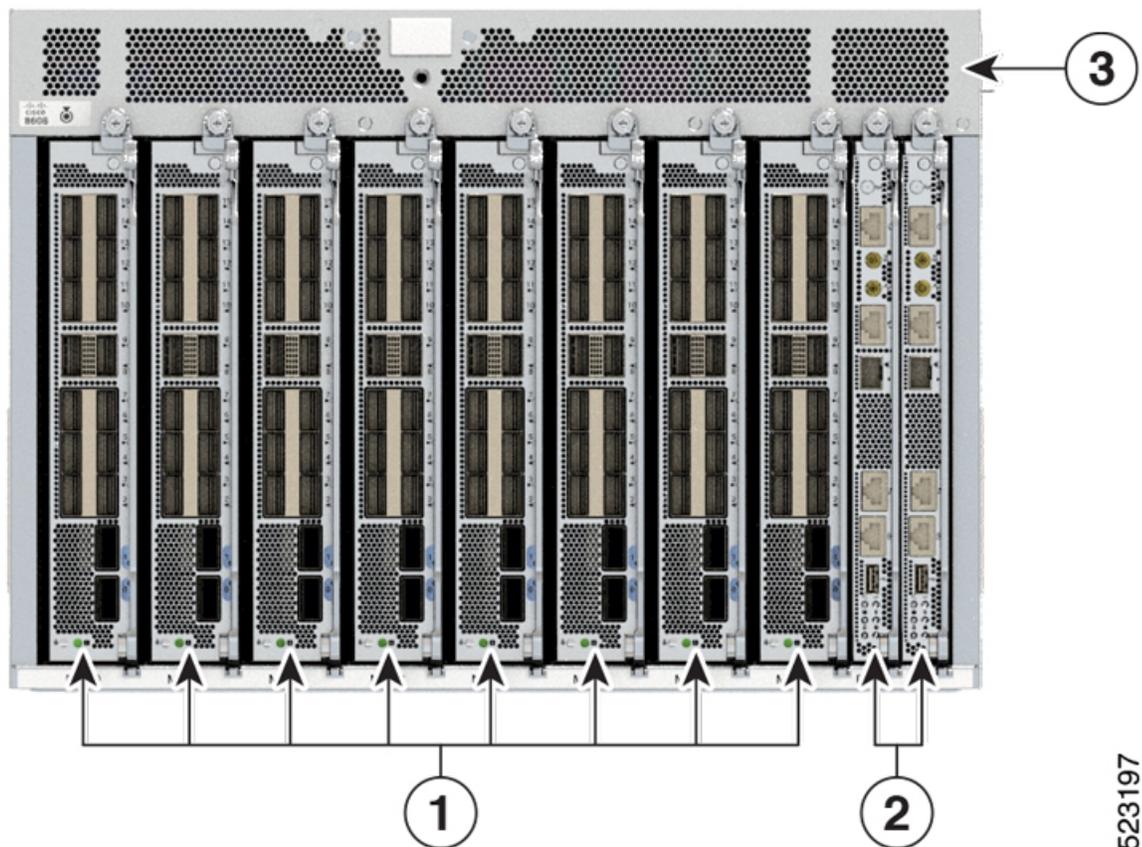
523197

Figure 1: Redundant Set of RP Installed in Slots RP0 and RP1 in an Cisco 8608 8-Slot Centralized Chassis

Your router has two slots for RPs: RP0 and RP1 (see [Figure 1: Redundant Set of RP Installed in Slots RP0 and RP1 in an Cisco 8608 8-Slot Centralized Chassis, on page 2](#) and [Figure 2: Redundant Set of RP Installed in Slots RP0 and RP1 in an Cisco 8808 8-Slot Distributed Chassis, on page 3](#)). RP0 is the slot on the left, facing the front of the chassis, and RP1 is the slot on right. These slots are configured for redundancy by default, and the redundancy cannot be eliminated. To establish RP redundancy, install RP into both slots.

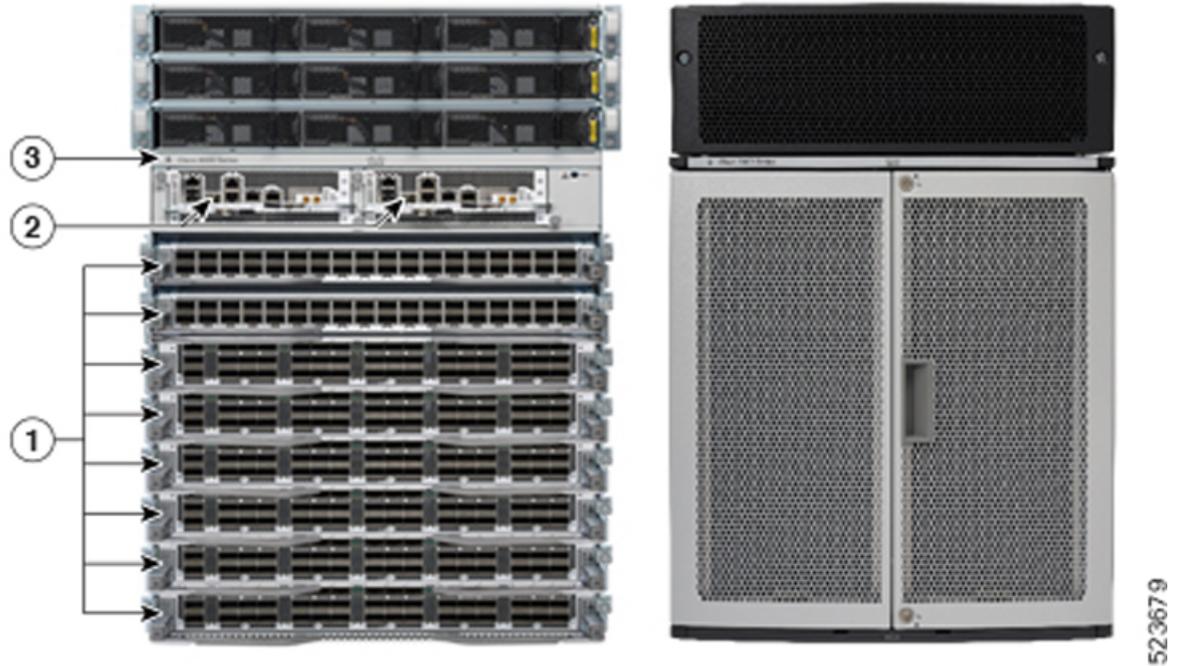
Figure 2: Redundant Set of RP Installed in Slots RP0 and RP1 in an Cisco 8808 8-Slot Distributed Chassis

1	Modular Port Adaptors (MPAs)
2	Route Processors (RPs)
3	Chassis
