## **Cisco ONS 15454 DWDM Troubleshooting Guide, Releases 10.x.x**

**First Published:** 2013-10-14

**Last Modified:** 2017-10-13

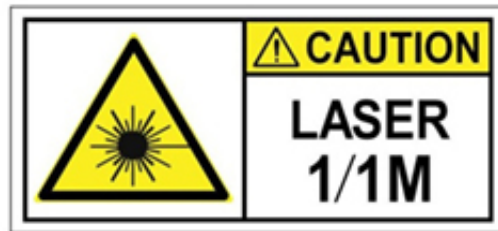
*Figure 1: Class 1M Laser Product Label*

Cisco NCS 2000 Series cards are classified as Laser Class 1 or 1M as per IEC 60825-1 and Hazard Level 1M as per IEC 60825-2.
