## **Cisco ONS 15454 Troubleshooting Guide**

Product and Documentation Release 7.2

Last Updated: September 2010

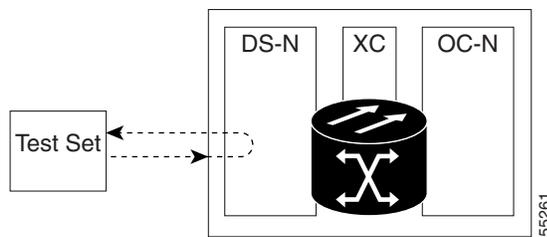
**Figure 1-1 Facility Loopback Path on a Near-End DS-N Card**

A facility loopback tests the line interface unit (LIU) of a card, the electrical interface assembly (EIA), and related cabling. After applying a facility loopback on a port, use a test set to run traffic over the loopback. A successful facility loopback isolates the LIU, the EIA, or the cabling plant as the potential cause of a network problem. [Figure 1-1](#) shows a facility loopback on a DS-N electrical card.

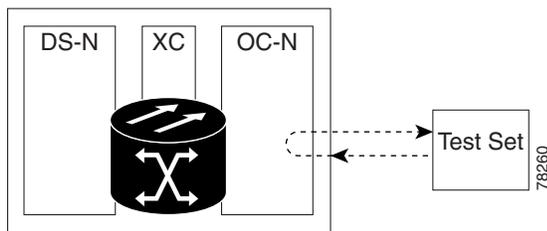
**Figure 1-2 Facility Loopback Path on a Near-End OC-N Card**

To test an OC-N card LIU, connect an optical test set to the OC-N port and perform a facility loopback. Alternately, use a loopback or hairpin circuit on a card that is farther along the circuit path. [Figure 1-2](#) shows a facility loopback on an OC-N card.

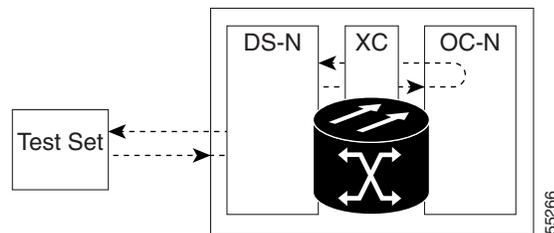
**Figure 1-4** Terminal Loopback Path on an OC-N Card

A terminal loopback tests a circuit path as it passes through the cross-connect card and loops back from the card with the loopback. [Figure 1-4](#) shows a terminal loopback on an OC-N card. The test-set traffic comes into the electrical port and travels through the cross-connect card to the optical card. The terminal loopback on the optical card turns the signal around before it reaches the LIU and sends it back through the cross-connect card to the electrical card. This test verifies that the cross-connect card and terminal circuit paths are valid, but does not test the LIU on the optical card.

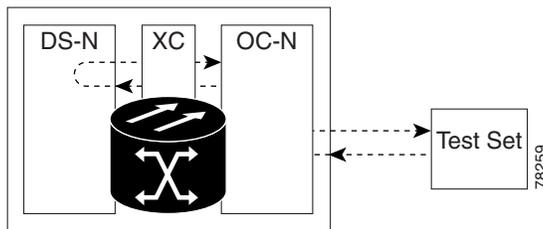
**Figure 1-6 Terminal Loopback Path on a DS-N Card**

Figure 1-6 shows a terminal loopback on a DS-N electrical card. The test-set traffic comes in on the optical card and travels through the cross-connect card to the electrical card. The terminal loopback on the electrical card turns the signal around before it reaches the LIU and sends it back through the cross-connect card to the optical card. This test verifies that the cross-connect card and terminal circuit paths are valid, but does not test the LIU on the electrical card.

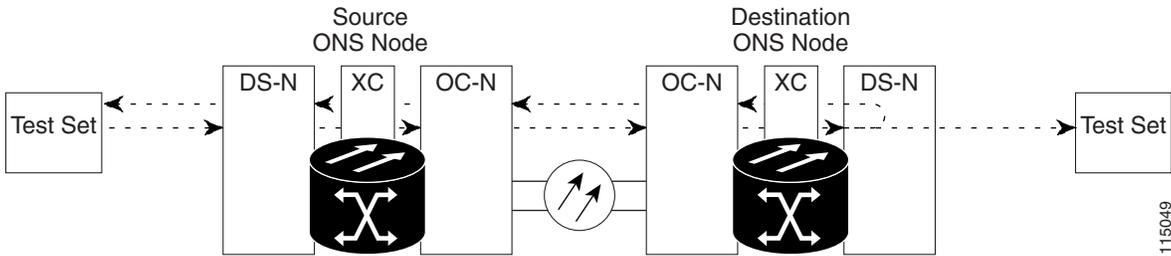
**Figure 1-7 Terminal Loopback on a DS-N Card with a Bridged Signal**

Bridged DS-N and OC-N terminal loopback examples are shown in [Figure 1-7](#) and [Figure 1-8](#).

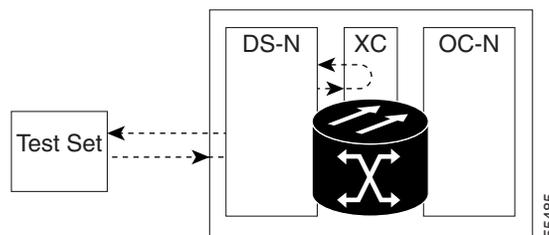
**Figure 1-9** Hairpin Circuit Path on a DS-N Card

Figure 1-9 shows the hairpin circuit path on a DS-N card.

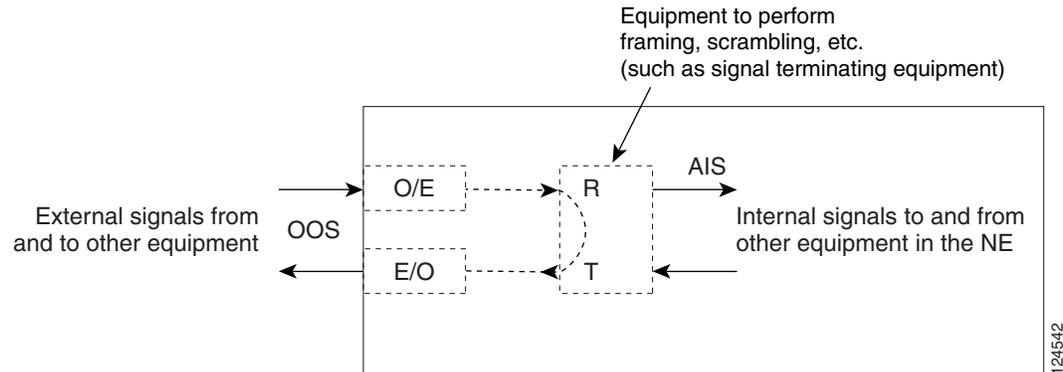
**Figure 1-10 Network Element with SONET Cross-Connect Loopback Function**

The XC loopback breaks down the existing path and creates a new cross-connect—a hairpin—while the source of the original path is set to inject a line-side AIS-P. The loopback signal path and AIS injection are shown in Figure 1-10.

A cross-connect (XC) loopback tests an OC-N circuit path as it passes through the cross-connect card and loops back to the port being tested without affecting other traffic on the optical port. Cross-connect loopbacks are less invasive than terminal or facility loopbacks. Facility and terminal loopback testing and circuit verification often involve taking down the whole line; however, a cross-connect loopback allows you to create a loopback on any embedded channel at supported payloads of STS-1 granularity and higher. For example, you can place a loopback on a single STS-6c on an optical facility without interrupting the other STS circuits.

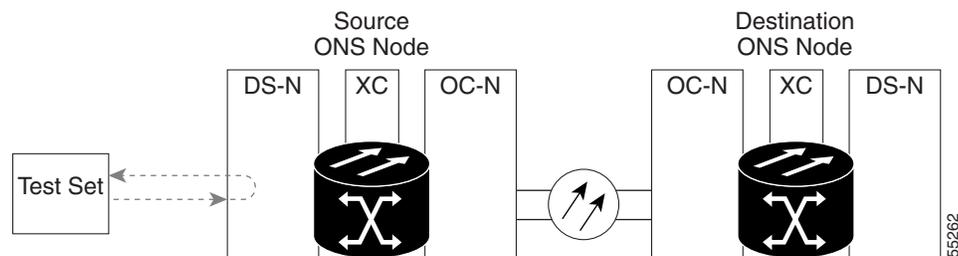
**Figure 1-11 Facility Loopback on a Circuit Source DS-N Port**

The facility loopback test is performed on the node's source electrical port in the network circuit; in this example, the DS-N port in the source node. Completing a successful facility loopback on this port isolates the cabling, the electrical card, and the EIA as possible failure points. [Figure 1-11](#) shows an example of a facility loopback on a source DS-N port.

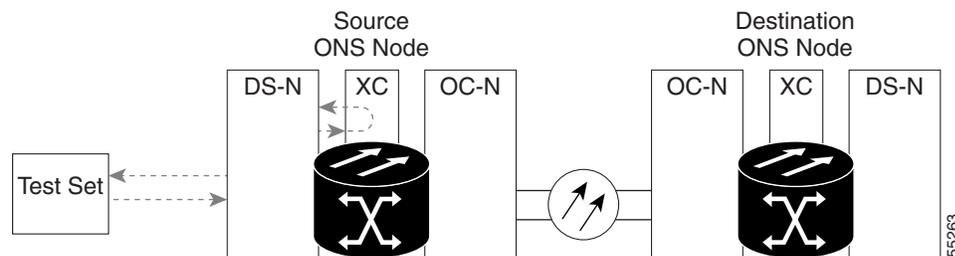
**Figure 1-12** Hairpin on a Source-Node Port

The hairpin test is performed on the cross-connect card in the network circuit. A hairpin circuit uses the same port for both source and destination. Completing a successful hairpin through the port isolates the possibility that the cross-connect card is the cause of the faulty circuit. Figure 1-12 shows an example of a hairpin loopback on a source-node port.

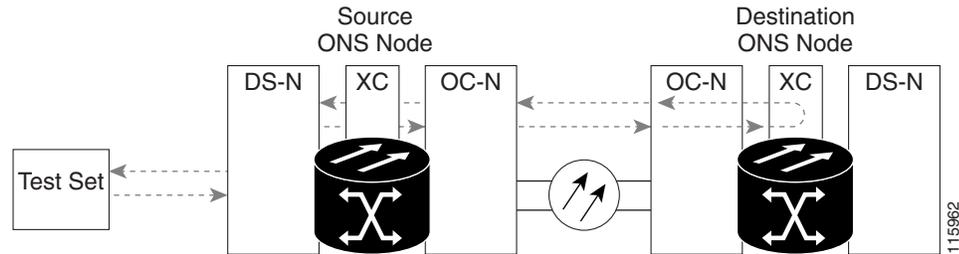
**Figure 1-13** XC Loopback on a Destination OC-N Port

The XC loopback tests whether any problem exists on the circuit’s OC-N span, isolating this span from others present on the card. The loopback occurs on the cross-connect card in a network circuit. [Figure 1-13](#) shows an example of an XC loopback on a destination OC-N port. The traffic pattern looks similar to a terminal loopback but traffic is only carried on one STS instead of affecting the entire port.

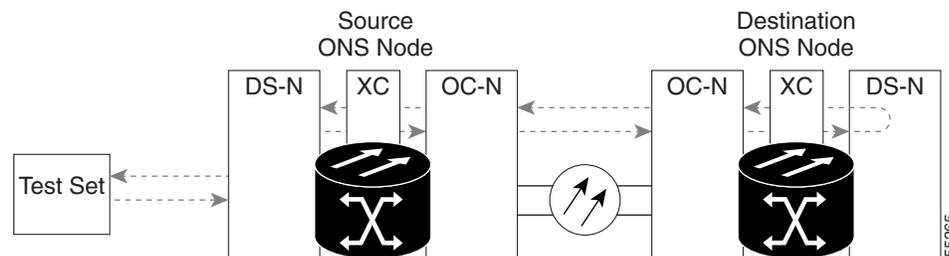
**Figure 1-14** Terminal Loopback to a Destination DS-N Port

The terminal loopback test is performed on the destination-node electrical port in the circuit, such as a destination-node electrical port. You create a bidirectional circuit that starts on the source-node electrical port and loops back on the destination-node electrical port. Then you proceed with the terminal loopback test. Completing a successful terminal loopback to a destination-node electrical port verifies that the circuit is good to the destination electrical port. Figure 1-14 shows an example of a terminal loopback on a destination DS-N port.

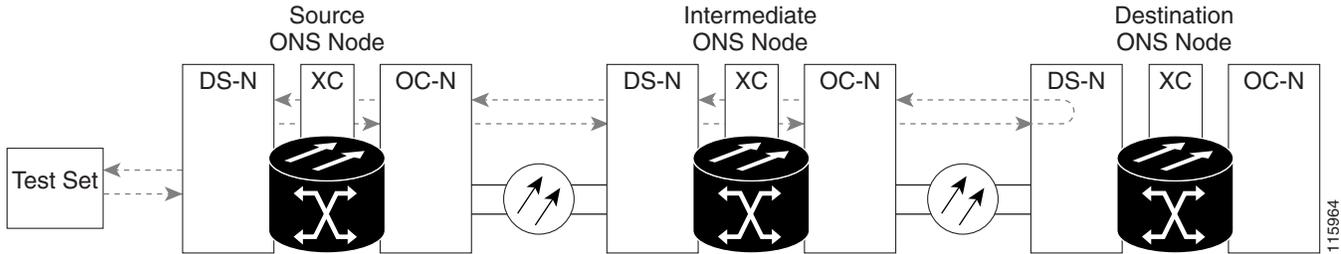
Figure 1-15 Facility Loopback on a Circuit Destination DS-N Port

The facility loopback test is performed on the destination-node electrical port in the network circuit. Completing a successful facility loopback on this port isolates the cabling, the electrical card, and the EIA as possible failure points. [Figure 1-15](#) shows an example of a facility loopback on a destination DS-N port.

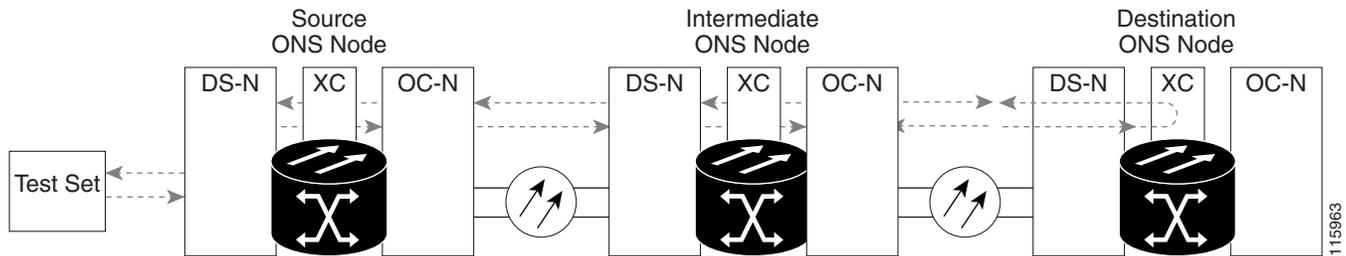
**Figure 1-16** Hairpin on a Destination-Node DS-N Port

The hairpin test is performed on the cross-connect card in the network circuit and uses the same port as source as well as destination. Completing a successful hairpin through the card isolates the possibility that the cross-connect card is the cause of the faulty circuit. [Figure 1-16](#) shows an example of a hairpin loopback on a destination-node port.

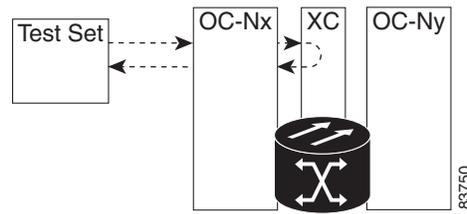
**Figure 1-17** XC Loopback on a Source OC-N Port

The XC loopback tests whether problem exists on the circuit’s OC-N span by isolating this span from others on the card. The loopback also eliminates the cross-connect card as the source of trouble for a faulty circuit. The loopback occurs on the cross-connect card in a network circuit. [Figure 1-17](#) shows an example of an XC loopback on a source OC-N port.

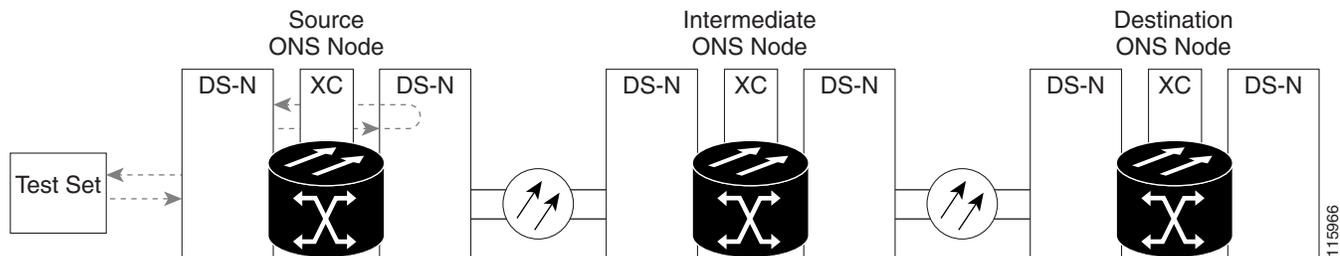
**Figure 1-18** Terminal Loopback on a Source DS-N Port

The terminal loopback test is performed on the source-node electrical port in the circuit, such as a source-node electrical port. You first create a bidirectional circuit that starts on the destination-node electrical port and loops back on the source-node electrical port. Then you proceed with the terminal loopback test. Completing a successful terminal loopback to a source-node electrical port verifies that the circuit is good to the source electrical port. [Figure 1-18](#) shows an example of a terminal loopback on a source DS-N port.

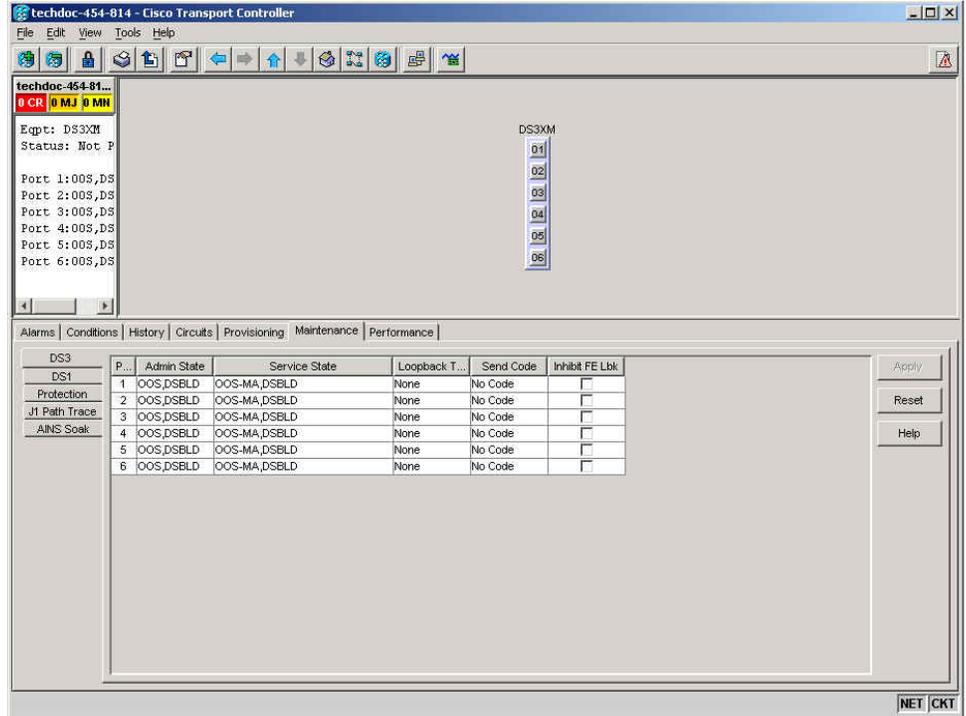
The DS3XM-6 card and DS3XM-12 cards support FEAC functions that are not available on basic DS-3 cards. Click the DS3XM-6 or DS3XM-12 **Maintenance > DS1** tabs at the card view to reveal the two additional function columns. [Figure 1-19](#) shows the DS3 subtab and the additional Send Code and Inhibit FE Lbk function columns.

Figure 1-19 Accessing FEAC Functions on the DS3XM-6 Card

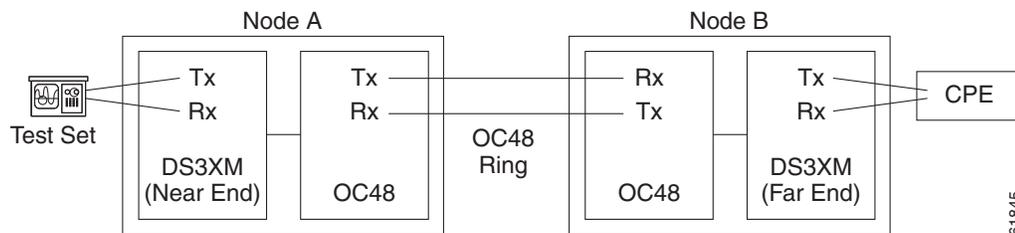
The “far end” in FEAC refers to the equipment connected to the DS3XM card and not to the far end of a circuit. In Figure 1-20, if a DS3XM-6 (near-end) port is configured to send a line loop code, the code will be sent to the connected test set, not the DS3XM-6 (far-end) port.

Figure 1-20 Diagram of FEAC Circuit

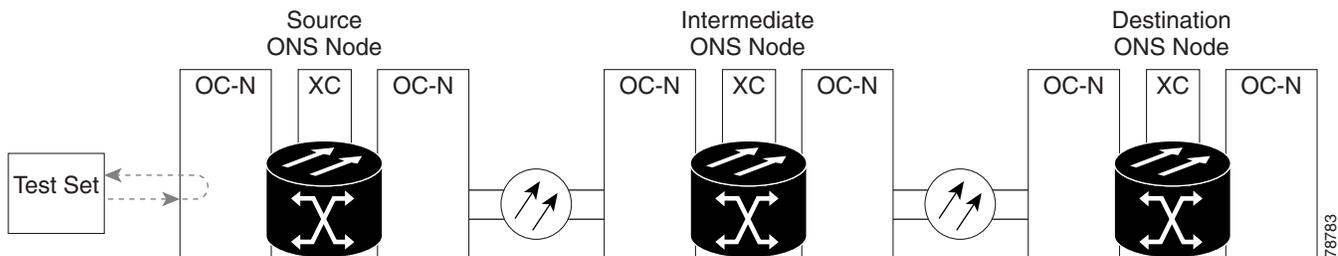
The facility loopback test is performed on the node source port in the network circuit. In the testing situation used in this example, the source OC-N port in the source node. Completing a successful facility loopback on this port isolates the OC-N port as a possible failure point. [Figure 1-21](#) shows an example of a facility loopback on a circuit source OC-N port.

**Figure 1-21 Facility Loopback on a Circuit Source OC-N Port**

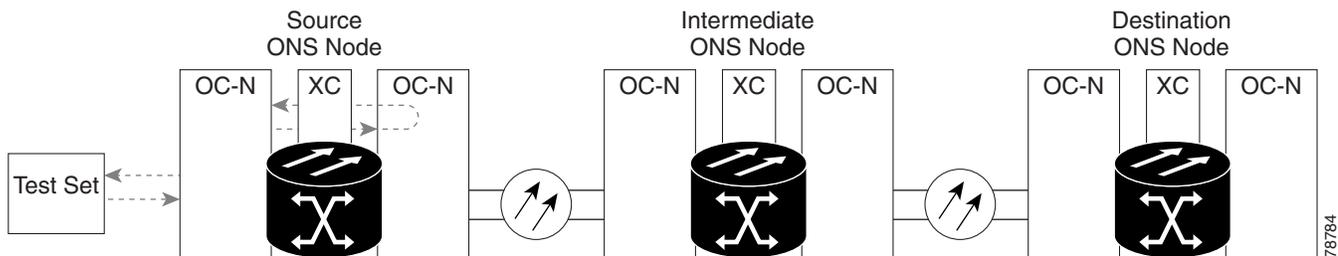
The terminal loopback test is performed on the source-node optical port. For the circuit in this example, it is the source OC-N port in the source node. You first create a bidirectional circuit that starts on the node destination optical port and loops back on the node source optical port. You then proceed with the terminal loopback test. Completing a successful terminal loopback to a node source port verifies that the circuit is good to the source port. Figure 1-22 shows an example of a terminal loopback on a source OC-N port.

**Figure 1-22** Terminal Loopback on a Source-Node OC-N Port

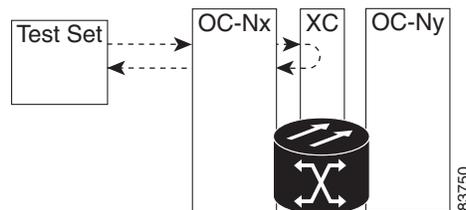
The XC loopback test occurs on the cross-connect card in a network circuit. Completing a successful XC loopback from an OC-N card through the cross-connect card eliminates the cross-connect card as the source of trouble for a faulty circuit. [Figure 1-24](#) shows an example of an XC loopback path on a source OC-N port.

**Figure 1-24** XC Loopback on a Source OC-N Port

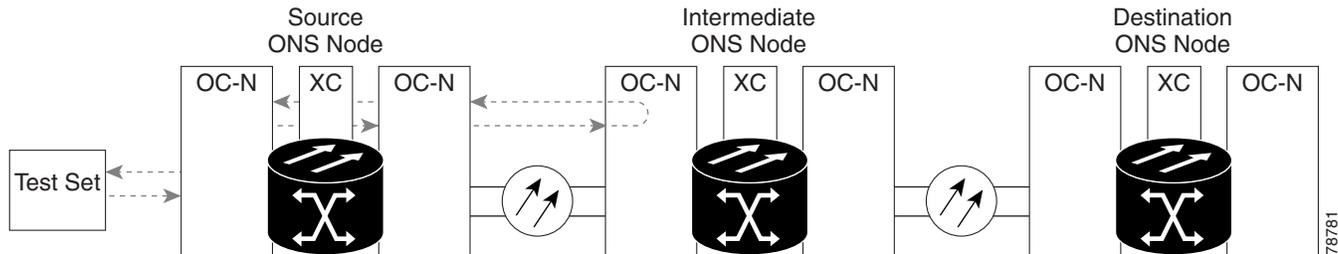
Performing the facility loopback test on an intermediate port isolates whether this node is causing circuit failure. In the situation shown in [Figure 1-25](#), the test is being performed on an intermediate OC-N port.

**Figure 1-25 Facility Loopback Path to an Intermediate-Node OC-N Port**

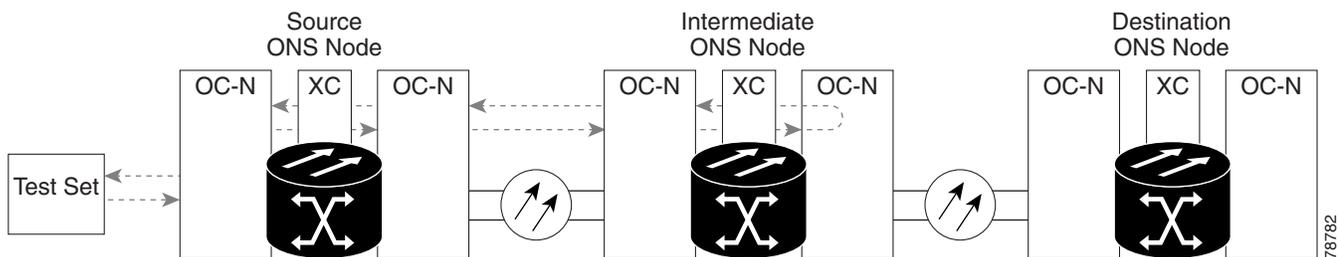
In the next troubleshooting test, you perform a terminal loopback on the intermediate-node port to isolate whether the destination port is causing circuit trouble. In the example situation in [Figure 1-26](#), the terminal loopback is performed on an intermediate optical port in the circuit. You first create a

bidirectional circuit that originates on the source-node optical port and loops back on the intermediate-node port. You then proceed with the terminal loopback test. If you successfully complete a terminal loopback on the node, this node is excluded from possible sources of circuit trouble.

**Figure 1-26** Terminal Loopback Path to an Intermediate-Node OC-N Port

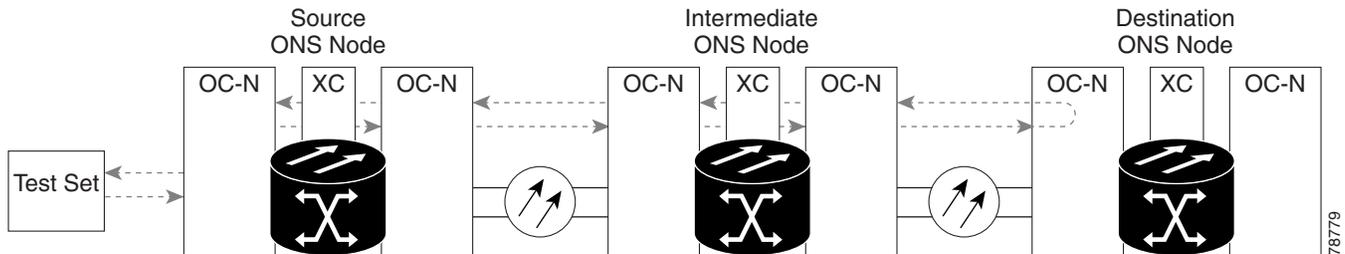
You perform a facility loopback test at the destination port to determine whether this local port is the source of circuit trouble. The example in [Figure 1-28](#) shows a facility loopback being performed on a destination-node OC-N port.

**Figure 1-28** Facility Loopback Path to a Destination-Node OC-N Port

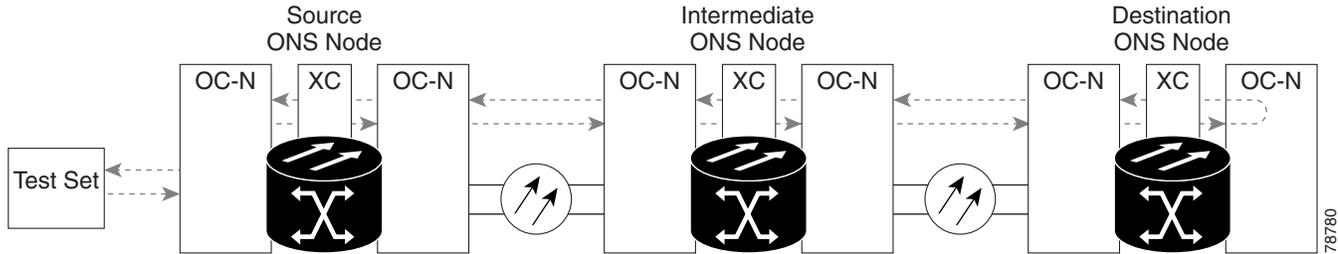
The terminal loopback at the destination-node port is the final local hardware error elimination in the circuit troubleshooting process. If this test is completed successfully, you have verified that the circuit is good up to the destination port. The example in [Figure 1-29](#) shows a terminal loopback on an intermediate-node destination OC-N port.

Figure 1-29 Terminal Loopback Path to a Destination-Node OC-N Port

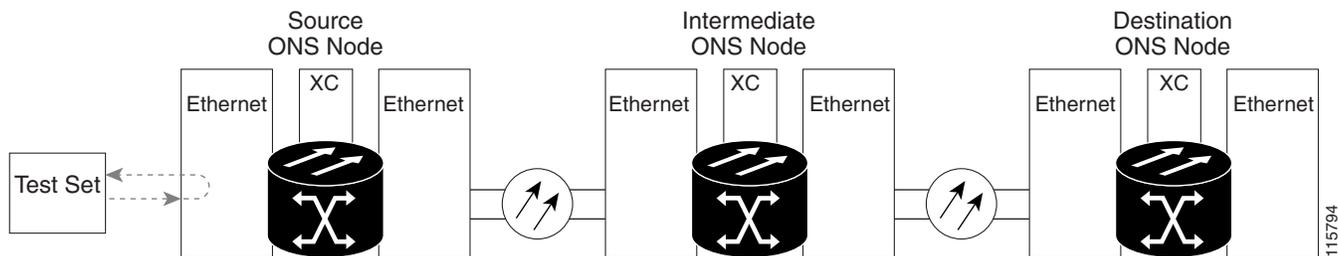
**Figure 1-30** Facility Loopback on a Circuit Source Ethernet Port

The facility loopback test is performed on the node source port in the network circuit. In the testing situation used in this example, the source G-Series port in the source node. Completing a successful facility loopback on this port isolates the G-Series port as a possible failure point. [Figure 1-21](#) shows an example of a facility loopback on a circuit source Ethernet port.

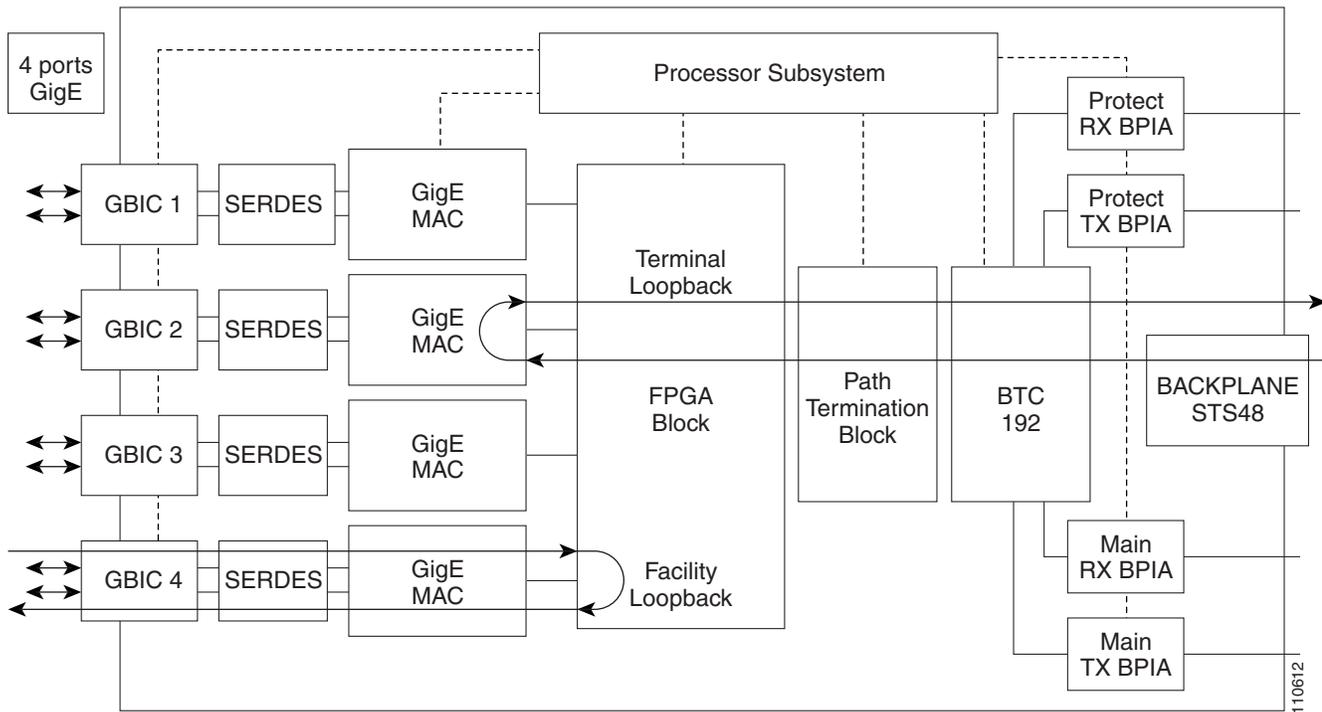
The terminal loopback test is performed on the node source Ethernet port. For the circuit in this example, it is the source G-Series port in the source node. You first create a bidirectional circuit that starts on the node destination G-Series port and loops back on the node source G-Series port. You then proceed with the terminal loopback test. Completing a successful terminal loopback to a node source port verifies that the circuit is good to the source port. [Figure 1-31](#) shows terminal loopback on a G-Series port.

Figure 1-31 Terminal Loopback on a G-Series Port

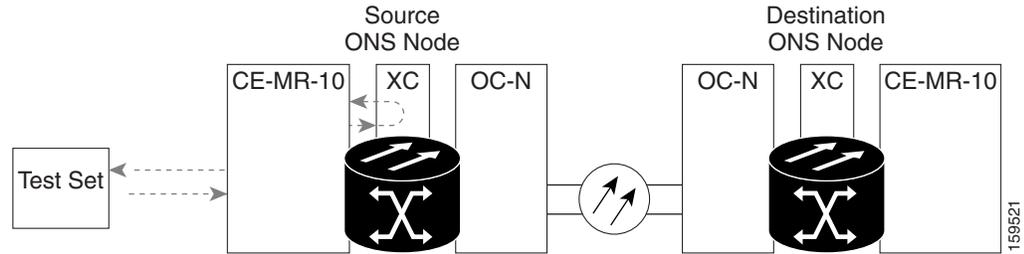
Figure 1-32 Hairpin on a Source-Node Ethernet Port

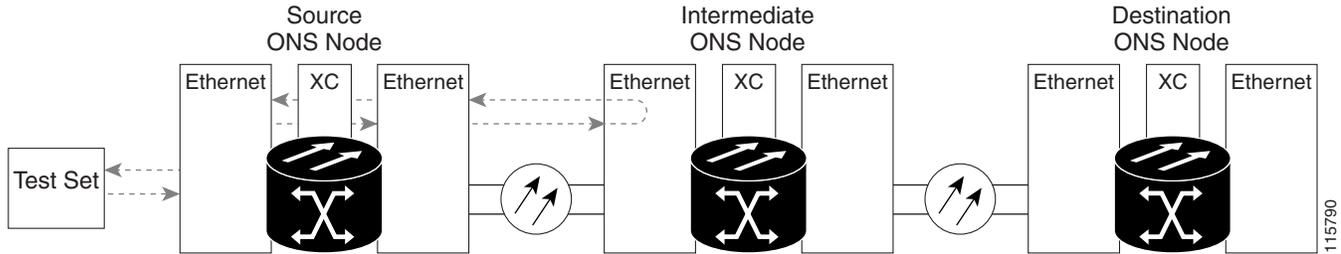
Performing the facility loopback test on an intermediate port isolates whether this node is causing circuit failure. It is shown in [Figure 1-33](#).

Figure 1-33 Facility Loopback on an Intermediate-Node Ethernet Port

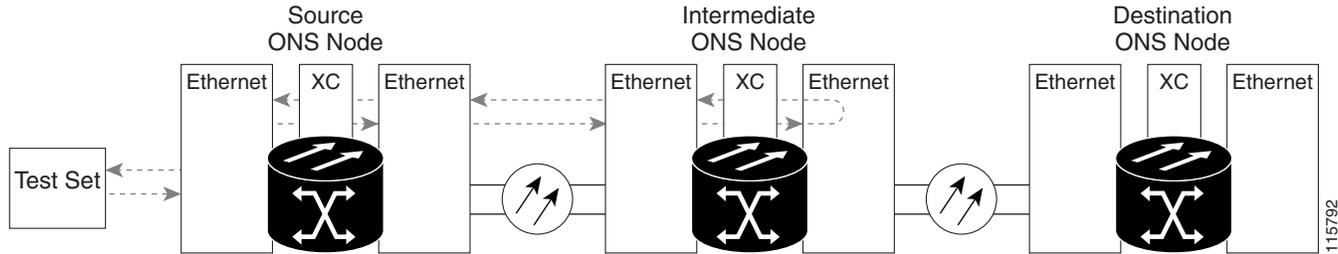
In the next troubleshooting test, you perform a terminal loopback on the intermediate-node port to isolate whether the destination port is causing circuit trouble. In the example situation in [Figure 1-34](#), the terminal loopback is performed on an intermediate Ethernet port in the circuit. You first create a bidirectional circuit that originates on the source-node Ethernet port and loops back on the intermediate-node port. You then proceed with the terminal loopback test. If you successfully complete a terminal loopback on the node, this node is excluded from possible sources of circuit trouble.

Figure 1-34 Terminal Loopback on an Intermediate-Node Ethernet Port

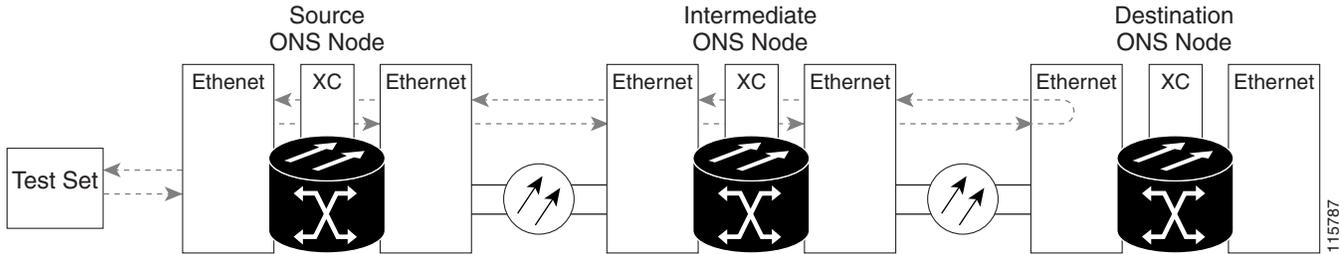
You perform a facility loopback test at the destination port to determine whether this local port is the source of circuit trouble. The example in [Figure 1-35](#) shows a facility loopback being performed on an Ethernet port.

Figure 1-35 Facility Loopback on a Destination-Node Ethernet Port

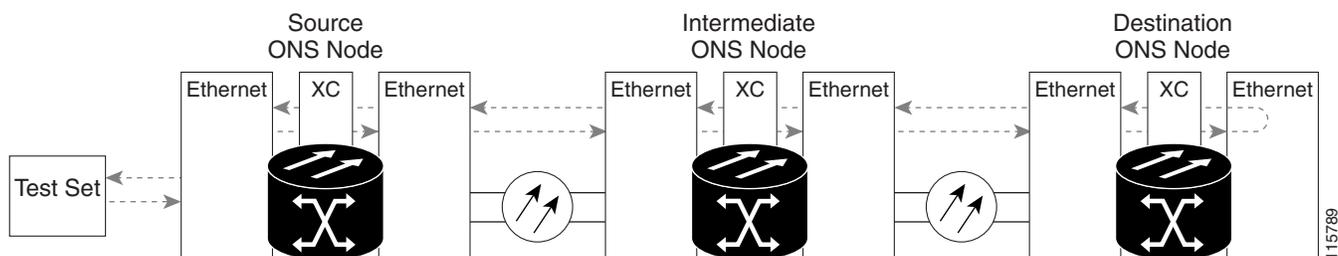
**Figure 1-36** Terminal Loopback on a Destination-Node Ethernet Port

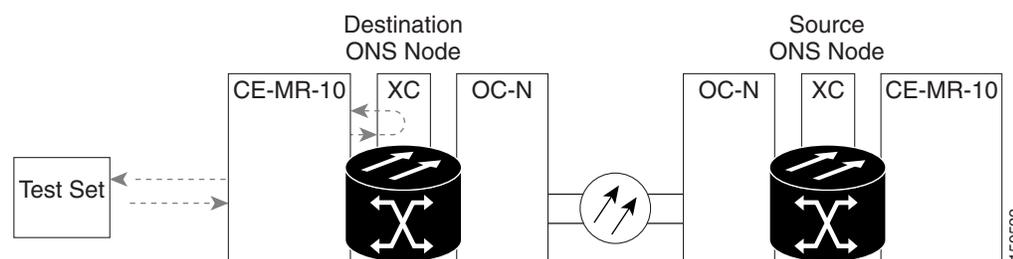
**Figure 1-37** Hairpin on a Destination-Node Ethernet Port

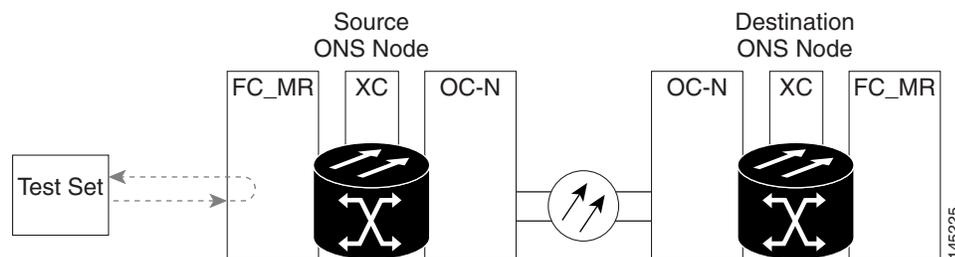
Figure 1-38 shows an example of a facility loopback on a circuit source FC\_MR port.

**Figure 1-38 Facility Loopback on a Circuit Source FC\_MR Port**

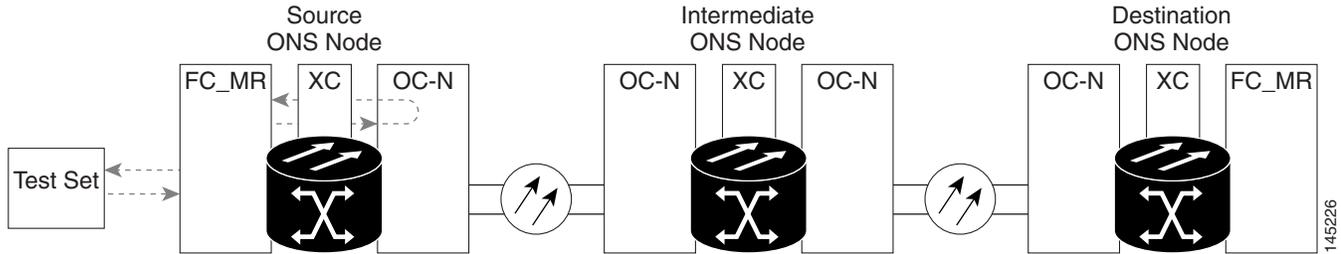
The terminal loopback test is performed on the node source FC\_MR muxponder or transponder port. For the circuit in this example, the test port is the source FC\_MR port in the source node. Completing a successful terminal loopback to a node source port verifies that the circuit is good to the source port. [Figure 1-39](#) shows an example of a terminal loopback on a source FC\_MR port.

Figure 1-39 Terminal Loopback on a Source-Node FC\_MR Port

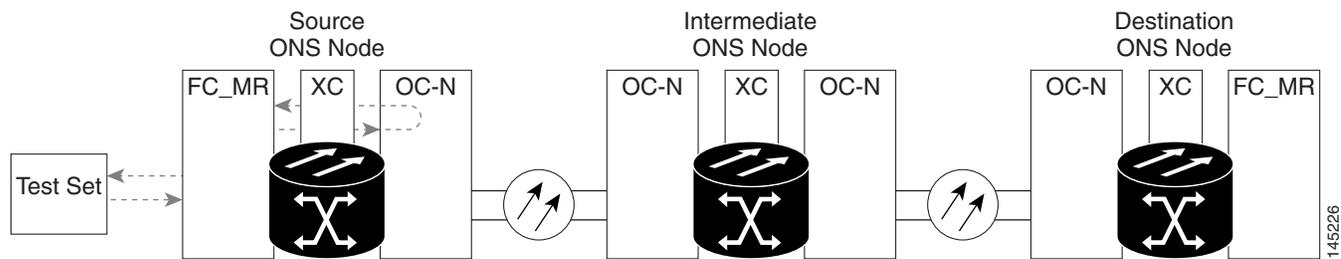
Performing the facility loopback test on an intermediate port determines whether this node is causing circuit failure. In the example shown in [Figure 1-40](#), the test is being performed on an intermediate FC\_MR port.

You perform a facility loopback test at the destination port to determine whether this local port is the source of circuit trouble. The example in [Figure 1-40](#) shows a facility loopback being performed on an FC\_MR port.

**Figure 1-40** Facility Loopback on an Intermediate-Node FC\_MR Port

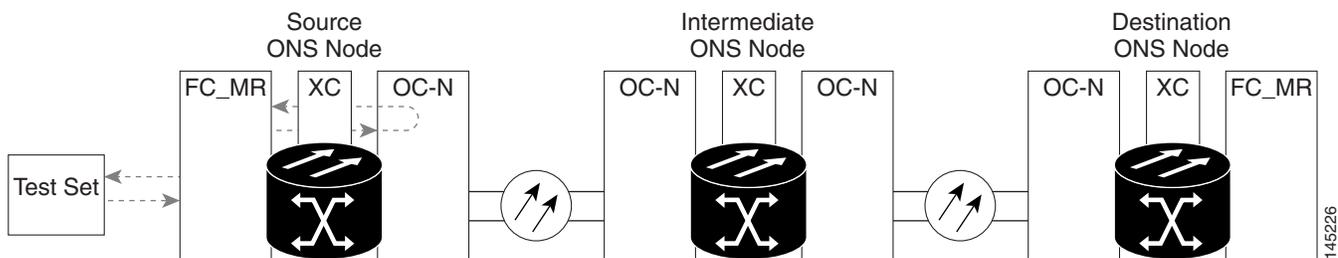
In the next troubleshooting test, you perform a terminal loopback on the intermediate-node port to isolate whether the destination port is causing circuit trouble. In the example situation in [Figure 1-41](#), the terminal loopback is performed on an intermediate FC\_MR port in the circuit. If you successfully complete a terminal loopback on the node, this node is excluded from possible sources of circuit trouble.

The terminal loopback at the destination-node port is the final local hardware error elimination in the circuit troubleshooting process. If this test is completed successfully, you have verified that the circuit is good up to the destination port. The example in [Figure 1-41](#) shows a terminal loopback on an intermediate-node destination FC\_MR port.

**Figure 1-41** Terminal Loopback on an Intermediate-Node FC\_MR Port

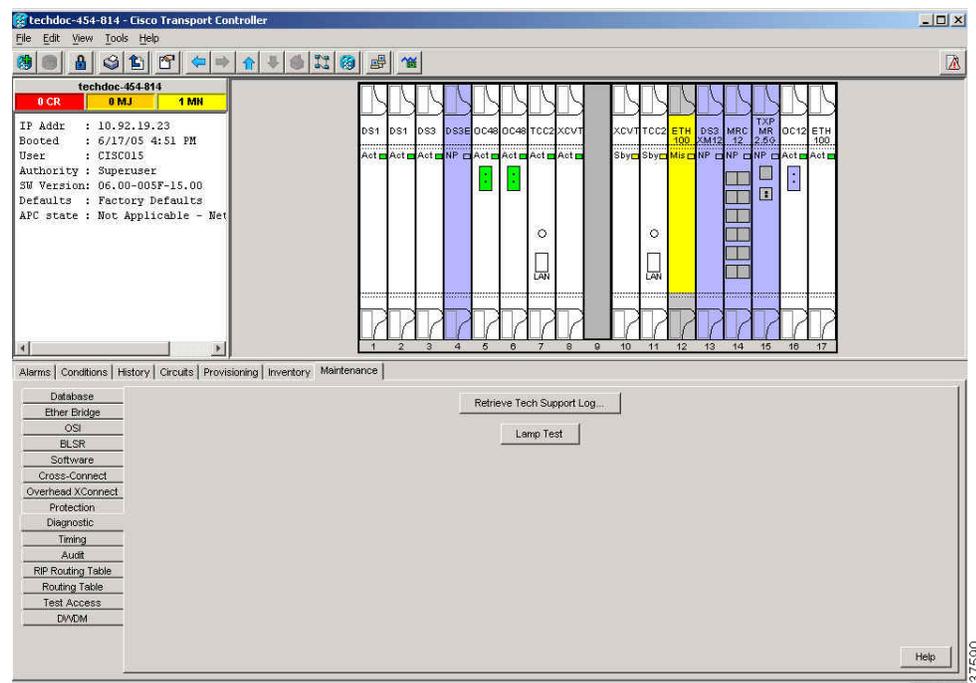
**Step 1** In node view, click the **Maintenance > Diagnostic** tabs (Figure 1-42).

**Figure 1-42** CTC Node View Diagnostic Window

- 
- Step 1** In the node view, click the **Maintenance > Diagnostic** tabs (Figure 1-42).
  - Step 2** Click **Retrieve Tech Support Log**.
  - Step 3** In the Saving Diagnostic File dialog box, navigate to the directory (local or network) where you want to save the file.
  - Step 4** Enter a name in the File Name field.

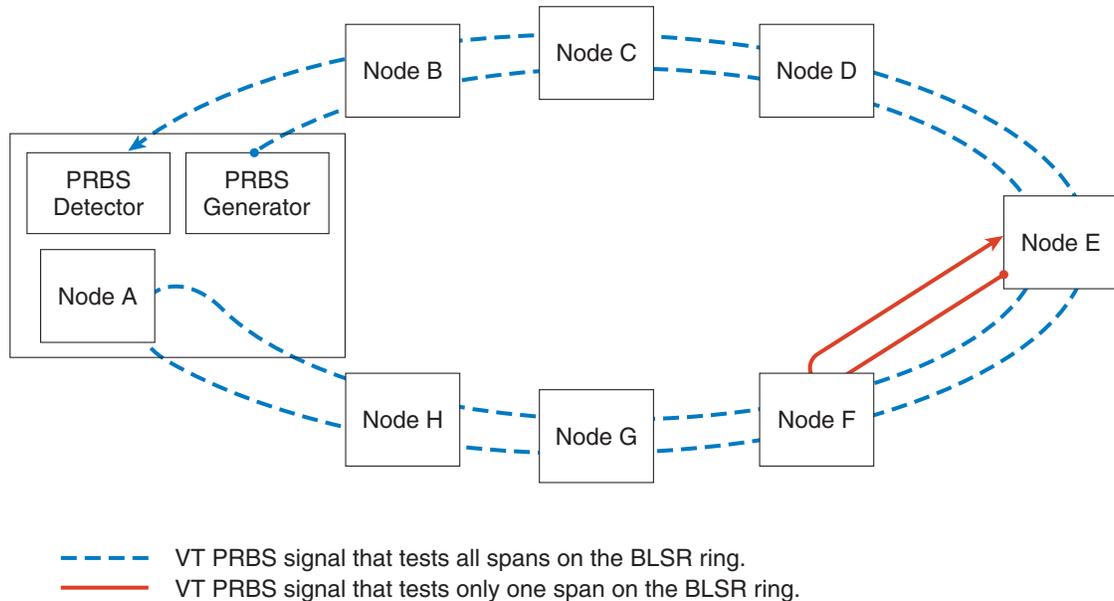
The diagnostic circuit can be configured for an end-to-end or multiple-node path layout, traversing the transmit and receive standby paths as shown in Figure 1-43.

**Figure 1-43 CTC Node View Diagnostic Window**

NOTE: The end without the arrow is where the PRBS pattern is generated. The end with the arrow is the end where the PRBS pattern is detected.

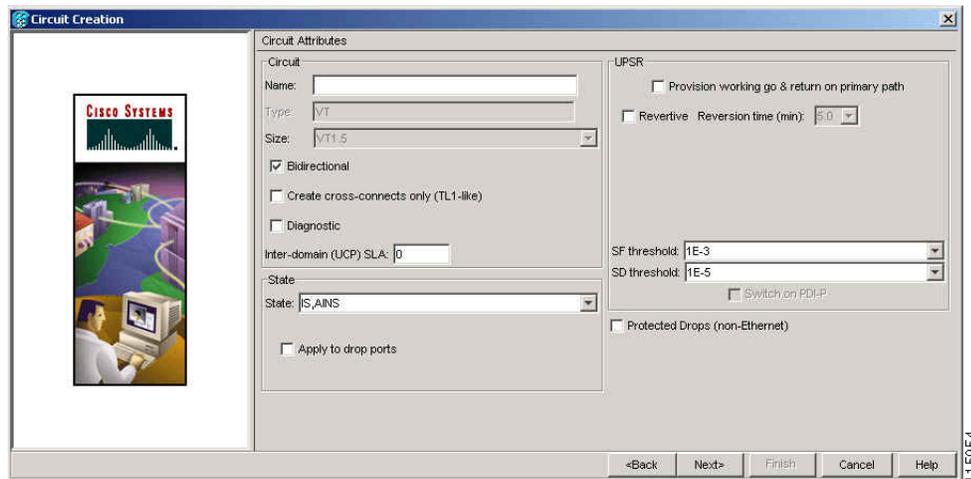
**Figure 1-44 Network View Circuit Creation Dialog Box**

- Name—Assign a name to the circuit. The name can be alphanumeric and up to 48 characters, (including spaces). Circuit names should be 44 characters or less if you want the ability to create monitor circuits. If you leave the field blank, CTC assigns a default name to the circuit.
- Size—VT1.5 is the default. You cannot change it.
- Bidirectional—This is the default value. Leave it checked for this circuit.
- State—This option is not available when you check the Diagnostic option.
- Diagnostic—Check this box to create a diagnostic circuit.
- Apply to drop ports—Leave this box unchecked.
- Create cross-connects only (TL1-like)—Not applicable to diagnostic circuits.
- Inter-domain (UCP) SLA—Not applicable to diagnostic circuits.
- Protected Drops—Not applicable to diagnostic circuits.

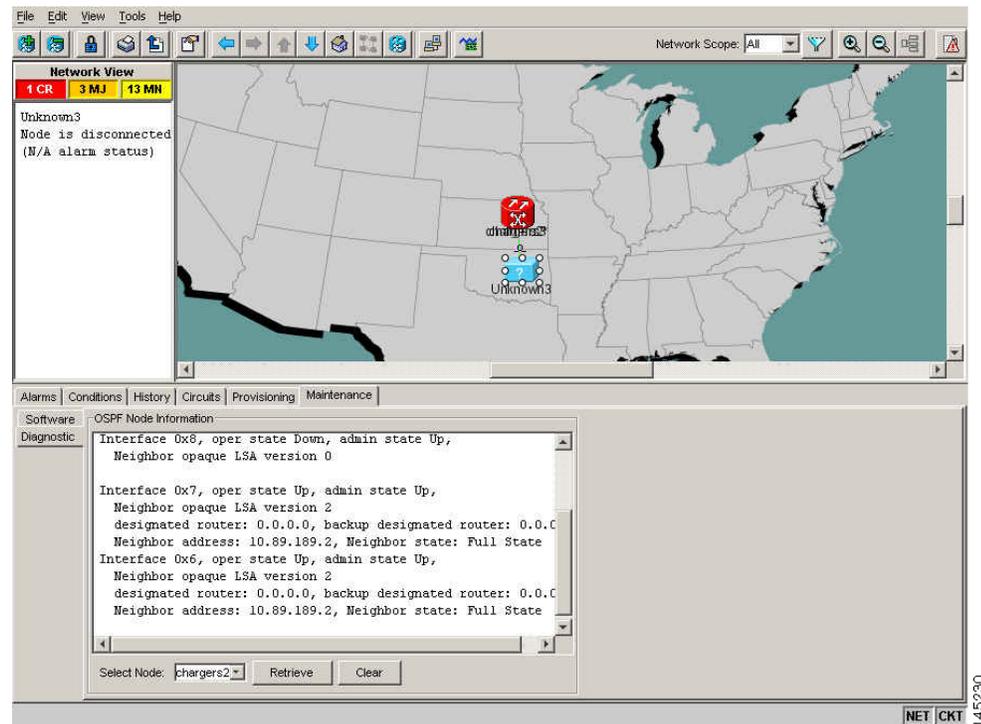
CTC contains a data communications network (DCN) tool that assists with network troubleshooting for Open Shortest Path First (OSPF) networks. This tool, located in network view, is shown in [Figure 1-45](#). It executes an internal dump command to retrieve information about all nodes accessible from the entry point.

Figure 1-45 DCN Tools OSPF Dump

The dump, which provides the same information as a dump executed by special networking commands, is available at the network view in the Maintenance > Diagnostic tabs. You can select the access point node in the Select Node drop-down list. To create the dump, click Retrieve. (To clear the dump, click Clear.)

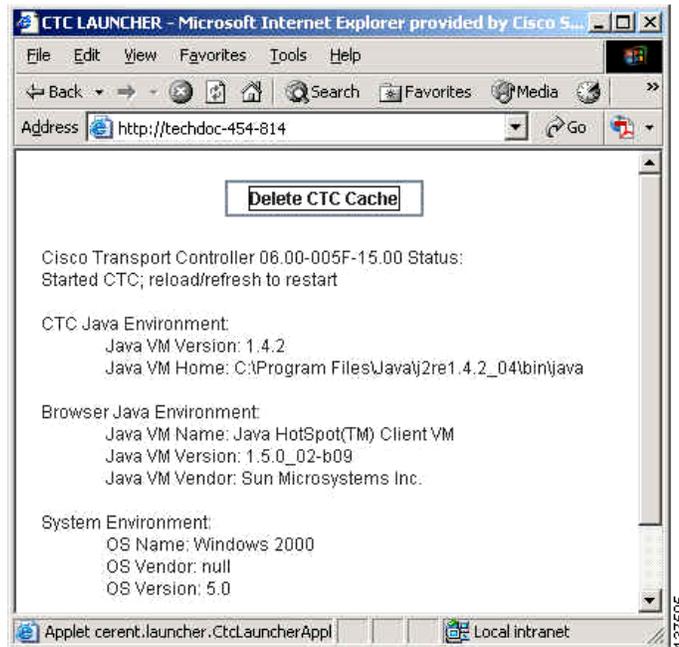
- 
- Step 1** Enter an ONS 15454 IP address into the browser URL field. The initial browser window shows a **Delete CTC Cache** button.
  - Step 2** Close all open CTC sessions and browser windows. The PC operating system does not allow you to delete files that are in use.
  - Step 3** Click **Delete CTC Cache** on the initial browser window to clear the CTC cache. [Figure 1-46](#) shows the Delete CTC Cache window.

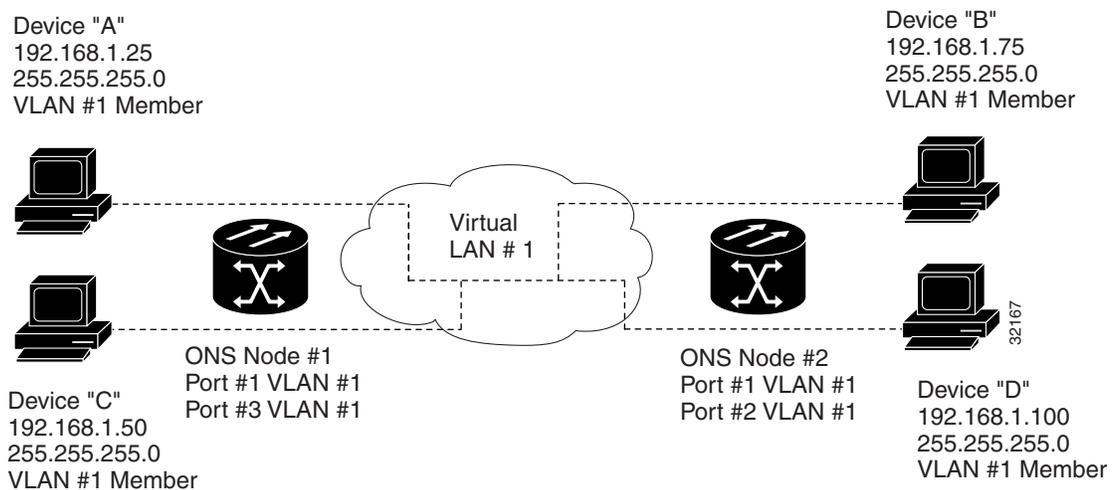
**Recommended Action** You can fix most connectivity problems in an Ethernet network by following a few guidelines. See [Figure 1-47](#) when using the steps in the “Verify Ethernet Connections” procedure on page 1-124.

**Figure 1-47 Ethernet Connectivity Reference**

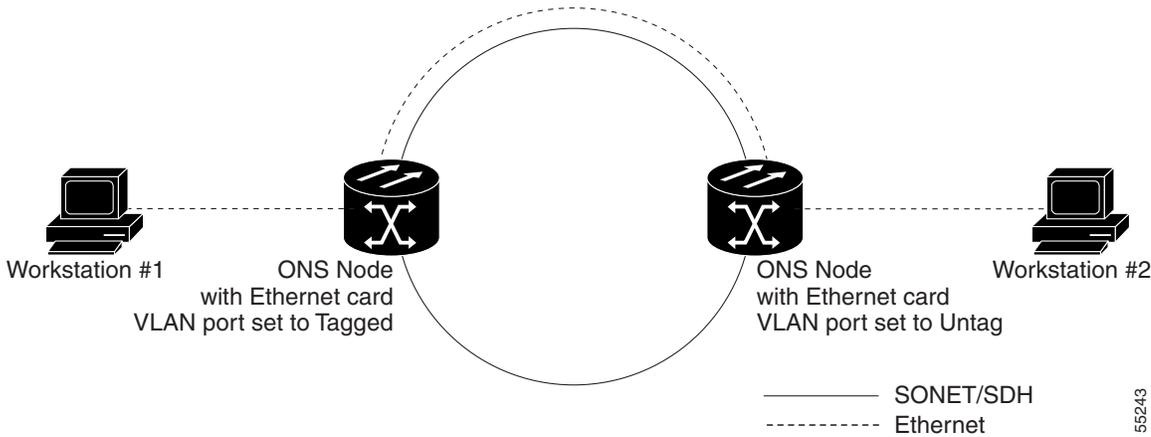
**Symptom** Networks that have a VLAN with one ONS 15454 Ethernet card port set to Tagged and one ONS 15454 Ethernet card set to Untag might have difficulty implementing Address Resolution Protocol (ARP) for a network device attached to the Untag port ([Figure 1-48](#)). They might also see a higher than normal runt packets count at the network device attached to the Untag port. This symptom/limitation also exists when ports within the same card or ports within the same chassis are put on the same VLAN, with a mix of tagged and untagged.

**Recommended Action** The solution is to set both ports in the VLAN to Tagged to stop the stripping of the 4 bytes from the data packet and prevent the NIC card in the network access device from recognizing the packet as a runt and dropping it. Network devices with IEEE 802.1Q-compliant NIC cards accept the tagged packets. Network devices with non IEEE 802.1Q compliant NIC cards still drop these tagged packets. The solution might require upgrading network devices with non-IEEE 802.1Q compliant NIC cards to IEEE 802.1Q compliant NIC cards. You can also set both ports in the VLAN to Untag, but you will lose IEEE 802.1Q compliance.

Figure 1-48 VLAN with Ethernet Ports at Tagged and Untag

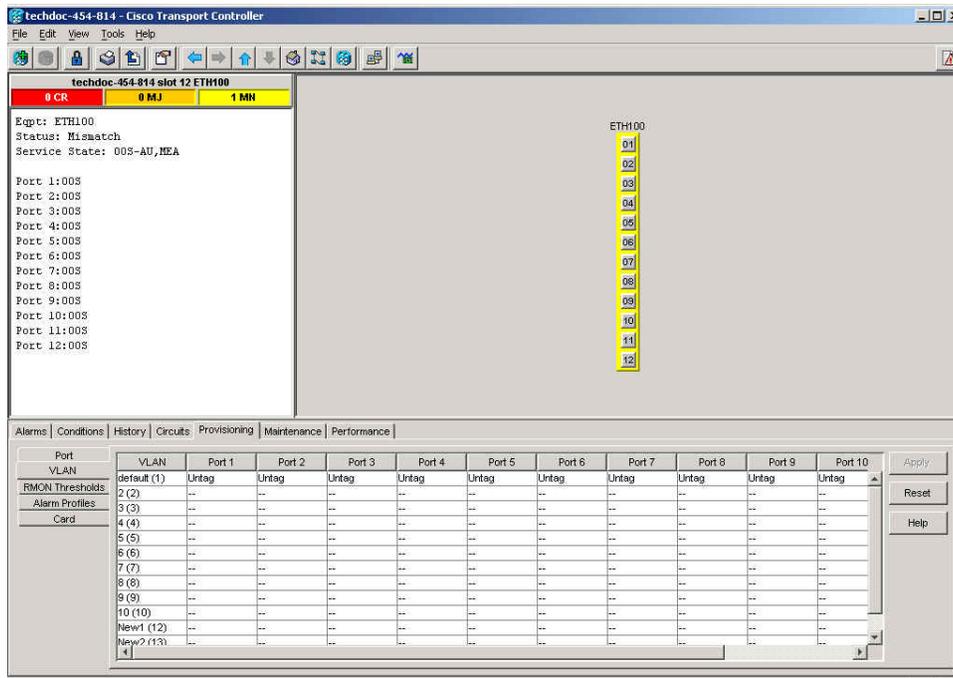
Figure 1-49 Configuring VLAN Membership for Individual Ethernet Ports

- Step 1** Open the CTC card view for the Ethernet card involved in the problem VLAN.
- Step 2** Click the **Provisioning > Ether VLAN** tabs (Figure 1-49).

- Step 3** If the port is set to **Tagged**, continue to look at other cards and their ports in the VLAN until you find the port that is set to **Untag**.
- Step 4** At the VLAN port set to **Untag**, click the port and choose **Tagged**.

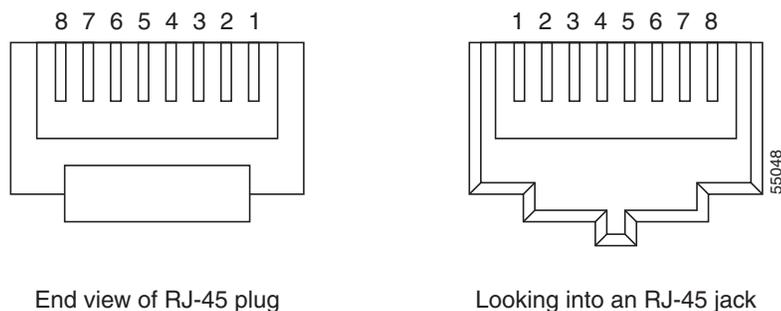
**Figure 1-50 RJ-45 Pin Numbers**

You can crimp your own LAN cables for use with the ONS 15454. Use a cross-over cable when connecting an ONS 15454 to a hub, LAN modem, or switch, and use a LAN cable when connecting an ONS 15454 to a router or workstation. Use Category-5 cable RJ-45 T-568B, Color Code (100 Mbps), and a crimping tool. [Figure 1-50](#) shows the wiring of an RJ-45 connector. [Figure 1-51](#) shows a LAN cable layout, and [Table 1-4](#) shows the cable pinouts. [Figure 1-52](#) shows a cross-over cable layout, and [Table 1-5](#) shows the cross-over pinouts.

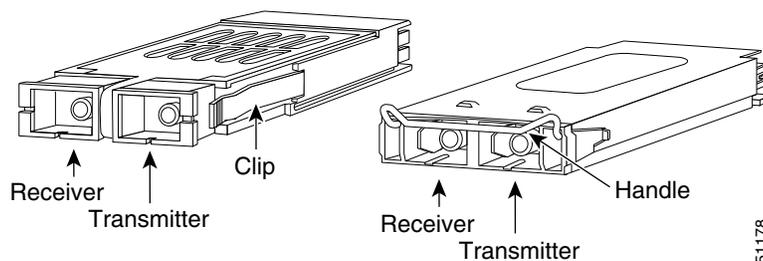
**Figure 1-53** *GBICs*

GBICs are available in two different models. One GBIC model has two clips (one on each side of the GBIC) that secure the GBIC in the slot on the E1000-2-G, G-Series, or G1K-4 card. The other model has a locking handle. Both models are shown in [Figure 1-53](#).

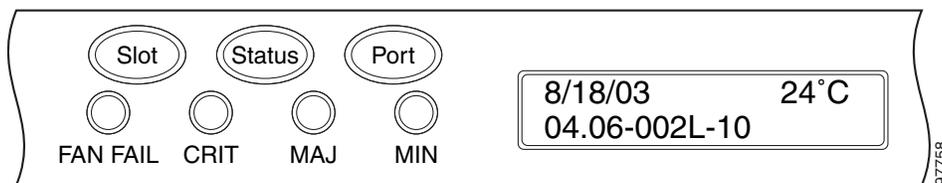
**Figure 2-2 Shelf LCD Panel**

- Step 1** View the temperature displayed on the ONS 15454 LCD front panel ([Figure 2-2](#)).

- 
- Step 1** Check for any outstanding alarms that were raised against the active and standby TCC2/TCC2P and resolve them.
- Step 2** If the alarm does not clear, determine whether the LCD display on the fan tray ([Figure 2-2 on page 2-120](#)) is blank or if the text is garbled. If so, proceed to [Step 8](#). If not, continue with [Step 3](#).
- Step 3** At the earliest maintenance window, reset the standby TCC2/TCC2P:

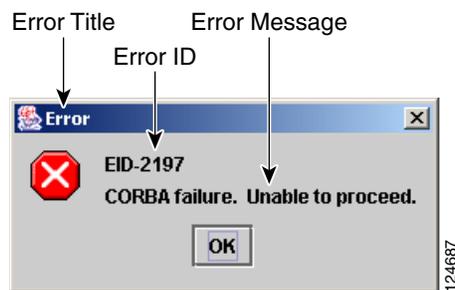
**Figure 4-1** Error Dialog Box

This chapter lists the Cisco ONS 15454, 15454 SDH, 15600, 15327, 15310-CL, and 15310-MA error messages. The error dialog box in [Figure 4-1](#) consists of three parts: the error title, error ID, and error message. The table lists two types of messages: error messages (EID-*nnnn*) and warning messages (WID-*nnnn*). Error messages are alerts that an unexpected or undesirable operation has occurred which either indicates the risk of loss of traffic or an inability to properly manage devices in the network. Warnings are alerts that the requested operation could lead to an error. Warnings are sometimes used to convey important information.
