## Alarm Troubleshooting

This chapter gives a description, severity, and troubleshooting procedure for each commonly encountered Cisco ONS 15454 alarm and condition. Tables 2-1 through 2-5 provide lists of ONS 15454 alarms organized by severity. Table 2-6 on page 2-10 provides a list of alarms organized alphabetically. Table 2-7 gives definitions of all ONS 15454 alarm logical objects, which are the basis of the alarm profile list in Table 2-8 on page 2-22. For a comprehensive list of all conditions and instructions for using TL1 commands, refer to the *Cisco ONS SONET TL1 Command Guide*.

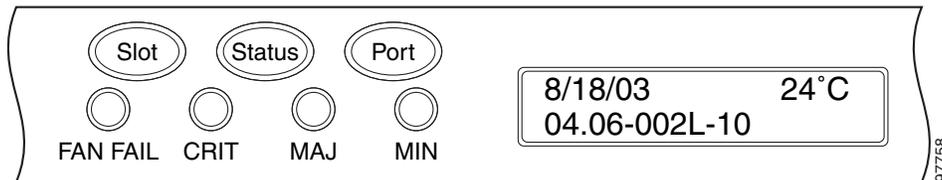
**Figure 2-1 Shelf LCD Panel**

- Step 1** View the temperature displayed on the ONS 15454 LCD front panel (Figure 2-1).

- Step 2** If the temperature of the shelf exceeds 194 degrees F (90 degrees C), the alarm should clear if you solve the ONS 15454 temperature problem. Complete the [“Clear the HITEMP Alarm” procedure on page 2-121](#).
- Step 3** If the temperature of the shelf is under 194 degrees F (90 degrees C), the HITEMP alarm is not the cause of the AUTOLSROFF alarm. Complete the [“Physically Replace a Traffic Card” procedure on page 2-267](#) for the OC-192 card.
- Step 4** If card replacement does not clear the alarm, call Cisco TAC 1 800 553-2447 to discuss the case and if necessary open a returned materials authorization (RMA) on the original OC-192 card.

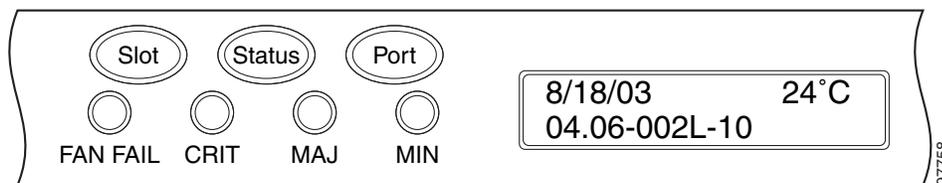
**Figure 2-2 Shelf LCD Panel**

- Step 1** View the temperature displayed on the ONS 15454 LCD front panel (Figure 2-2).

- Step 2** Verify that the environmental temperature of the room is not abnormally high.
- Step 3** If the room temperature is not abnormal, physically ensure that nothing prevents the fan-tray assembly from passing air through the ONS 15454 shelf.
- Step 4** If airflow is not blocked, physically ensure that blank faceplates fill the ONS 15454 shelf empty slots. Blank faceplates help airflow.
- Step 5** If faceplates fill the empty slots, determine whether the air filter needs replacement. Refer to the “Inspect, Clean, and Replace the Reusable Air Filter” procedure on page 2-271.
- Step 6** If the fan does not run or the alarm persists, complete the “Replace the Fan-Tray Assembly” procedure on page 2-273.

- 
- Step 1** Check for any outstanding alarms that were raised against the active and standby TCC2/TCC2P and resolve them.
- Step 2** If the alarm does not clear, determine whether the LCD display on the fan tray ([Figure 2-2 on page 2-121](#)) is blank or if the text is garbled. If so, proceed to [Step 8](#). If not, continue with [Step 3](#).
- Step 3** At the earliest maintenance window, reset the standby TCC2/TCC2P:
