Cisco ONS 15454 Troubleshooting Guide

Product and Documentation Release 8.0

General Troubleshooting

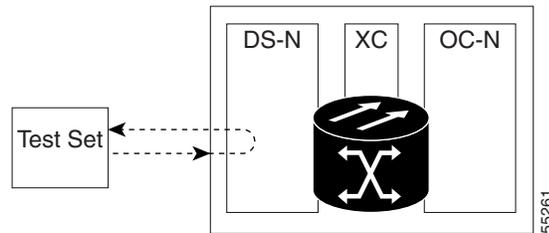
Figure 1-1 Facility Loopback Path on a Near-End DS-N Card

A facility loopback tests the line interface unit (LIU) of a card, the electrical interface assembly (EIA), and related cabling. After applying a facility loopback on a port, use a test set to run traffic over the loopback. A successful facility loopback isolates the LIU, the EIA, or the cabling plant as the potential cause of a network problem. [Figure 1-1](#) shows a facility loopback on a DS-N electrical card.

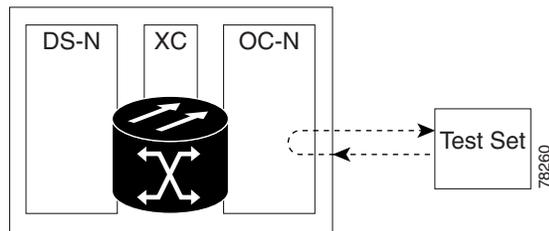
Figure 1-2 Facility Loopback Path on a Near-End OC-N Card

To test an OC-N card LIU, connect an optical test set to the OC-N port and perform a facility loopback. Alternately, use a loopback or hairpin circuit on a card that is farther along the circuit path. [Figure 1-2](#) shows a facility loopback on an OC-N card.

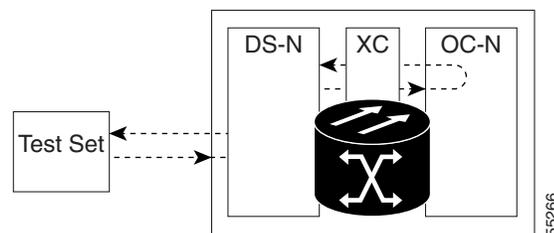
Figure 1-4 Terminal Loopback Path on an OC-N Card

A terminal loopback tests a circuit path as it passes through the cross-connect card and loops back from the card with the loopback. [Figure 1-4](#) shows a terminal loopback on an OC-N card. The test-set traffic comes into the electrical port and travels through the cross-connect card to the optical card. The terminal loopback on the optical card turns the signal around before it reaches the LIU and sends it back through the cross-connect card to the electrical card. This test verifies that the cross-connect card and terminal circuit paths are valid, but does not test the LIU on the optical card.

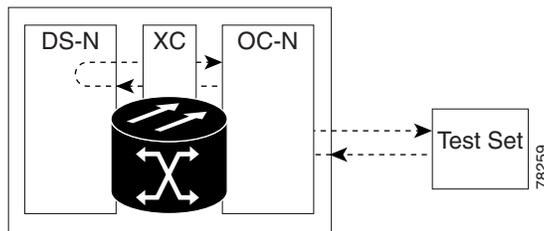
Figure 1-6 Terminal Loopback Path on a DS-N Card

Figure 1-6 shows a terminal loopback on a DS-N electrical card. The test-set traffic comes in on the optical card and travels through the cross-connect card to the electrical card. The terminal loopback on the electrical card turns the signal around before it reaches the LIU and sends it back through the cross-connect card to the optical card. This test verifies that the cross-connect card and terminal circuit paths are valid, but does not test the LIU on the electrical card.

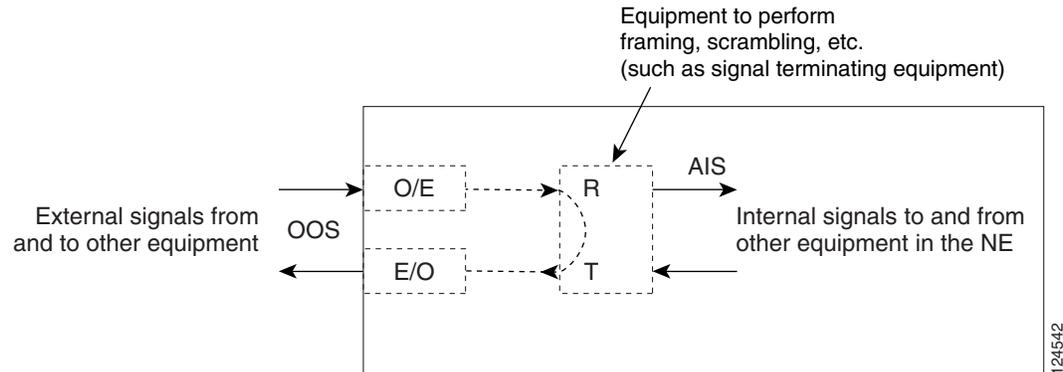
Figure 1-10 Network Element with SONET Cross-Connect Loopback Function

The XC loopback breaks down the existing path and creates a new cross-connect—a hairpin—while the source of the original path is set to inject a line-side AIS-P. The loopback signal path and AIS injection are shown in Figure 1-10.

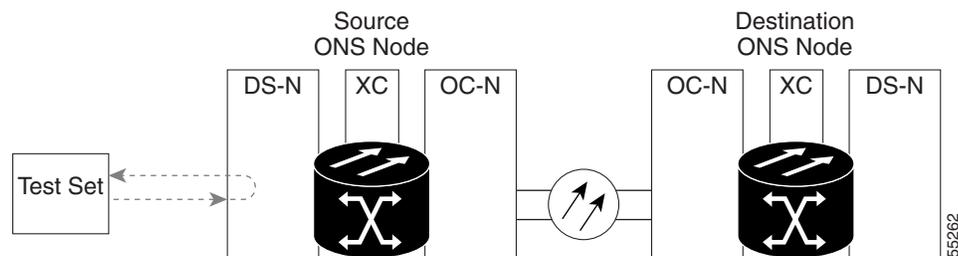
Figure 1-11 Facility Loopback on a Circuit Source DS-N Port

The facility loopback test is performed on the node's source electrical port in the network circuit; in this example, the DS-N port in the source node. Completing a successful facility loopback on this port isolates the cabling, the electrical card, and the EIA as possible failure points. [Figure 1-11](#) shows an example of a facility loopback on a source DS-N port.

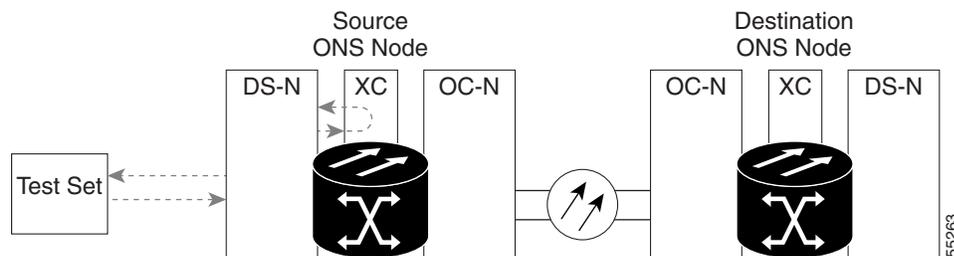
Figure 1-12 Hairpin on a Source-Node Port

The hairpin test is performed on the cross-connect card in the network circuit. A hairpin circuit uses the same port for both source and destination. Completing a successful hairpin through the port isolates the possibility that the cross-connect card is the cause of the faulty circuit. Figure 1-12 shows an example of a hairpin loopback on a source-node port.

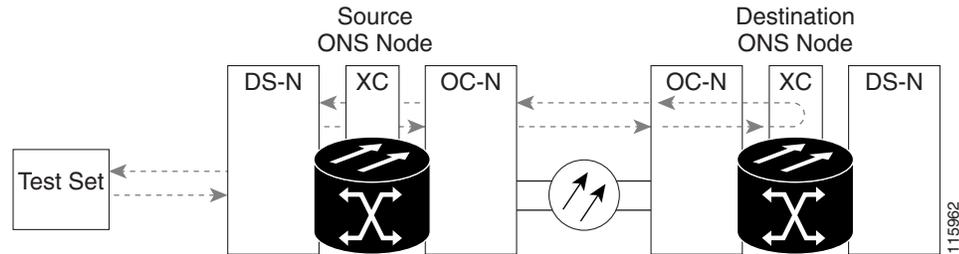
Figure 1-13 XC Loopback on a Destination OC-N Port

The XC loopback tests whether any problem exists on the circuit’s OC-N span, isolating this span from others present on the card. The loopback occurs on the cross-connect card in a network circuit. [Figure 1-13](#) shows an example of an XC loopback on a destination OC-N port. The traffic pattern looks similar to a terminal loopback but traffic is only carried on one STS instead of affecting the entire port.

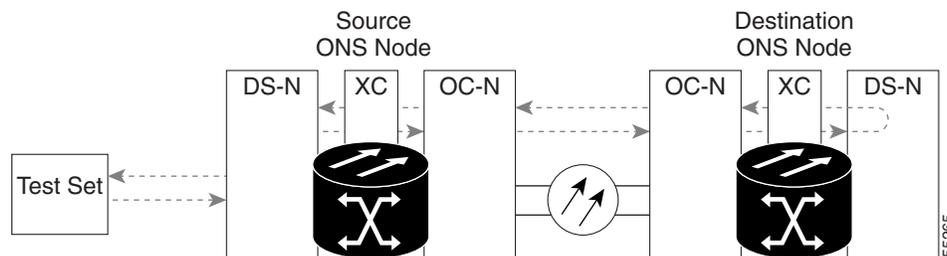
Figure 1-14 Terminal Loopback to a Destination DS-N Port

The terminal loopback test is performed on the destination-node electrical port in the circuit, such as a destination-node electrical port. You create a bidirectional circuit that starts on the source-node electrical port and loops back on the destination-node electrical port. Then you proceed with the terminal loopback test. Completing a successful terminal loopback to a destination-node electrical port verifies that the circuit is good to the destination electrical port. Figure 1-14 shows an example of a terminal loopback on a destination DS-N port.

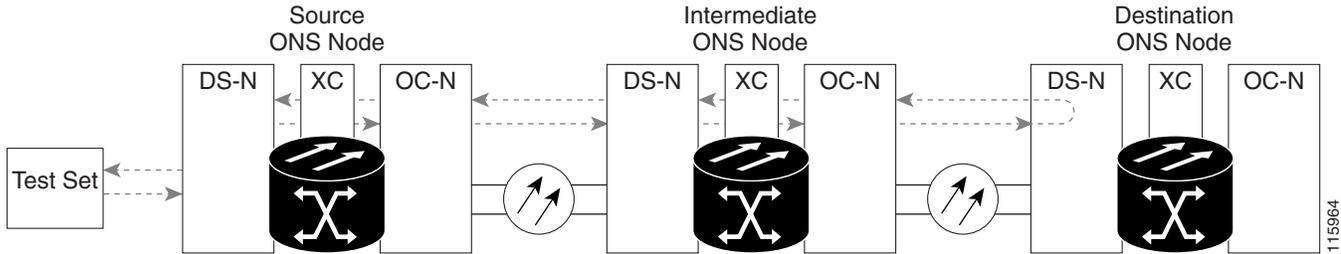
Figure 1-15 Facility Loopback on a Circuit Destination DS-N Port

The facility loopback test is performed on the destination-node electrical port in the network circuit. Completing a successful facility loopback on this port isolates the cabling, the electrical card, and the EIA as possible failure points. [Figure 1-15](#) shows an example of a facility loopback on a destination DS-N port.

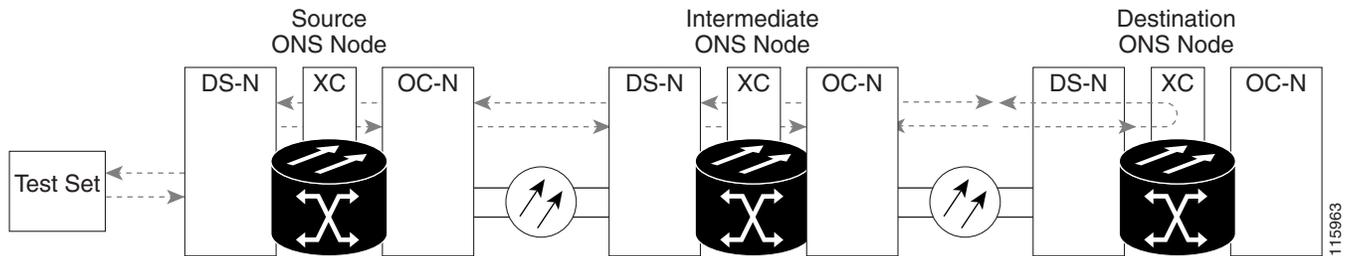
Figure 1-16 Hairpin on a Destination-Node DS-N Port

The hairpin test is performed on the cross-connect card in the network circuit and uses the same port as source as well as destination. Completing a successful hairpin through the card isolates the possibility that the cross-connect card is the cause of the faulty circuit. [Figure 1-16](#) shows an example of a hairpin loopback on a destination-node port.

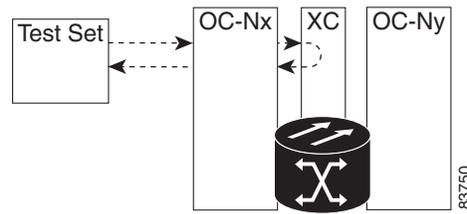
Figure 1-17 XC Loopback on a Source OC-N Port

The XC loopback tests whether problem exists on the circuit’s OC-N span by isolating this span from others on the card. The loopback also eliminates the cross-connect card as the source of trouble for a faulty circuit. The loopback occurs on the cross-connect card in a network circuit. [Figure 1-17](#) shows an example of an XC loopback on a source OC-N port.

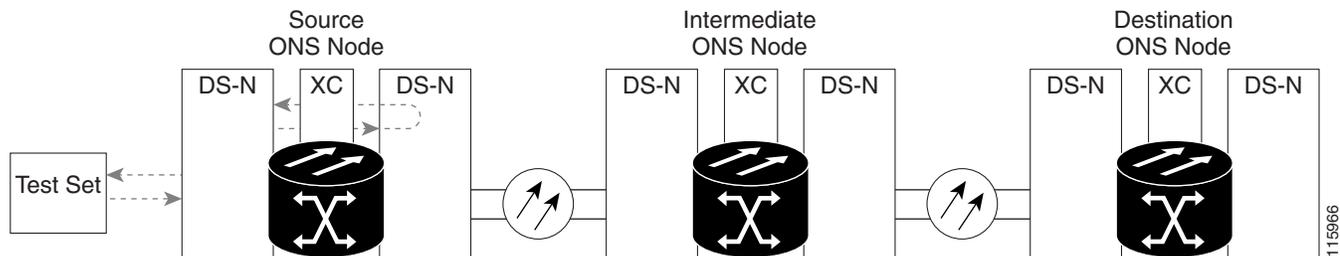
Figure 1-18 Terminal Loopback on a Source DS-N Port

The terminal loopback test is performed on the source-node electrical port in the circuit, such as a source-node electrical port. You first create a bidirectional circuit that starts on the destination-node electrical port and loops back on the source-node electrical port. Then you proceed with the terminal loopback test. Completing a successful terminal loopback to a source-node electrical port verifies that the circuit is good to the source electrical port. Figure 1-18 shows an example of a terminal loopback on a source DS-N port.

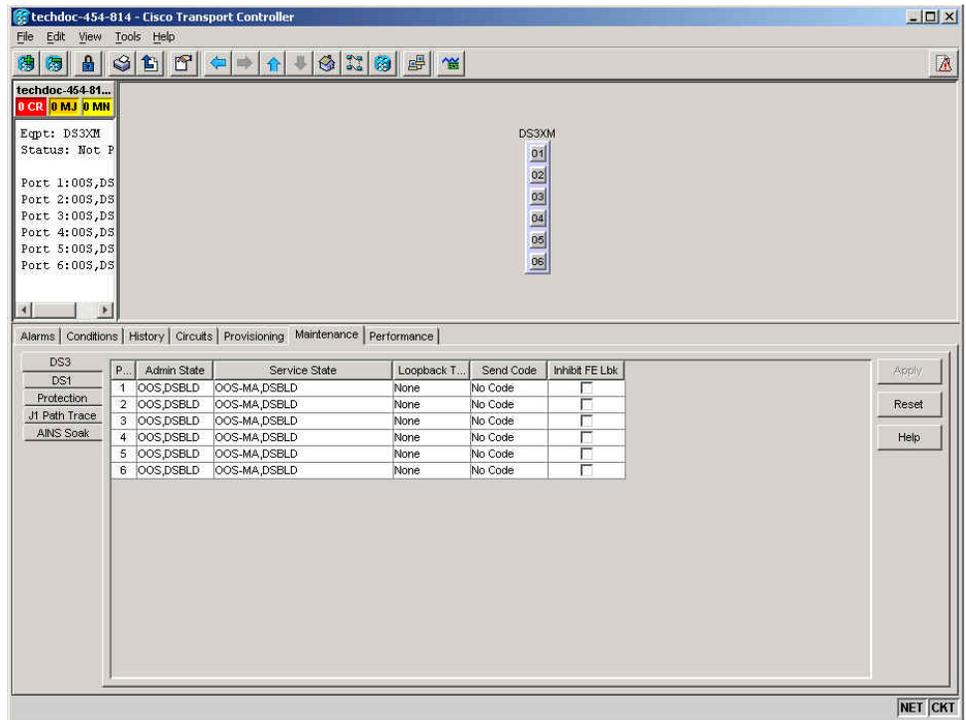
The DS3XM-6 card and DS3XM-12 cards support FEAC functions that are not available on basic DS-3 cards. Click the DS3XM-6 or DS3XM-12 **Maintenance > DS1** tabs at the card view to reveal the two additional function columns. [Figure 1-19](#) shows the DS3 subtab and the additional Send Code and Inhibit FE Lbk function columns.

Figure 1-19 Accessing FEAC Functions on the DS3XM-6 Card

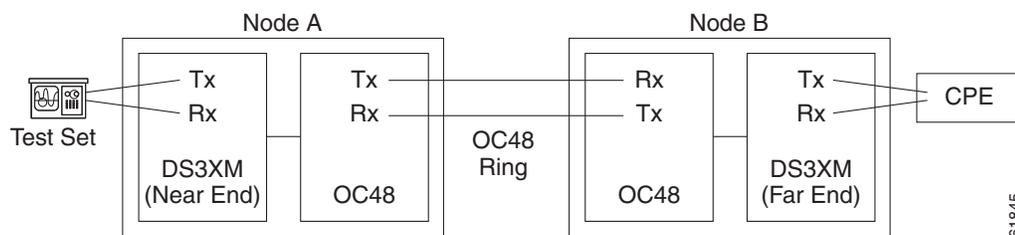
The “far end” in FEAC refers to the equipment connected to the DS3XM card and not to the far end of a circuit. In Figure 1-20, if a DS3XM-6 (near-end) port is configured to send a line loop code, the code will be sent to the connected test set, not the DS3XM-6 (far-end) port.

Figure 1-20 Diagram of FEAC Circuit

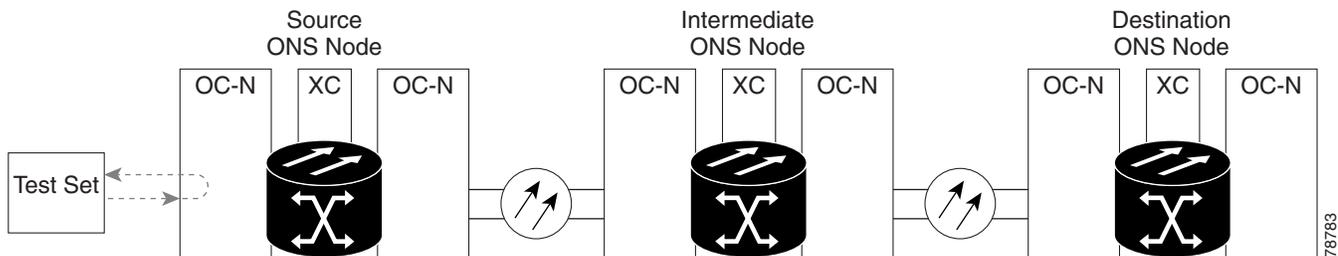
The facility loopback test is performed on the node source port in the network circuit. In the testing situation used in this example, the source OC-N port in the source node. Completing a successful facility loopback on this port isolates the OC-N port as a possible failure point. [Figure 1-21](#) shows an example of a facility loopback on a circuit source OC-N port.

Figure 1-21 Facility Loopback on a Circuit Source OC-N Port

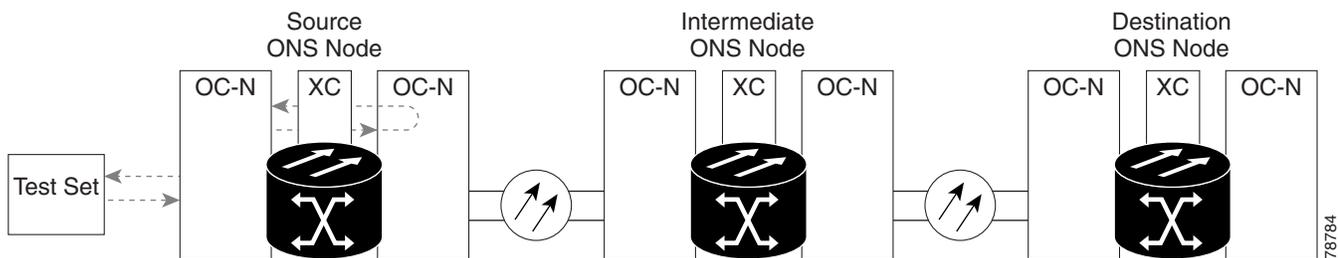
The terminal loopback test is performed on the source-node optical port. For the circuit in this example, it is the source OC-N port in the source node. You first create a bidirectional circuit that starts on the node destination optical port and loops back on the node source optical port. You then proceed with the terminal loopback test. Completing a successful terminal loopback to a node source port verifies that the circuit is good to the source port. Figure 1-22 shows an example of a terminal loopback on a source OC-N port.

Figure 1-22 Terminal Loopback on a Source-Node OC-N Port

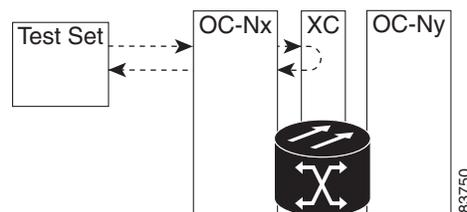
The XC loopback test occurs on the cross-connect card in a network circuit. Completing a successful XC loopback from an OC-N card through the cross-connect card eliminates the cross-connect card as the source of trouble for a faulty circuit. [Figure 1-24](#) shows an example of an XC loopback path on a source OC-N port.

Figure 1-24 XC Loopback on a Source OC-N Port

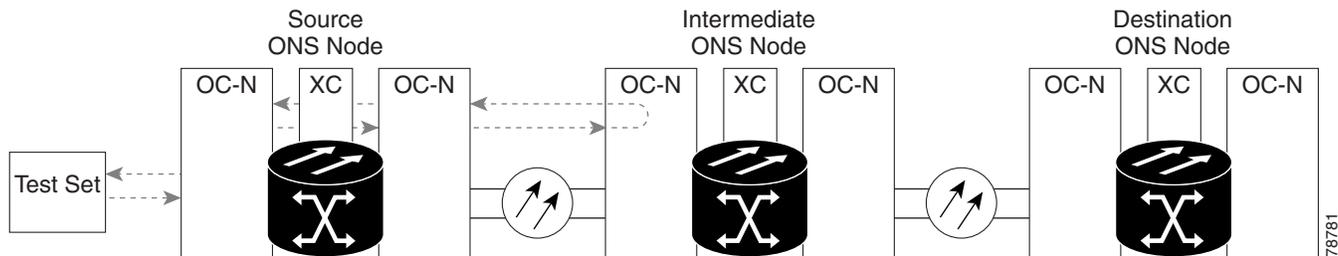
Performing the facility loopback test on an intermediate port isolates whether this node is causing circuit failure. In the situation shown in [Figure 1-25](#), the test is being performed on an intermediate OC-N port.

Figure 1-25 Facility Loopback Path to an Intermediate-Node OC-N Port

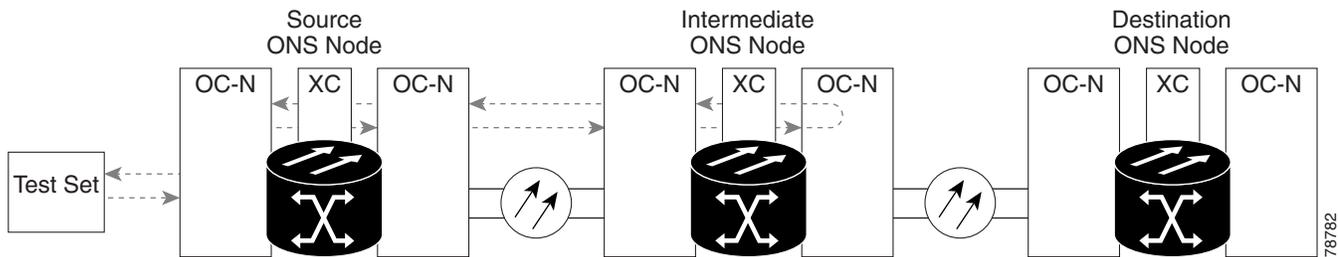
In the next troubleshooting test, you perform a terminal loopback on the intermediate-node port to isolate whether the destination port is causing circuit trouble. In the example situation in [Figure 1-26](#), the terminal loopback is performed on an intermediate optical port in the circuit. You first create a

bidirectional circuit that originates on the source-node optical port and loops back on the intermediate-node port. You then proceed with the terminal loopback test. If you successfully complete a terminal loopback on the node, this node is excluded from possible sources of circuit trouble.

Figure 1-26 Terminal Loopback Path to an Intermediate-Node OC-N Port

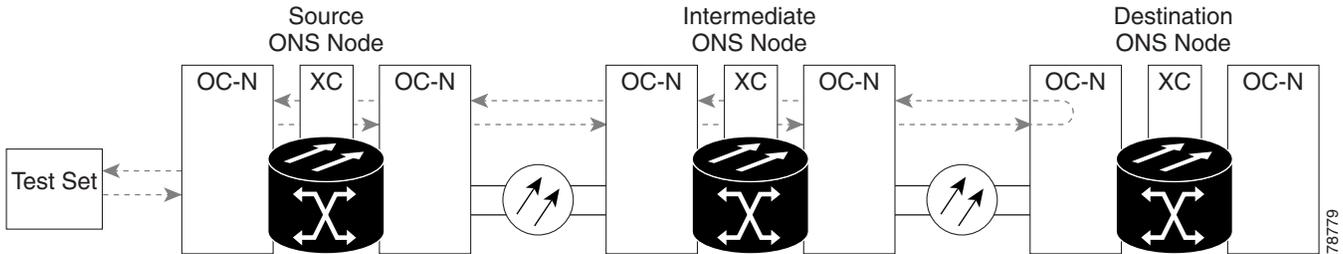
You perform a facility loopback test at the destination port to determine whether this local port is the source of circuit trouble. The example in [Figure 1-28](#) shows a facility loopback being performed on a destination-node OC-N port.

Figure 1-28 Facility Loopback Path to a Destination-Node OC-N Port

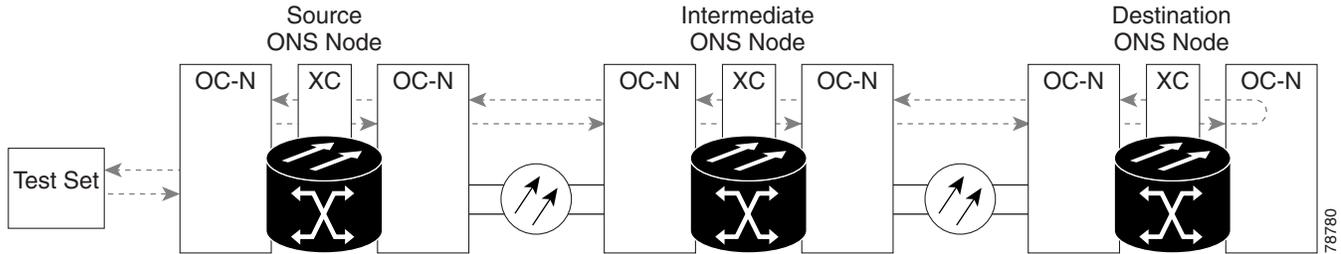
The terminal loopback at the destination-node port is the final local hardware error elimination in the circuit troubleshooting process. If this test is completed successfully, you have verified that the circuit is good up to the destination port. The example in [Figure 1-29](#) shows a terminal loopback on an intermediate-node destination OC-N port.

Figure 1-29 Terminal Loopback Path to a Destination-Node OC-N Port

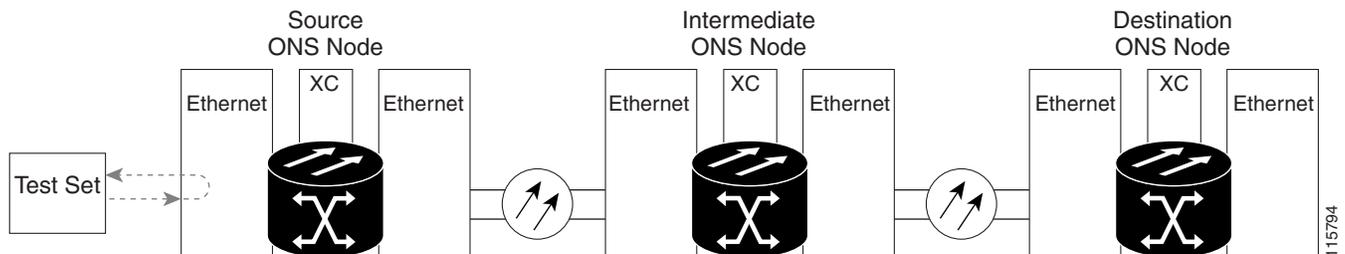
The facility loopback test is performed on the node source port in the network circuit. In the testing situation used in this example, the source G-Series port in the source node. Completing a successful facility loopback on this port isolates the G-Series port as a possible failure point. [Figure 1-21](#) shows an example of a facility loopback on a circuit source Ethernet port.

Figure 1-30 Facility Loopback on a Circuit Source Ethernet Port

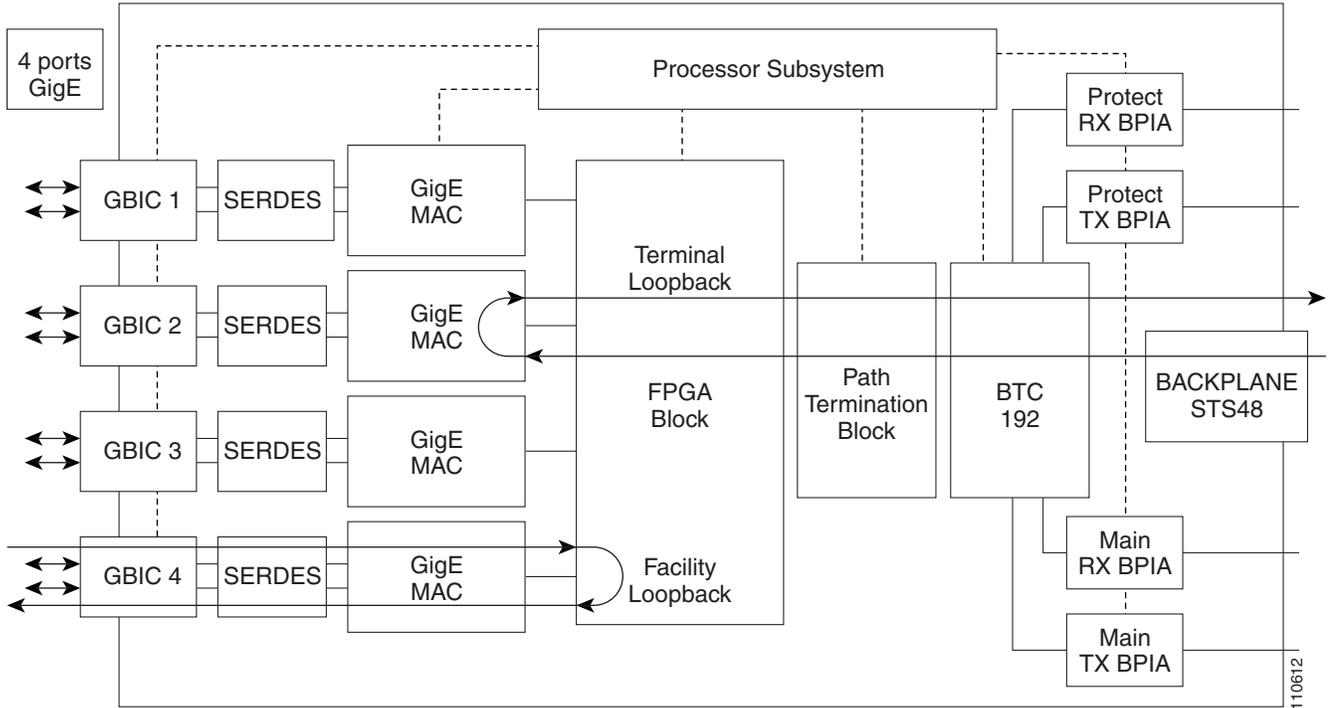
The terminal loopback test is performed on the node source Ethernet port. For the circuit in this example, it is the source G-Series port in the source node. You first create a bidirectional circuit that starts on the node destination G-Series port and loops back on the node source G-Series port. You then proceed with the terminal loopback test. Completing a successful terminal loopback to a node source port verifies that the circuit is good to the source port. [Figure 1-31](#) shows terminal loopback on a G-Series port.

Figure 1-31 Terminal Loopback on a G-Series Port

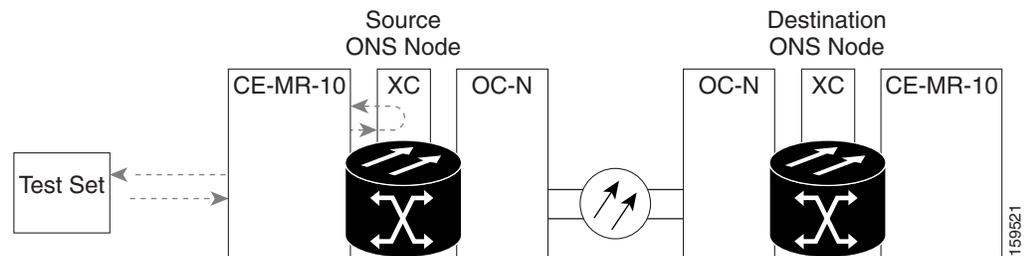
The hairpin test is performed on the cross-connect card in the network circuit. A hairpin circuit uses the same port for both source and destination. Completing a successful hairpin through the port isolates the possibility that the cross-connect card is the cause of the faulty circuit. [Figure 1-32](#) shows an example of a hairpin loopback on a source-node port.

Figure 1-32 Hairpin on a Source-Node Ethernet Port

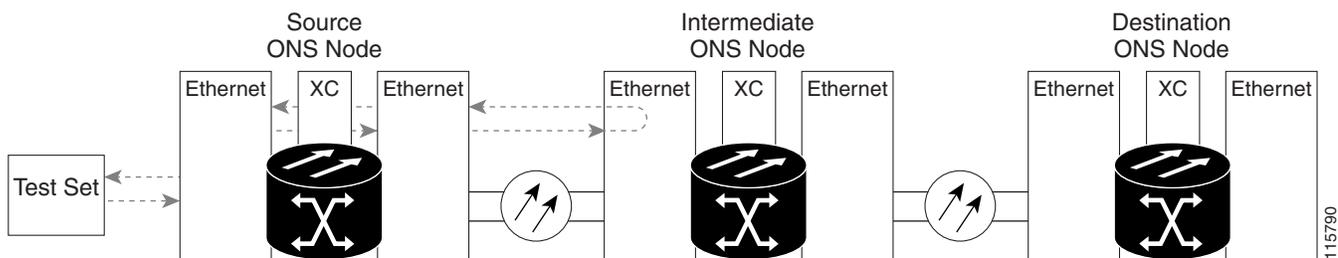
Performing the facility loopback test on an intermediate port isolates whether this node is causing circuit failure. It is shown in [Figure 1-33](#).

Figure 1-33 Facility Loopback on an Intermediate-Node Ethernet Port

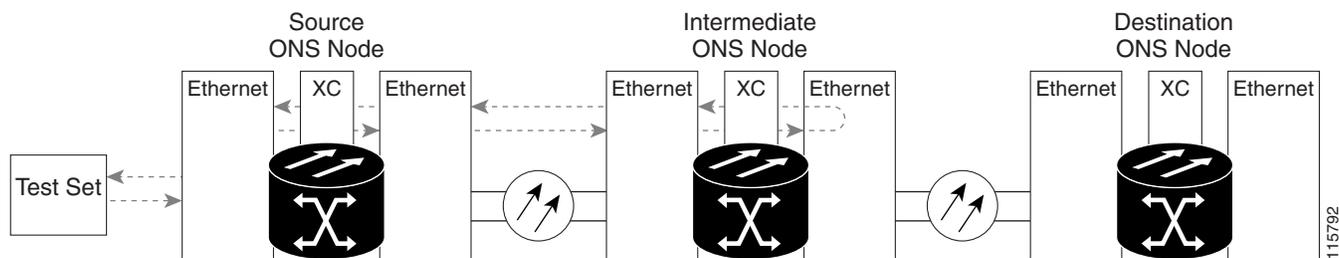
In the next troubleshooting test, you perform a terminal loopback on the intermediate-node port to isolate whether the destination port is causing circuit trouble. In the example situation in [Figure 1-34](#), the terminal loopback is performed on an intermediate Ethernet port in the circuit. You first create a bidirectional circuit that originates on the source-node Ethernet port and loops back on the intermediate-node port. You then proceed with the terminal loopback test. If you successfully complete a terminal loopback on the node, this node is excluded from possible sources of circuit trouble.

Figure 1-34 Terminal Loopback on an Intermediate-Node Ethernet Port

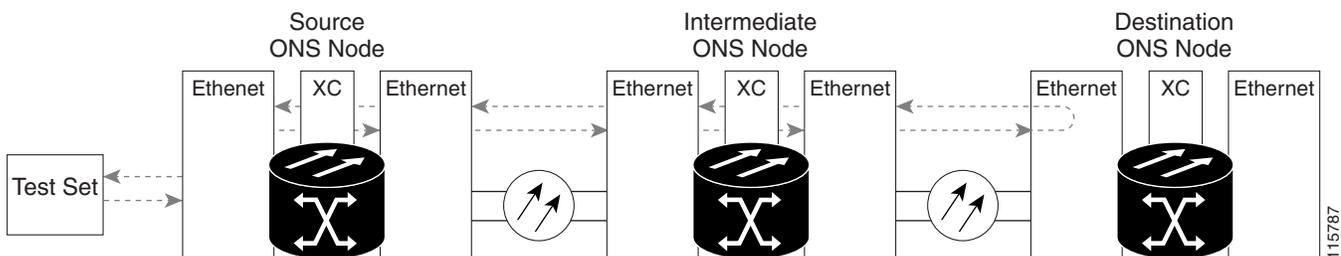
You perform a facility loopback test at the destination port to determine whether this local port is the source of circuit trouble. The example in [Figure 1-35](#) shows a facility loopback being performed on an Ethernet port.

Figure 1-35 Facility Loopback on a Destination-Node Ethernet Port

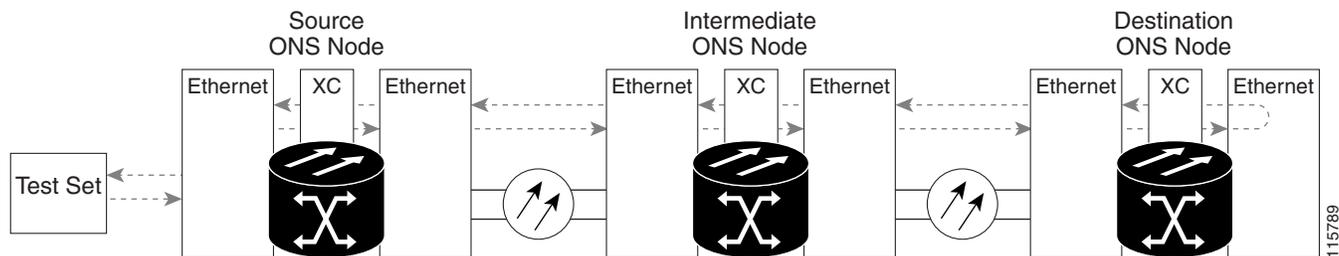
The terminal loopback at the destination-node port is the final local hardware error elimination in the circuit troubleshooting process. If this test is completed successfully, you have verified that the circuit is good up to the destination port. The example in [Figure 1-29](#) shows a terminal loopback on an intermediate-node destination Ethernet port.

Figure 1-36 Terminal Loopback on a Destination-Node Ethernet Port

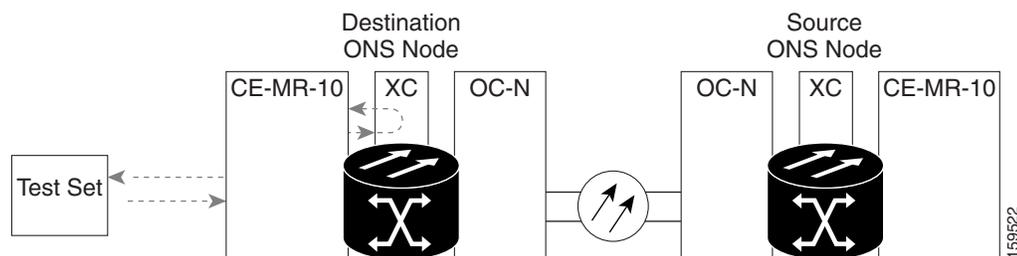
The hairpin test is performed on the cross-connect card in the network circuit. A hairpin circuit uses the same port as source as well as destination. Completing a successful hairpin through the card isolates the possibility that the cross-connect card is the cause of the faulty circuit. Figure 1-37 shows an example of a hairpin loopback on a destination-node port.

Figure 1-37 Hairpin on a Destination-Node Ethernet Port

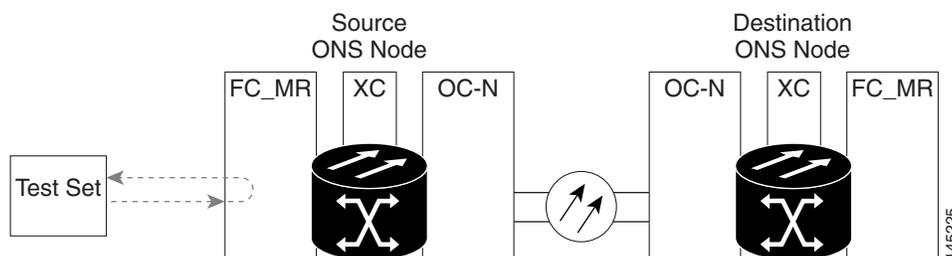
[Figure 1-38](#) shows an example of a facility loopback on a circuit source FC_MR port.

Figure 1-38 Facility Loopback on a Circuit Source FC_MR Port

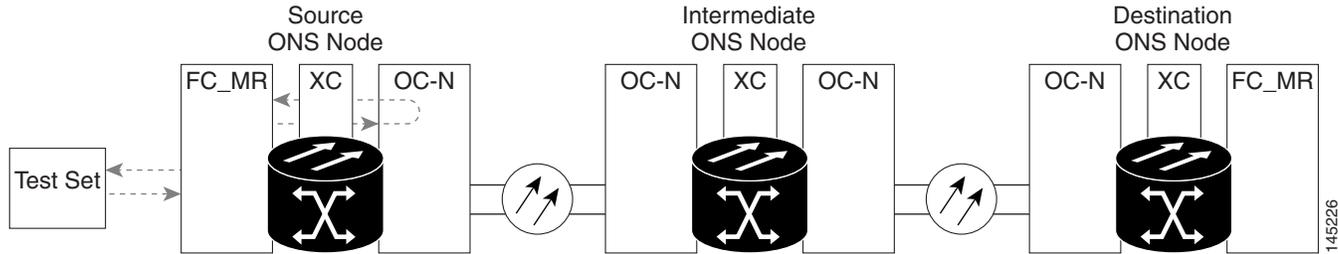
The terminal loopback test is performed on the node source FC_MR muxponder or transponder port. For the circuit in this example, the test port is the source FC_MR port in the source node. Completing a successful terminal loopback to a node source port verifies that the circuit is good to the source port. [Figure 1-39](#) shows an example of a terminal loopback on a source FC_MR port.

Figure 1-39 Terminal Loopback on a Source-Node FC_MR Port

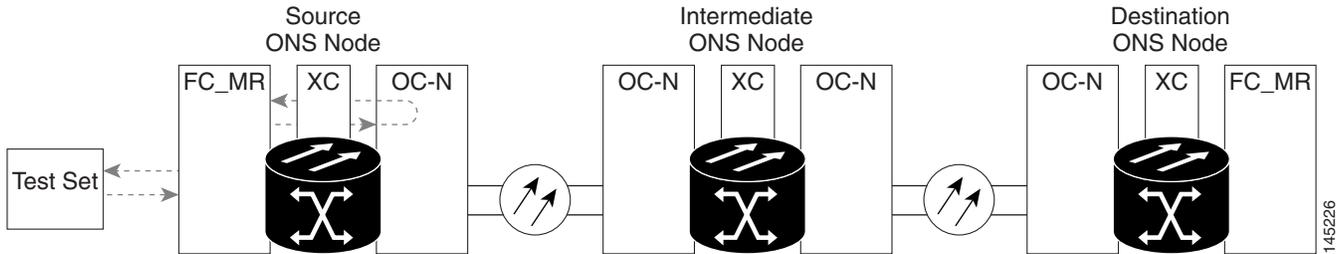
Performing the facility loopback test on an intermediate port determines whether this node is causing circuit failure. In the example shown in [Figure 1-40](#), the test is being performed on an intermediate FC_MR port.

Figure 1-40 Facility Loopback on an Intermediate-Node FC_MR Port

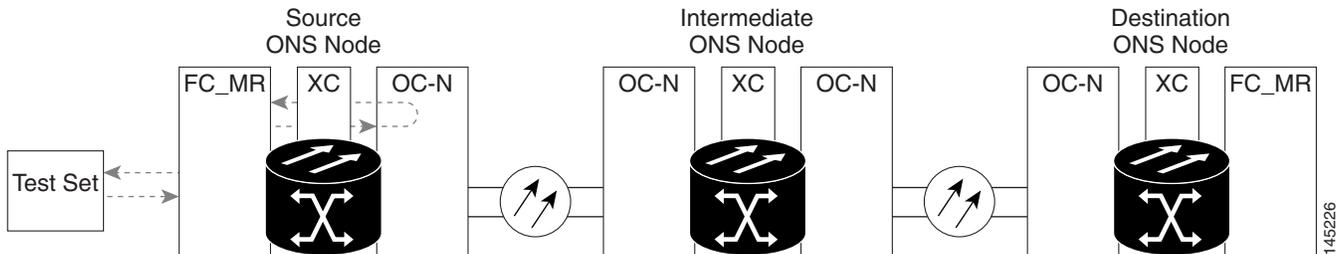
In the next troubleshooting test, you perform a terminal loopback on the intermediate-node port to isolate whether the destination port is causing circuit trouble. In the example situation in [Figure 1-41](#), the terminal loopback is performed on an intermediate FC_MR port in the circuit. If you successfully complete a terminal loopback on the node, this node is excluded from possible sources of circuit trouble.

Figure 1-41 Terminal Loopback on an Intermediate-Node FC_MR Port

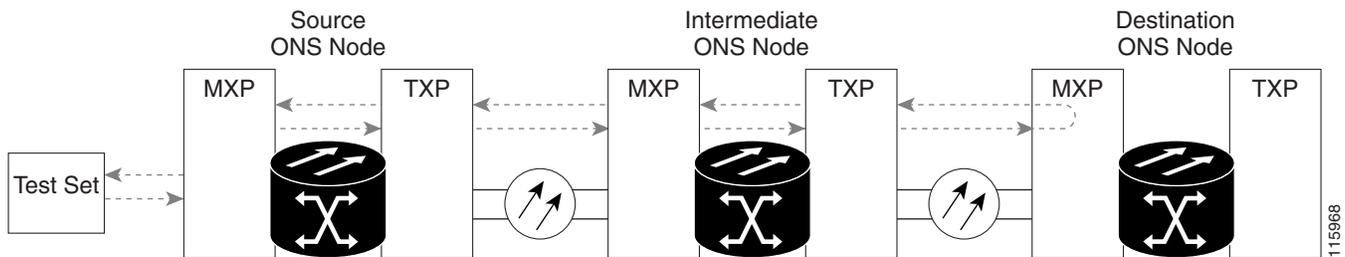
You perform a facility loopback test at the destination port to determine whether this local port is the source of circuit trouble. The example in [Figure 1-42](#) shows a facility loopback being performed on an FC_MR port.

Figure 1-42 Facility Loopback on a Destination-Node FC_MR Port

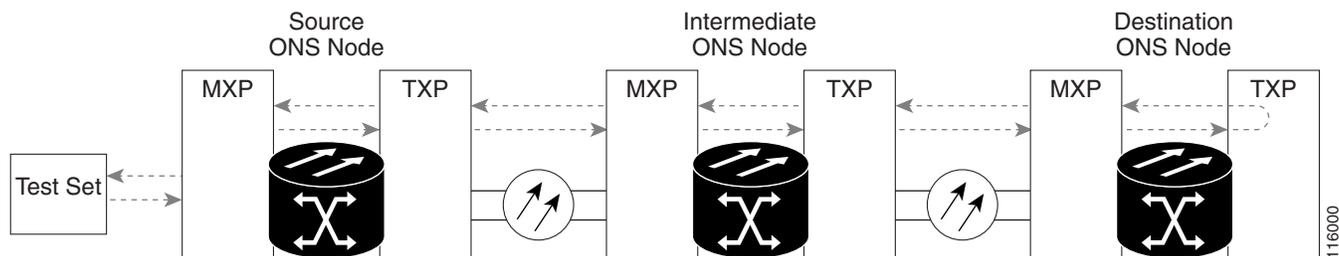
The terminal loopback at the destination-node port is the final local hardware error elimination in the circuit troubleshooting process. If this test is completed successfully, you have verified that the circuit is good up to the destination port. The example in [Figure 1-43](#) shows a terminal loopback on an intermediate-node destination FC_MR port.

Figure 1-43 Terminal Loopback on a Destination-Node FC_MR Port

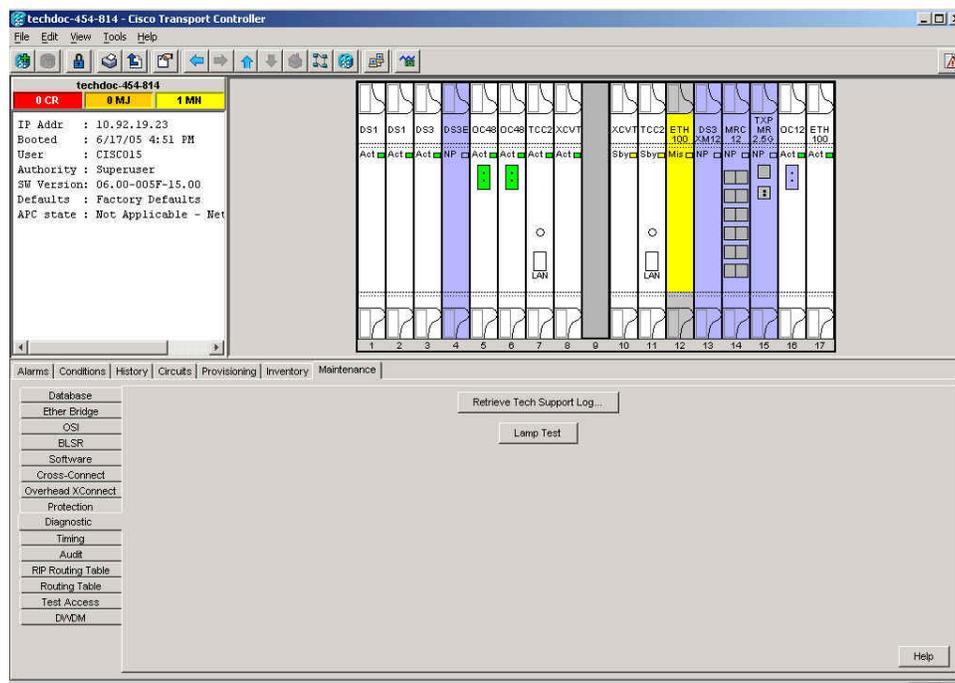
- Step 1** In node view, click the **Maintenance > Diagnostic** tabs (Figure 1-44).

Figure 1-44 CTC Node View Diagnostic Window

- Step 1** In the node view, click the **Maintenance > Diagnostic** tabs ([Figure 1-44](#)).
- Step 2** Click **Retrieve Tech Support Log**.
- Step 3** In the Saving Diagnostic File dialog box, navigate to the directory (local or network) where you want to save the file.
- Step 4** Enter a name in the File Name field.
- You do not have to give the archive file a particular extension. It is a compressed file (gzip) that can be unzipped and read by Cisco Technical Support.
- Step 5** Click **Save**.
- The Get Diagnostics status window shows a progress bar indicating the percentage of the file being saved, then shows “Get Diagnostics Complete.”
- Step 6** Click **OK**.
-

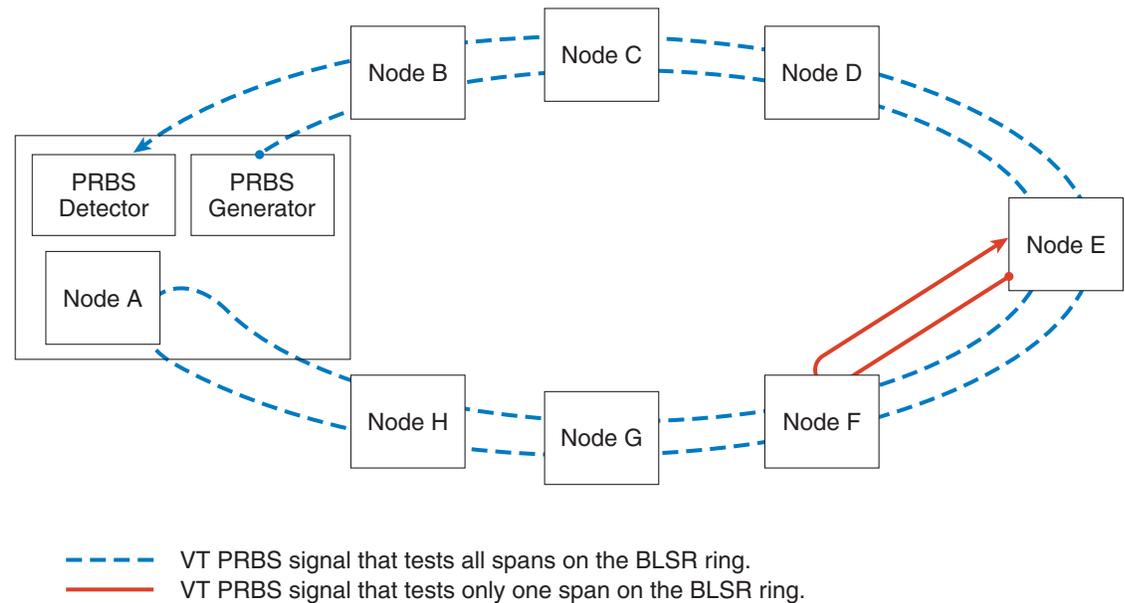
The diagnostic circuit can be configured for an end-to-end or multiple-node path layout, traversing the transmit and receive standby paths as shown in Figure 1-45.

Figure 1-45 CTC Node View Diagnostic Window

NOTE: The end without the arrow is where the PRBS pattern is generated. The end with the arrow is the end where the PRBS pattern is detected.

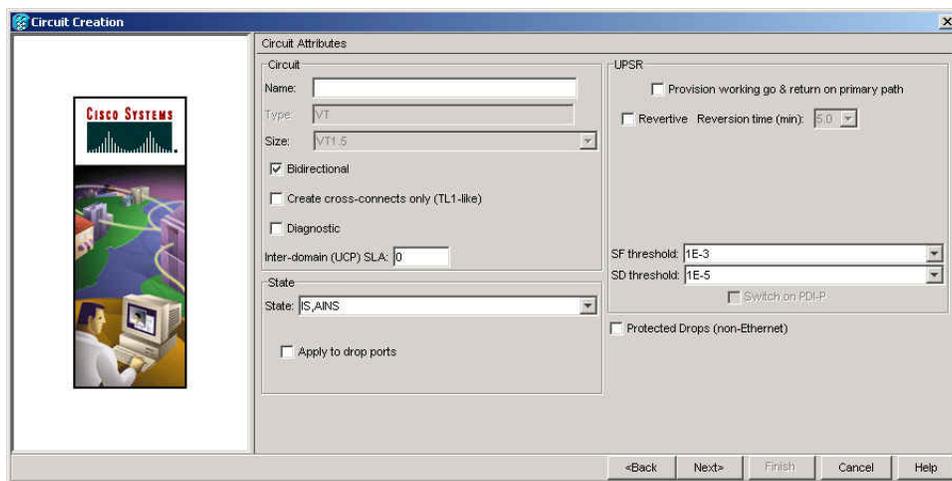
- Step 6** Click **Next**.
- Step 7** Define the circuit attributes in the Circuit Creation Dialog Box ([Figure 1-46](#)) using the following parameters:

Figure 1-46 Network View Circuit Creation Dialog Box

- Name—Assign a name to the circuit. The name can be alphanumeric and up to 48 characters, (including spaces). Circuit names should be 44 characters or less if you want the ability to create monitor circuits. If you leave the field blank, CTC assigns a default name to the circuit.
- Size—VT1.5 is the default. You cannot change it.

- Bidirectional—This is the default value. Leave it checked for this circuit.
- State—This option is not available when you check the Diagnostic option.
- Diagnostic—Check this box to create a diagnostic circuit.
- Apply to drop ports—Leave this box unchecked.
- Create cross-connects only (TL1-like)—Not applicable to diagnostic circuits.
- Inter-domain (UCP) SLA—Not applicable to diagnostic circuits.
- Protected Drops—Not applicable to diagnostic circuits.

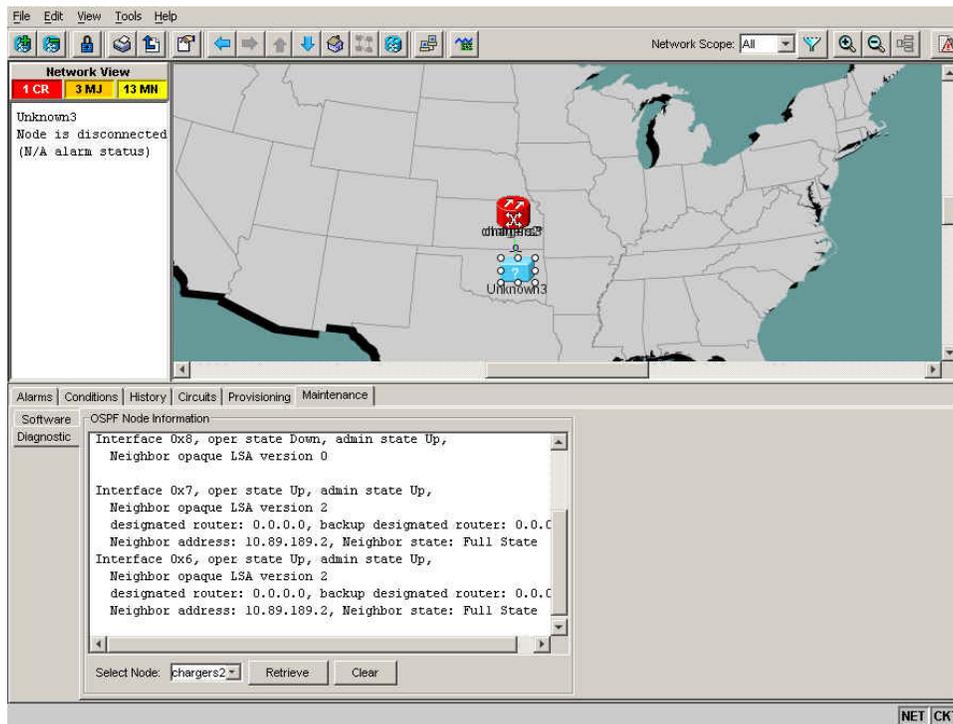
CTC contains a data communications network (DCN) tool that assists with network troubleshooting for Open Shortest Path First (OSPF) networks. This tool, located in network view, is shown in [Figure 1-47](#). It executes an internal dump command to retrieve information about all nodes accessible from the entry point.

Figure 1-47 DCN Tools OSPF Dump

The dump, which provides the same information as a dump executed by special networking commands, is available at the network view in the Maintenance > Diagnostic tabs. You can select the access point node in the Select Node drop-down list. To create the dump, click Retrieve. (To clear the dump, click Clear.)

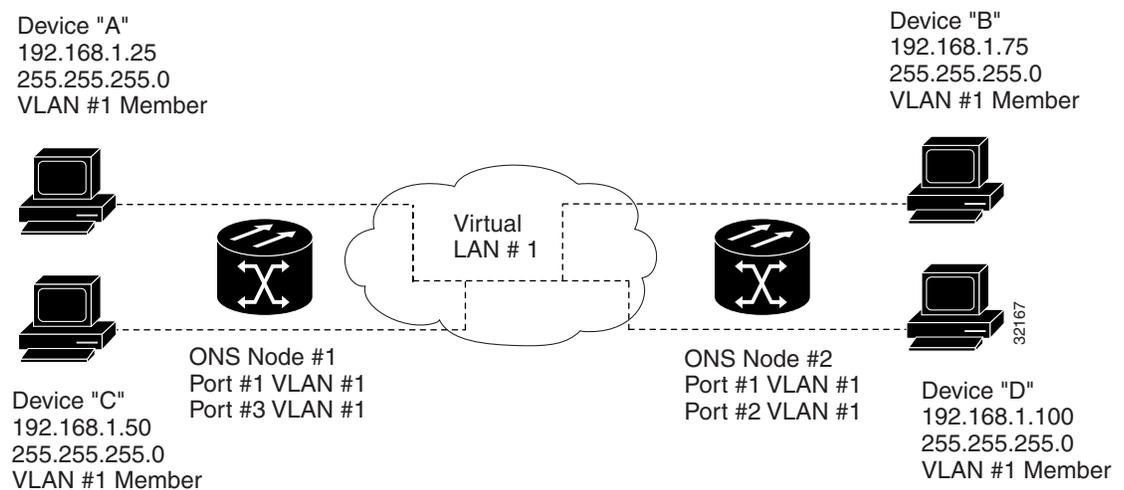
**Figure 1-49 Ethernet Connectivity Reference**

**Recommended Action** You can fix most connectivity problems in an Ethernet network by following a few guidelines. See [Figure 1-49](#) when using the steps in the “Verify Ethernet Connections” procedure on page 1-131.

- 
- Step 1** Verify that the alarm filter is turned OFF.
- Step 2** Check for SONET and DWDM alarms on the STS that carries the VLAN Ethernet circuit. Clear any alarms by looking them up in [Chapter 2, “Alarm Troubleshooting.”](#)

- Verify physical connectivity between the ONS 15454s and the attached device.
  - Verify that the ports are enabled on the Ethernet cards.
  - Verify that you are using the proper Ethernet cable and that it is wired correctly, or replace the cable with a known-good Ethernet cable.

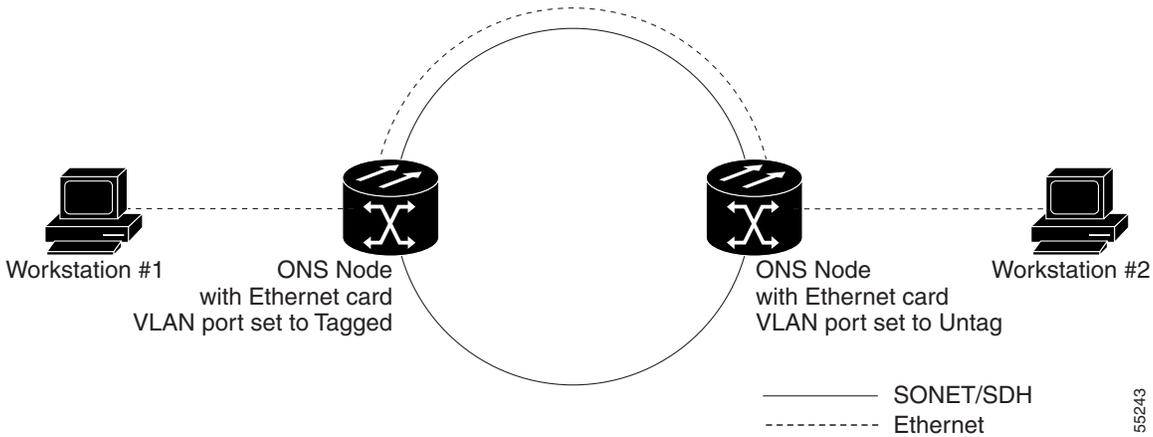
Figure 1-50 VLAN with Ethernet Ports at Tagged and Untag

**Symptom** Networks that have a VLAN with one ONS 15454 Ethernet card port set to Tagged and one ONS 15454 Ethernet card set to Untag might have difficulty implementing Address Resolution Protocol (ARP) for a network device attached to the Untag port ([Figure 1-50](#)). They might also see a higher than normal runt packets count at the network device attached to the Untag port. This symptom/limitation also exists when ports within the same card or ports within the same chassis are put on the same VLAN, with a mix of tagged and untagged.

**Possible Cause** The Tagged ONS 15454 adds the IEEE 802.1Q tag and the Untag ONS 15454 removes the Q-tag without replacing the bytes. The NIC of the network device categorizes the packet as a runt and drops the packet.

**Recommended Action** The solution is to set both ports in the VLAN to Tagged to stop the stripping of the 4 bytes from the data packet and prevent the NIC card in the network access device from recognizing the packet as a runt and dropping it. Network devices with IEEE 802.1Q-compliant NIC cards accept the tagged packets. Network devices with non IEEE 802.1Q compliant NIC cards still drop these tagged packets. The solution might require upgrading network devices with non-IEEE 802.1Q compliant NIC cards to IEEE 802.1Q compliant NIC cards. You can also set both ports in the VLAN to Untag, but you will lose IEEE 802.1Q compliance.

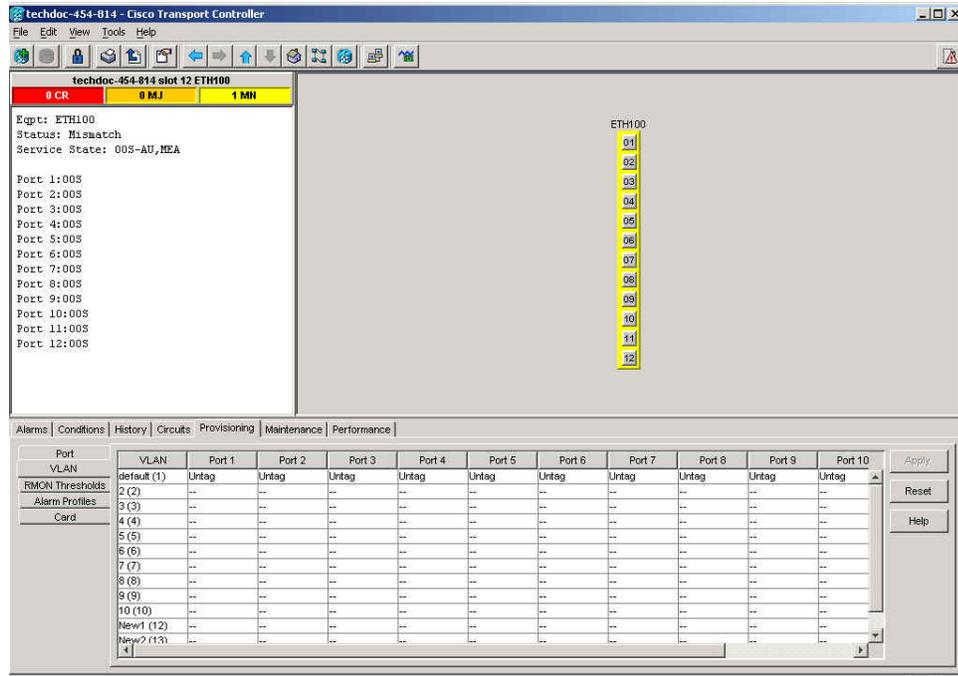
Figure 1-51 Configuring VLAN Membership for Individual Ethernet Ports

- Step 1** Open the CTC card view for the Ethernet card involved in the problem VLAN.
- Step 2** Click the **Provisioning > Ether VLAN** tabs (Figure 1-51).

- Step 3** If the port is set to **Tagged**, continue to look at other cards and their ports in the VLAN until you find the port that is set to **Untag**.
- Step 4** At the VLAN port set to **Untag**, click the port and choose **Tagged**.

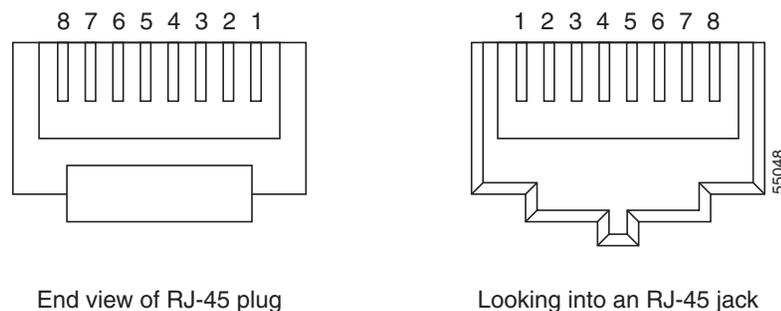
**Figure 1-52 RJ-45 Pin Numbers**

You can crimp your own LAN cables for use with the ONS 15454. Use a cross-over cable when connecting an ONS 15454 to a hub, LAN modem, or switch, and use a LAN cable when connecting an ONS 15454 to a router or workstation. Use Category-5 cable RJ-45 T-568B, Color Code (100 Mbps), and a crimping tool. [Figure 1-52](#) shows the wiring of an RJ-45 connector. [Figure 1-53](#) shows a LAN cable layout, and [Table 1-4](#) shows the cable pinouts. [Figure 1-54](#) shows a cross-over cable layout, and [Table 1-5](#) shows the cross-over pinouts.

End view of RJ-45 plug

Looking into an RJ-45 jack

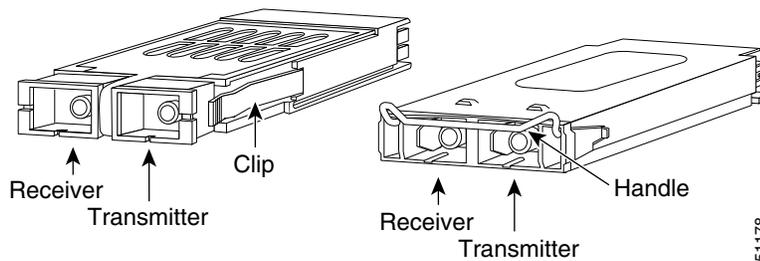
**Figure 1-55** GBICs

GBICs are available in two different models. One GBIC model has two clips (one on each side of the GBIC) that secure the GBIC in the slot on the E1000-2-G, G-Series, or G1K-4 card. The other model has a locking handle. Both models are shown in [Figure 1-55](#).

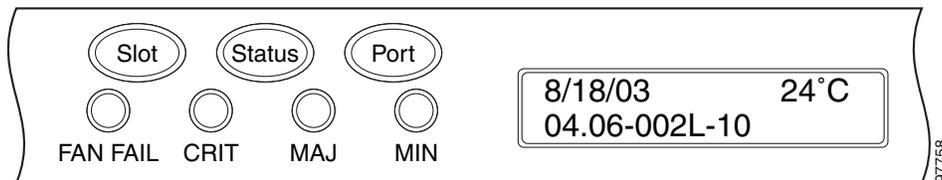
**Figure 2-1 Shelf LCD Panel**

**Step 1** View the temperature displayed on the ONS 15454 LCD front panel ([Figure 2-1](#)).

**Step 2** If the temperature of the shelf exceeds 194 degrees F (90 degrees C), the alarm should clear if you solve the ONS 15454 temperature problem. Complete the [“Clear the HITEMP Alarm” procedure on page 2-125](#).

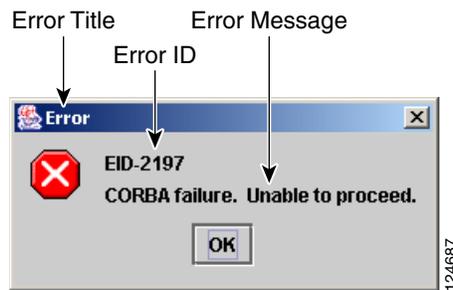
Figure 4-1 Error Dialog Box

This chapter lists the Cisco ONS 15454, Cisco 15454 SDH, Cisco ONS 15600, Cisco 15600 SDH, Cisco ONS 15310-CL, and Cisco ONS 15310-MA error messages. The error dialog box in [Figure 4-1](#) consists of three parts: the error title, error ID, and error message. The table lists two types of messages: error messages (EID-*nnnn*) and warning messages (WID-*nnnn*). Error messages are alerts that an unexpected or undesirable operation has occurred which either indicates the risk of loss of traffic or an inability to properly manage devices in the network. Warnings are alerts that the requested operation could lead to an error. Warnings are sometimes used to convey important information.
