CHAPTER 12

Upgrade Cards and Spans

This chapter explains how to upgrade a DS1-28/DS3-EC1-3 card to a DS1-84/DS3-EC1-3 card, and optical spans in a Cisco ONS 15310-MA.

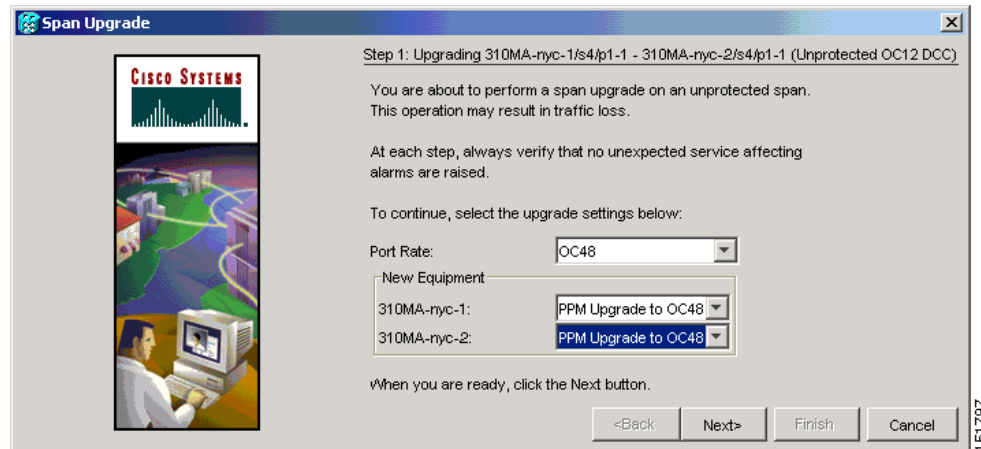
Figure 12-1 Span Upgrade Wizard

- Step 5** In network view, right-click the span you want to upgrade.
- Step 6** Choose **Span Upgrade** from the drop-down list.
- Step 7** The first Span Upgrade dialog box appears ([Figure 12-1](#)). Follow the instructions in the dialog box and the wizard will lead you through the rest of the span upgrade.

Note The Back button is only enabled in Step 2 of the wizard; because you cannot back out of an upgrade using the wizard, close the wizard and initiate the manual procedure if you need to back out of the upgrade at any point beyond Step 2.
