CHAPTER 2

Alarm Troubleshooting

This chapter gives a description, severity, and troubleshooting procedure for each commonly encountered Cisco DWDM alarm and condition. Tables 2-1 through 2-5 provide lists of DWDM alarms organized by severity. Table 2-6 on page 2-8 provides a list of alarms organized alphabetically. Table 2-7 gives definitions of all DWDM alarm logical objects, which are the basis of the alarm profile list in Table 2-8 on page 2-17. For a comprehensive list of all conditions and instructions for using TL1 commands, refer to the *Cisco SONET TL1 Command Guide*.

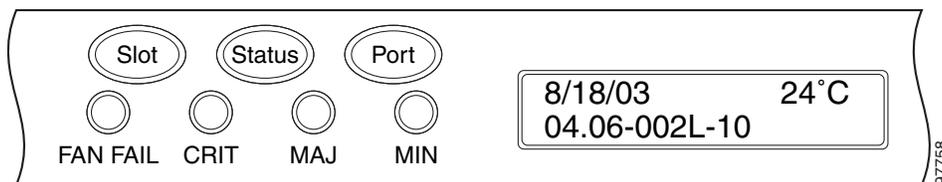
Figure 2-1 Shelf LCD Panel

Step 1 View the temperature displayed on the ONS 15454 LCD front panel (Figure 2-2).

Figure 2-2 shows the shelf LCD panel.

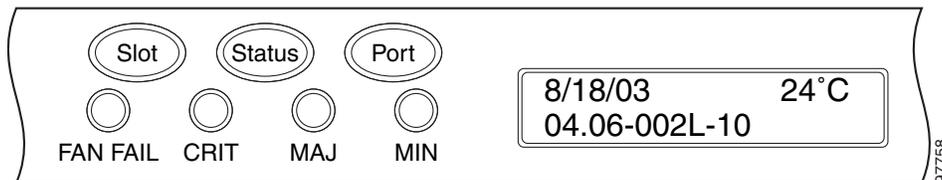
Figure 2-2 Shelf LCD Panel

- Step 1** View the temperature displayed on the ONS system LCD front panel. For example, the ONS 15454 front panel is illustrated in [Figure 2-2](#).

-
- Step 1** Check for any outstanding alarms that were raised against the active and standby TCC2/TCC2P and resolve them.
- Step 2** If the alarm does not clear, determine whether the LCD display on the fan tray ([Figure 2-2 on page 2-102](#)) is blank or if the text is garbled. If so, proceed to [Step 8](#). If not, continue with [Step 3](#).
- Step 3** At the earliest maintenance window, reset the standby TCC2/TCC2P:
