## **Cisco ONS 15454 DWDM Troubleshooting Guide, Releases 9.2.1 and 9.2.2**

Text Part Number: 78-19696-03

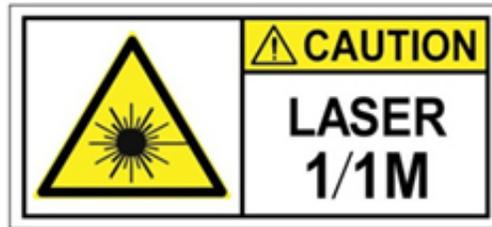
*Figure 1: Class 1M Laser Product Label*

Cisco NCS 2000 Series cards are classified as Laser Class 1 or 1M as per IEC 60825-1 and Hazard Level 1M as per IEC 60825-2.
