Alarm Troubleshooting

This chapter gives a description, severity, and troubleshooting procedure for each commonly encountered Cisco DWDM alarm and condition. Tables [Table 1](#) through [Table 1](#) provide lists of DWDM alarms organized by severity. [Table 1: Alarm Logical Object Type Definitions, on page 9](#) provides a list of alarms organized alphabetically. [Table 1: Alarm Logical Object Type Definitions, on page 9](#) gives definitions of all DWDM alarm logical objects, which are the basis of the alarm profile list in [Table 1](#). For a comprehensive list of all conditions and instructions for using TL1 commands, refer to the TL1 Command Guide. An alarm troubleshooting procedure applies to both the Cisco Transport Controller (CTC) and TL1 version of that alarm.

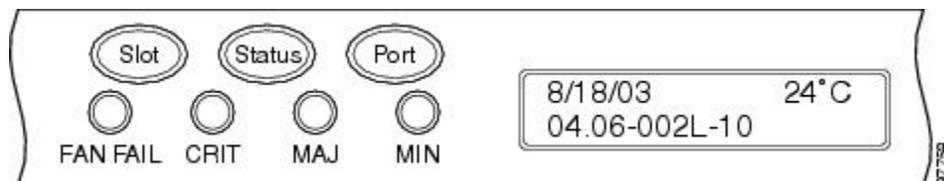
Figure 1: Shelf LCD Panel

- Step 1** View the temperature displayed on the LCD front panel (Figure 2: Shelf LCD Panel, on page 103). Figure 2: Shelf LCD Panel, on page 103 shows the shelf LCD panel.

- Step 1** View the temperature displayed on the system LCD front panel. For example, the front panel is illustrated in [Figure 2: Shelf LCD Panel](#), on page 103.

- 
- Step 1** Check for any outstanding alarms that were raised against the active and standby TCC2/TCC2P/TCC3 and resolve them.
- Step 2** If the alarm does not clear, determine whether the LCD display on the fan tray ([Figure 2: Shelf LCD Panel, on page 103](#)) is blank or if the text is garbled. If so, proceed to [Step 8, on page 118](#). If not, continue with [Step 3, on page 117](#).
