## **Troubleshooting Guide for Cisco NCS 1010, IOS XR Release 24.3.x**

**First Published:** 2024-06-14

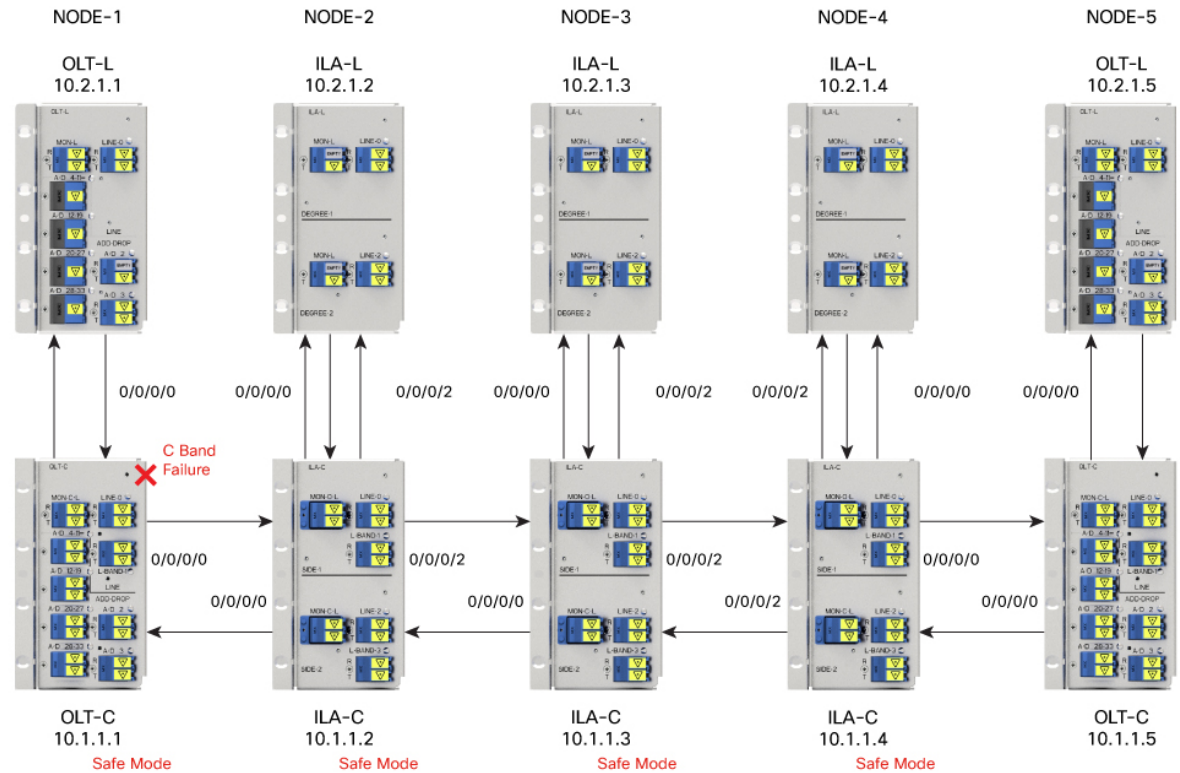
Figure 2: Example of C-band Failure on a C+L Band Network

In this section, we will troubleshoot C band failure due to amplifier shutdown or failure. To troubleshoot C-band failure on a C+L band network, start by running the following commands on the manager nodes in the same order:

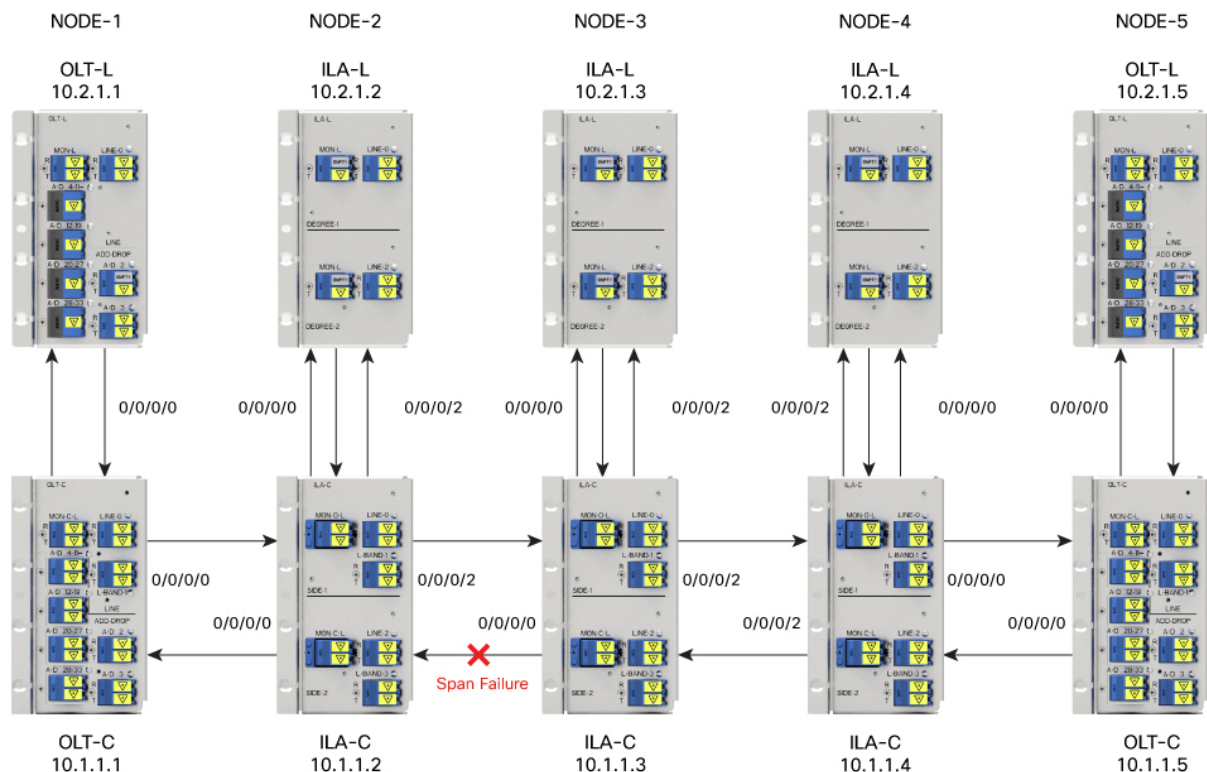
Figure 3: Example of Span Failure

To troubleshoot span failure on a C+L band network, start by running the following commands on the manager nodes in the same order:

**Step 1** Run the **show olc band-status** command on node 10.1.1.1.

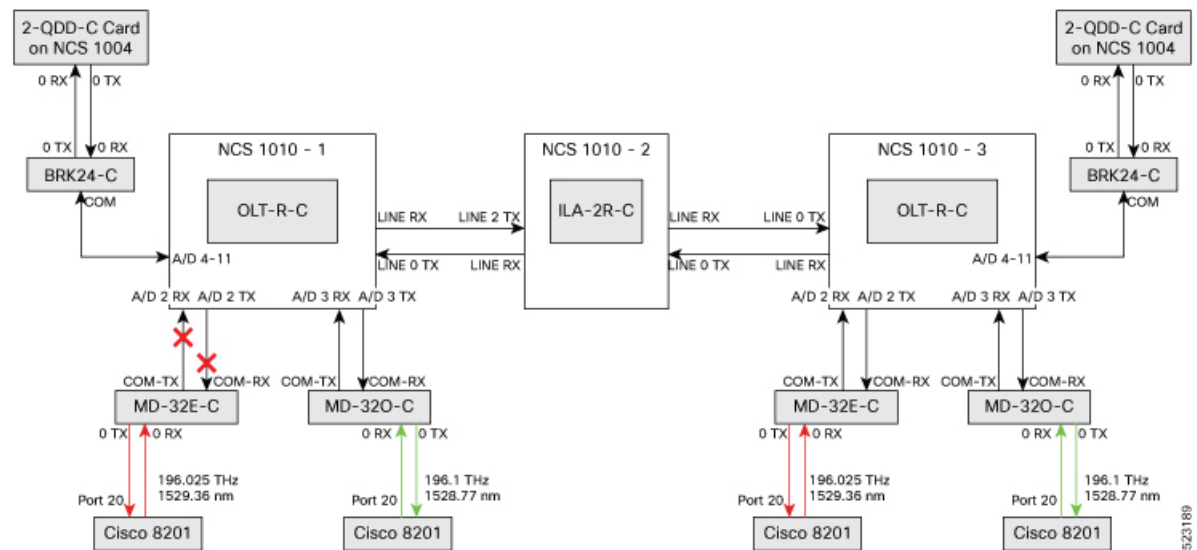
Figure 5: Fiber Cut at the AD Port OTS Controller and OMS Controller

The following figure displays client-side failure due to fiber cut:

The following example shows how to determine LOS-P failure at the AD port controller OTS:
