## General Troubleshooting

This chapter provides procedures for troubleshooting the most common problems encountered when operating the NCS 1010 chassis.

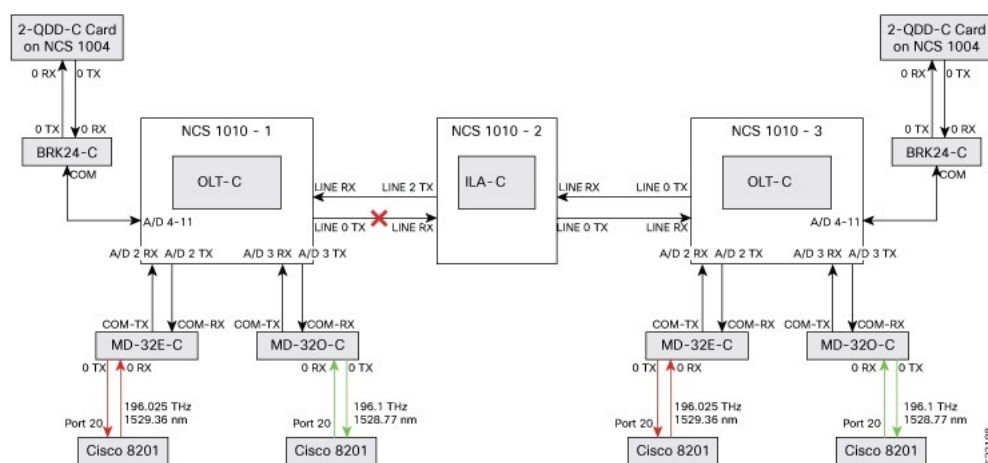
**Figure 6: Fiber Cut at the Line OTS Controller**

The following figure shows loss of fiber connection continuity at the Line port:

The following example shows how to determine a span failure. Look for the highlighted alarms in the **show controllers** output.
