Troubleshooting Guide for Cisco NCS 1010, IOS XR Release 26.x.x

First Published: 2026-03-02

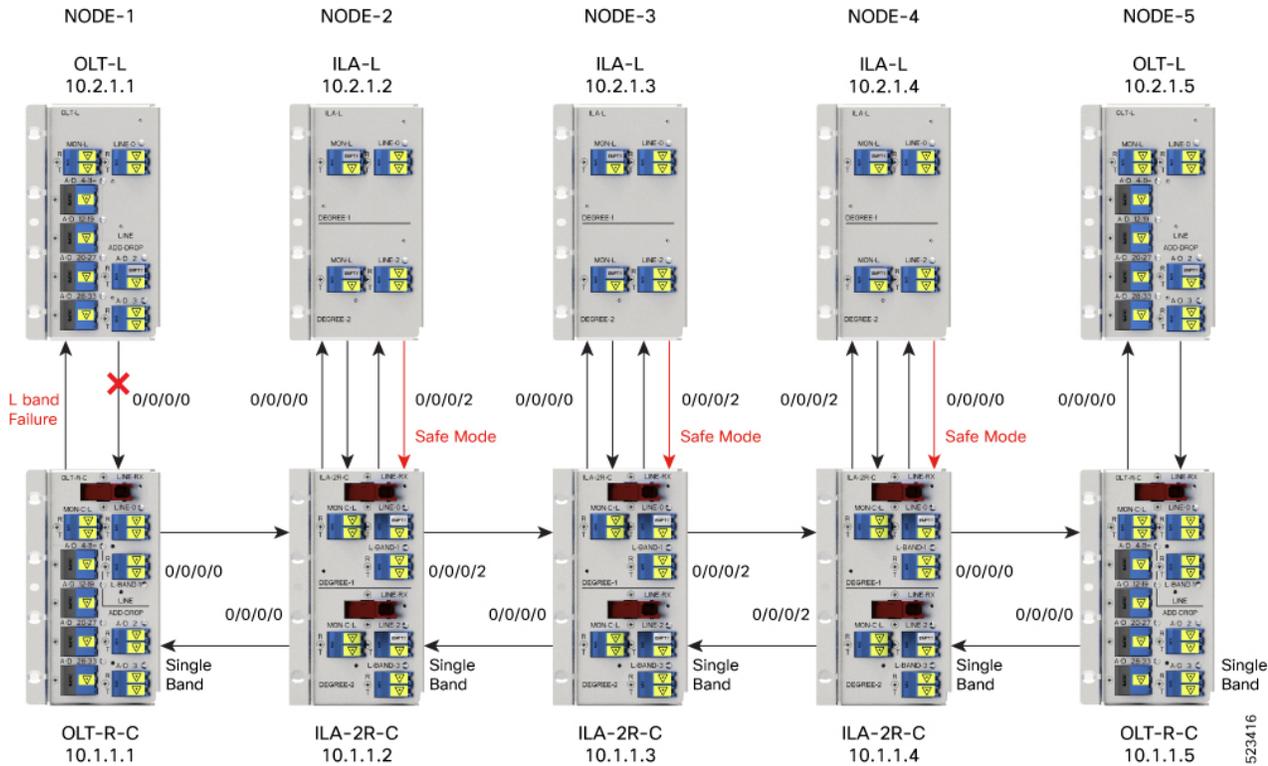
Figure 1: Example of L-band Failure

In this section, we will troubleshoot L band failure due to connectivity failure between OLT-C and OLT-L nodes. To troubleshoot L-band failure on a C+L band network, start by running the following commands on the manager nodes:

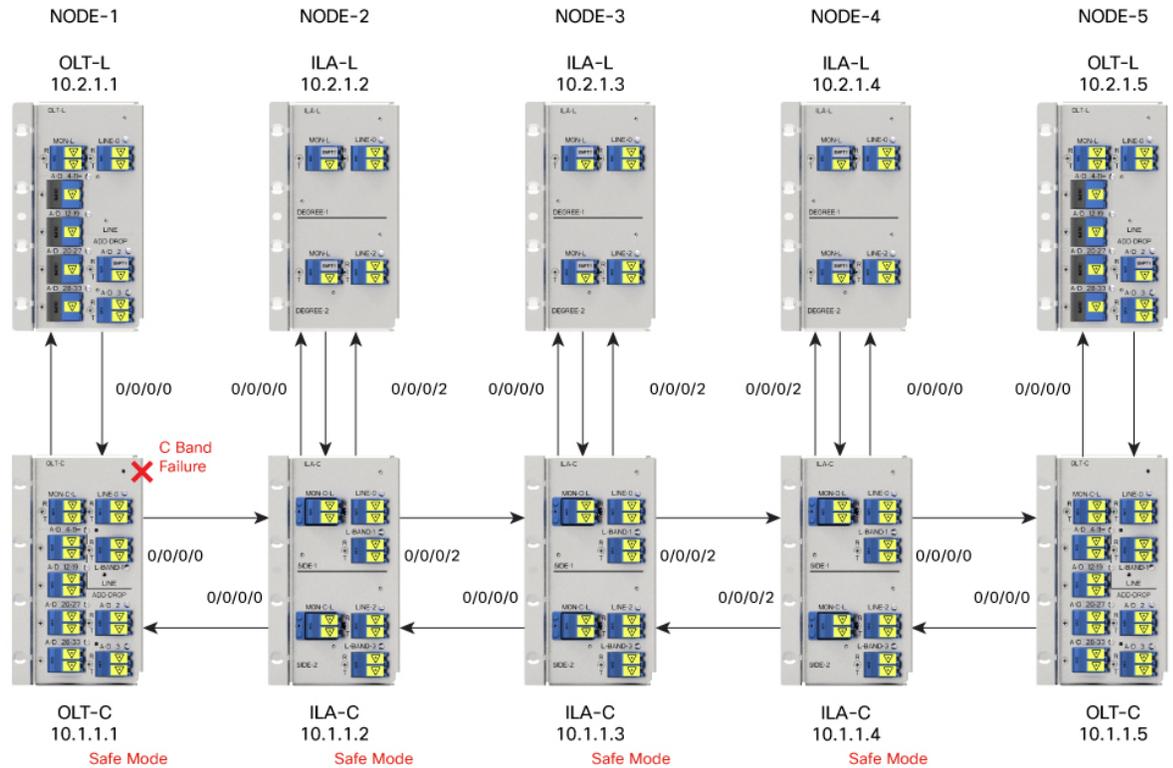
Figure 2: Example of C-band Failure on a C+L Band Network

In this section, we will troubleshoot C band failure due to amplifier shutdown or failure. To troubleshoot C-band failure on a C+L band network, start by running the following commands on the manager nodes in the same order:

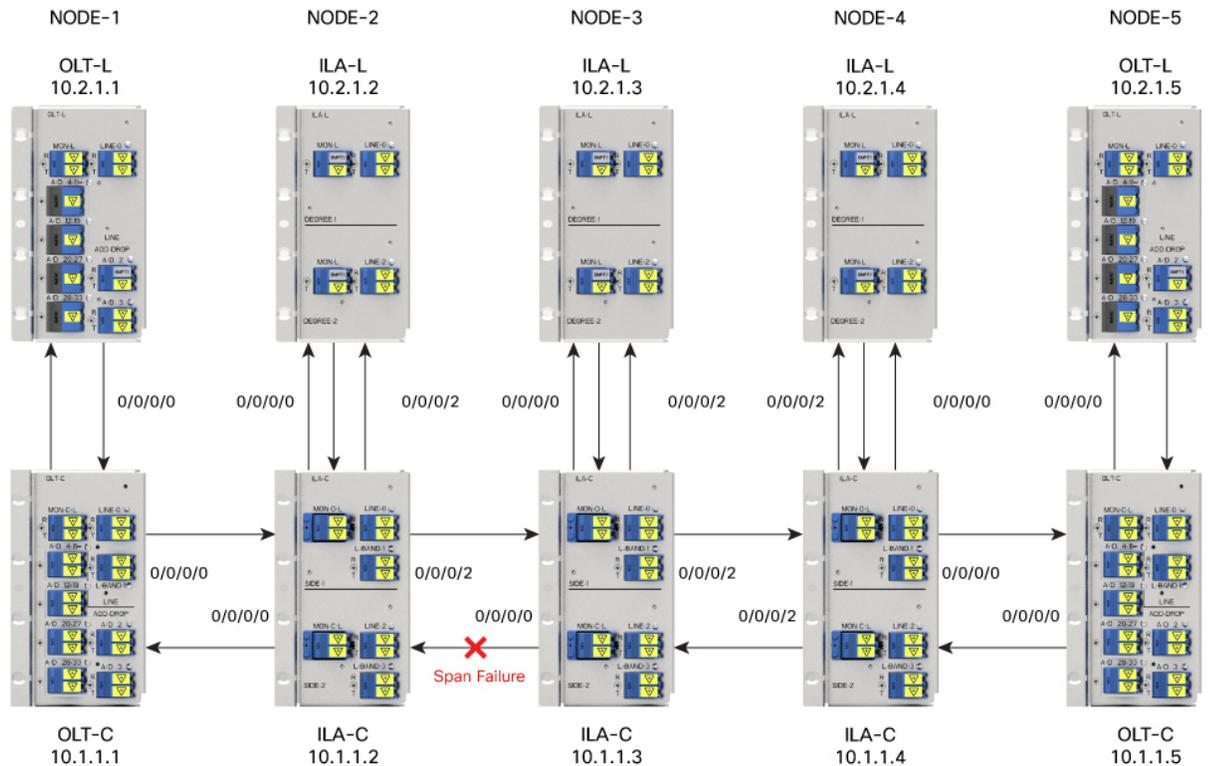
Figure 3: Example of Span Failure

To troubleshoot span failure on a C+L band network, start by running the following commands on the manager nodes in the same order:

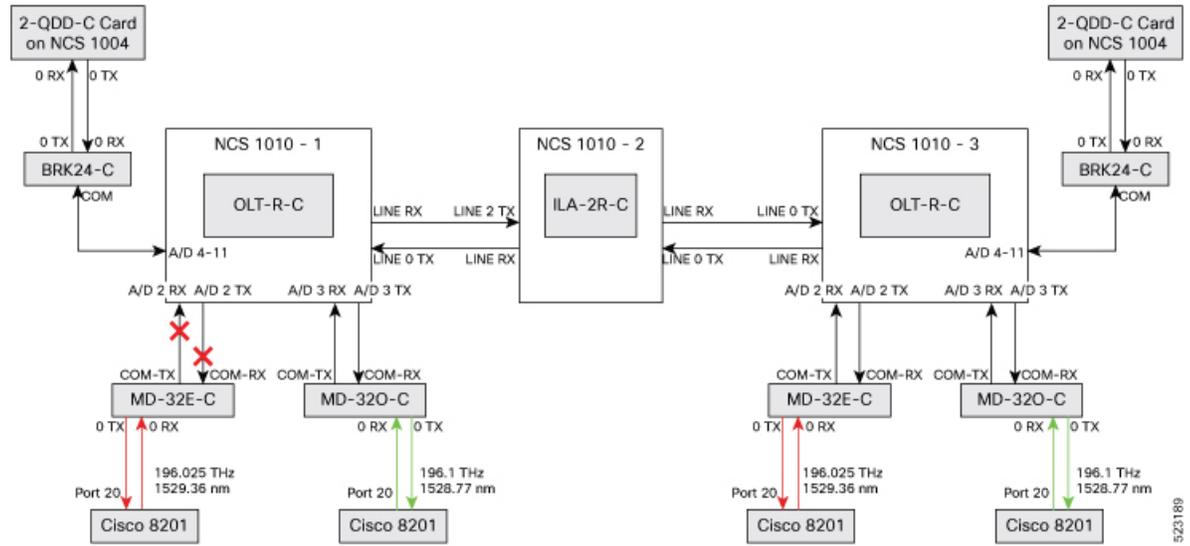
Figure 5: Fiber Cut at the AD Port OTS Controller and OMS Controller

The following figure displays client-side failure due to fiber cut:

The following example shows how to determine LOS-P failure at the AD port controller OTS:

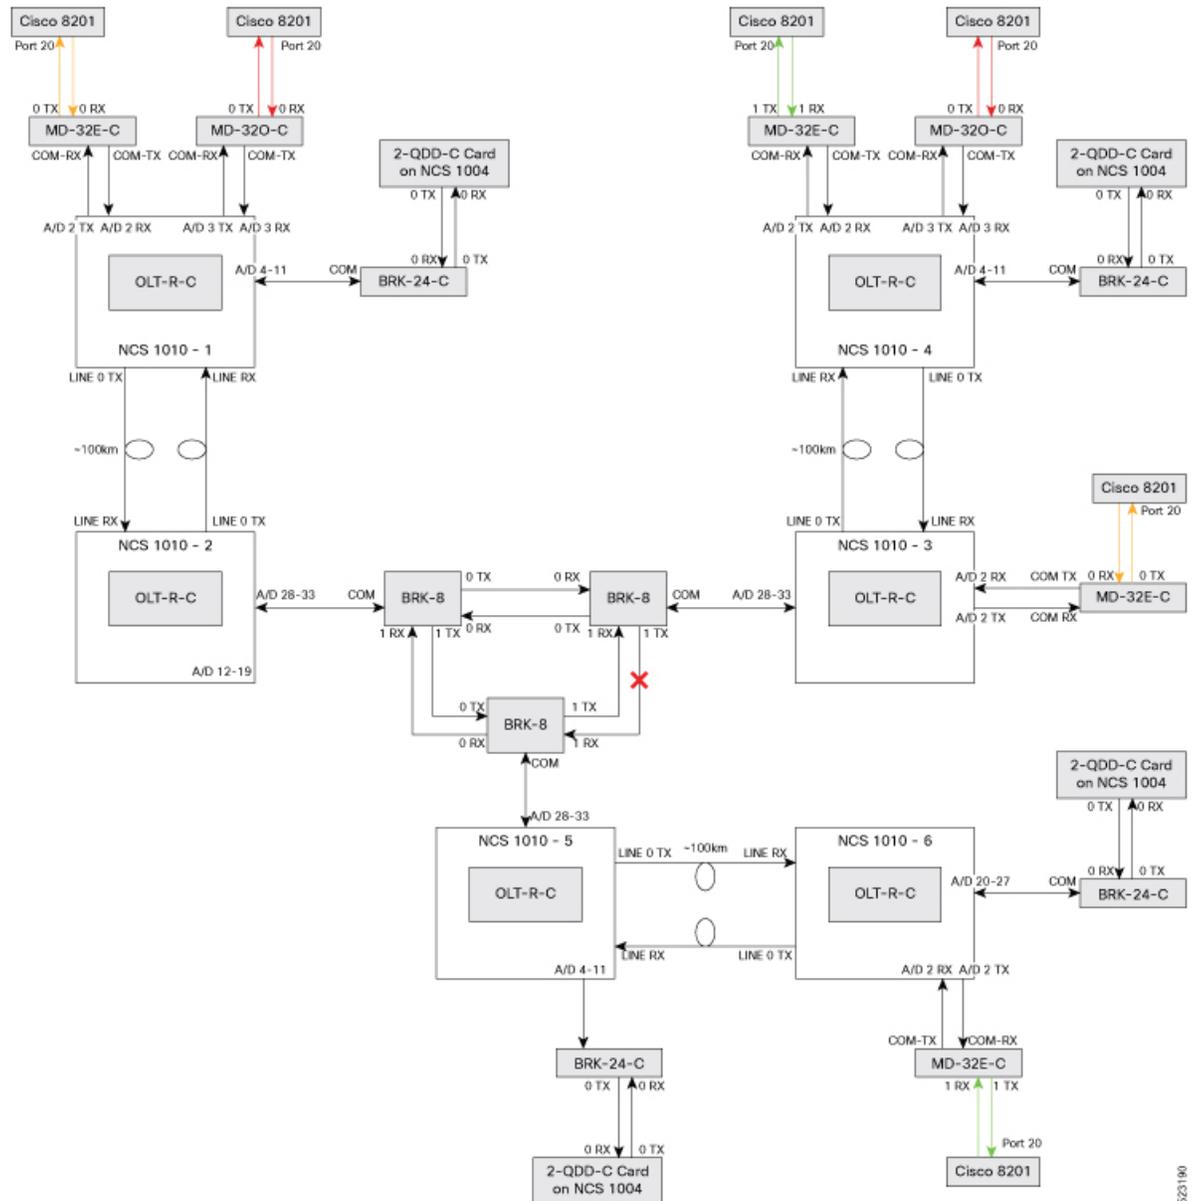
Figure 6: Fiber Cut Between Two Passive Devices

The following figure displays the fiber cut between two passive devices:

The following example shows how to determine the fiber cut between two passive devices:
