## General Troubleshooting

This chapter provides procedures for troubleshooting the most common problems encountered when operating the NCS 1010 chassis.

### Troubleshooting L Band Failure on a C+L Band Network

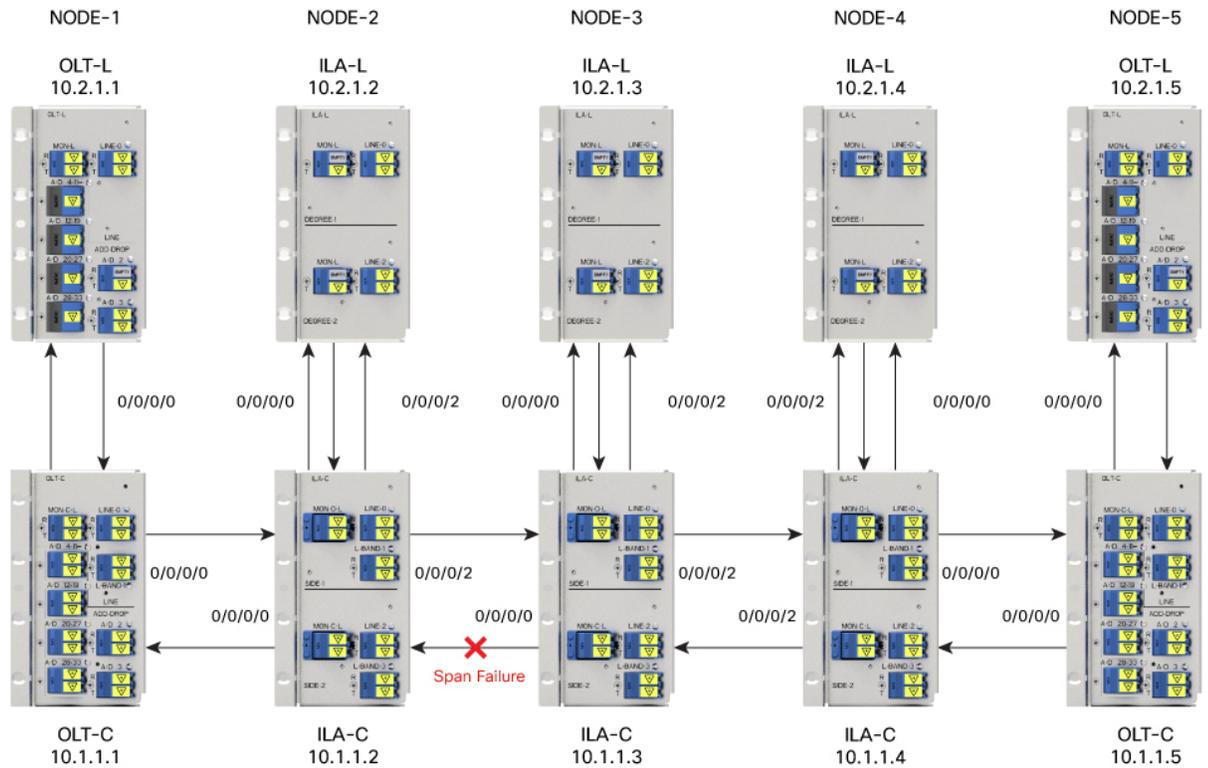
Figure 3: Example of Span Failure

To troubleshoot span failure on a C+L band network, start by running the following commands on the manager nodes in the same order:

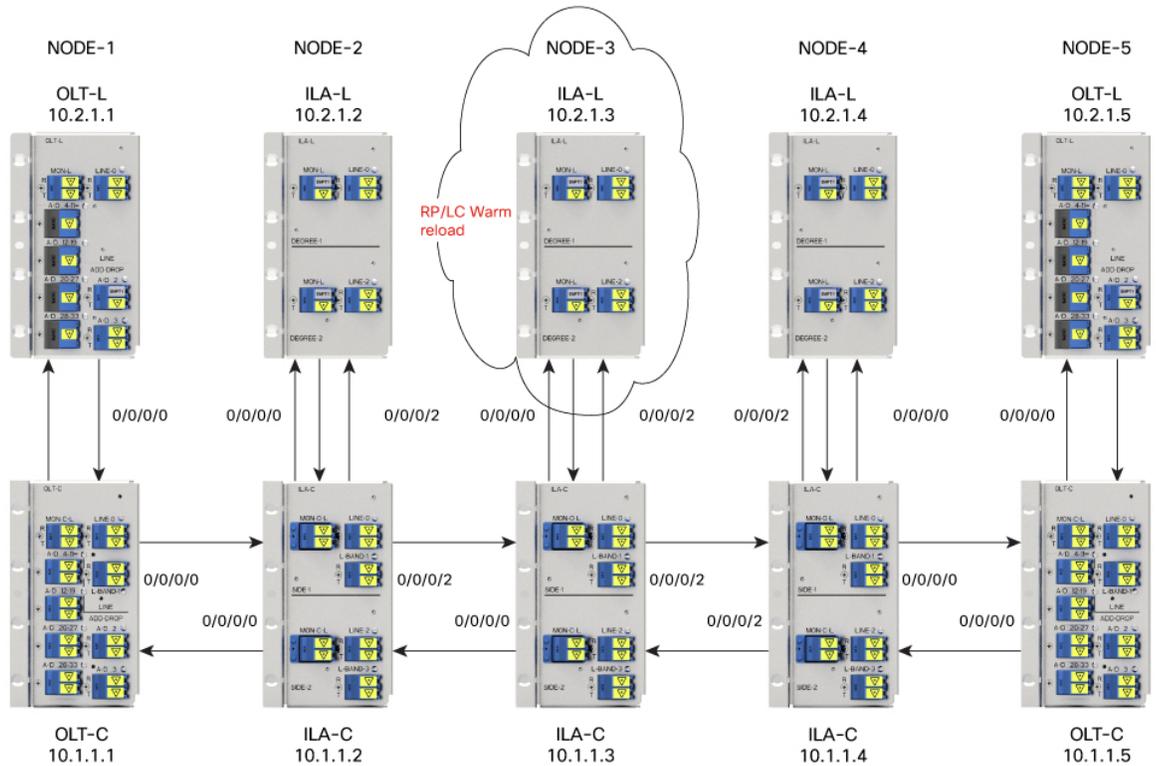
**Figure 4: Example RP or LC Warm Reload Troubleshooting on C+L Band Network**

On a C+L band network, RP or LC warm reload on a C or L band device might affect the partner band connectivity. In this case, traffic is not impacted. To troubleshoot a RP or LC warm reload on a C+L band network, following these steps:

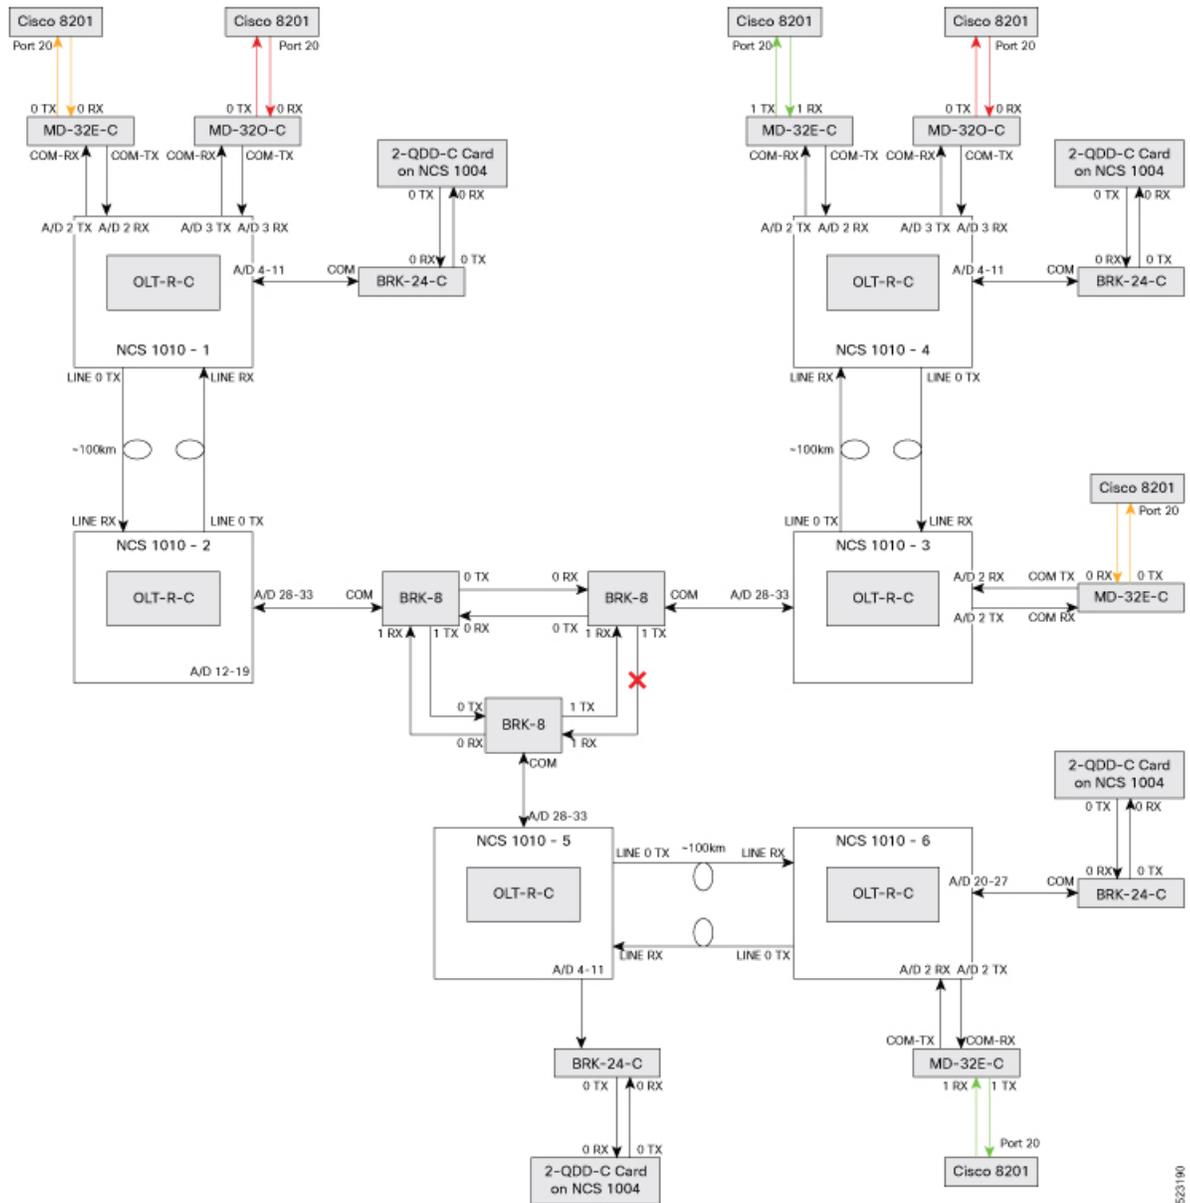
Figure 6: Fiber Cut Between Two Passive Devices

The following figure displays the fiber cut between two passive devices:

The following example shows how to determine the fiber cut between two passive devices:
