## **Troubleshooting Guide for Cisco NCS 1010, IOS XR Release 7.10.x**

**First Published:** 2023-08-18

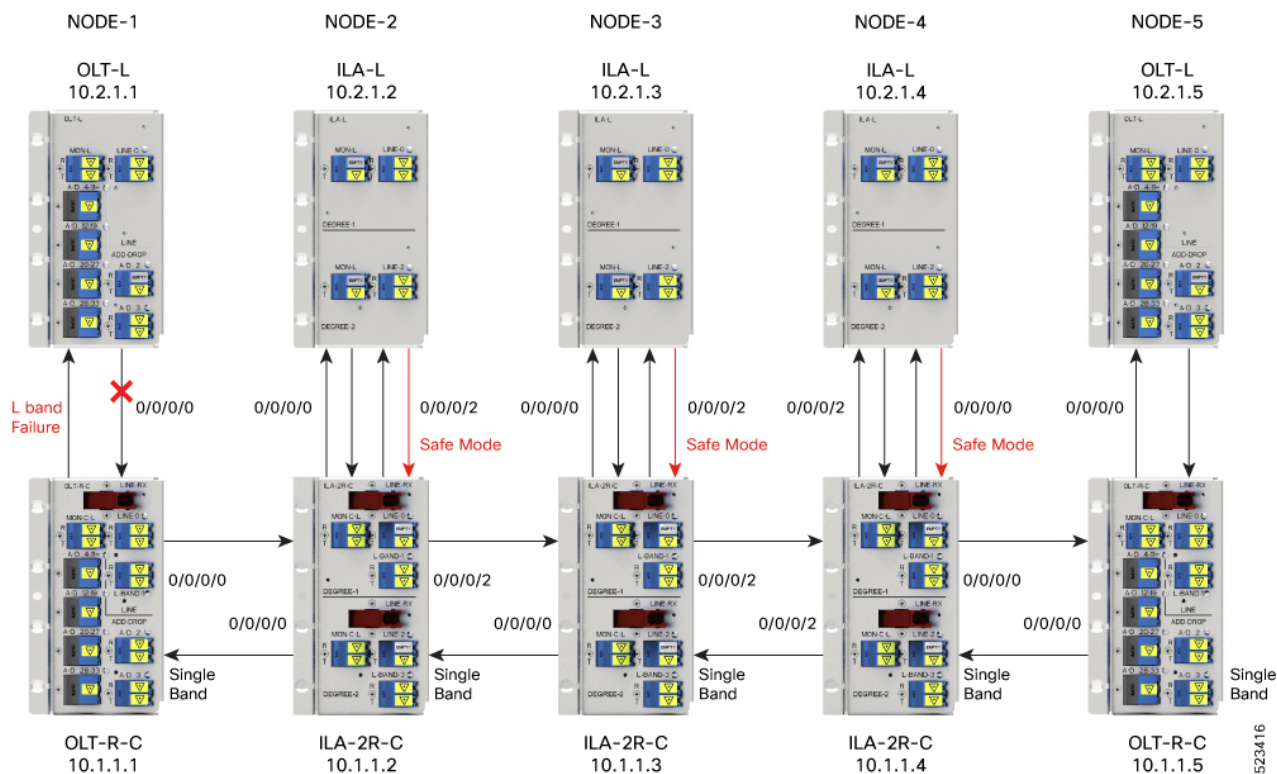
Figure 1: Example of L-band Failure

In this section, we will troubleshoot L band failure due to connectivity failure between OLT-C and OLT-L nodes. To troubleshoot L-band failure on a C+L band network, start by running the following commands on the manager nodes:

**Step 1** Run the `show olc band-status` command on node 10.2.1.1.

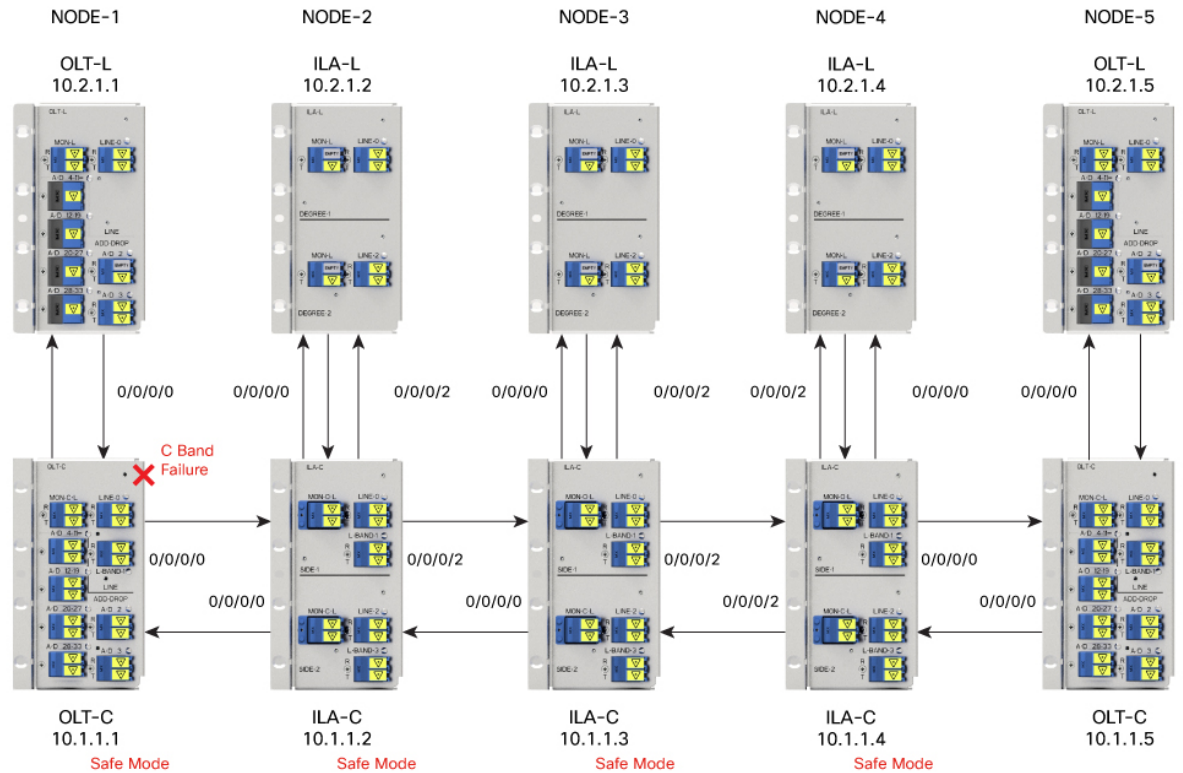
Figure 2: Example of C-band Failure on a C+L Band Network

In this section, we will troubleshoot C band failure due to amplifier shutdown or failure. To troubleshoot C-band failure on a C+L band network, start by running the following commands on the manager nodes in the same order:

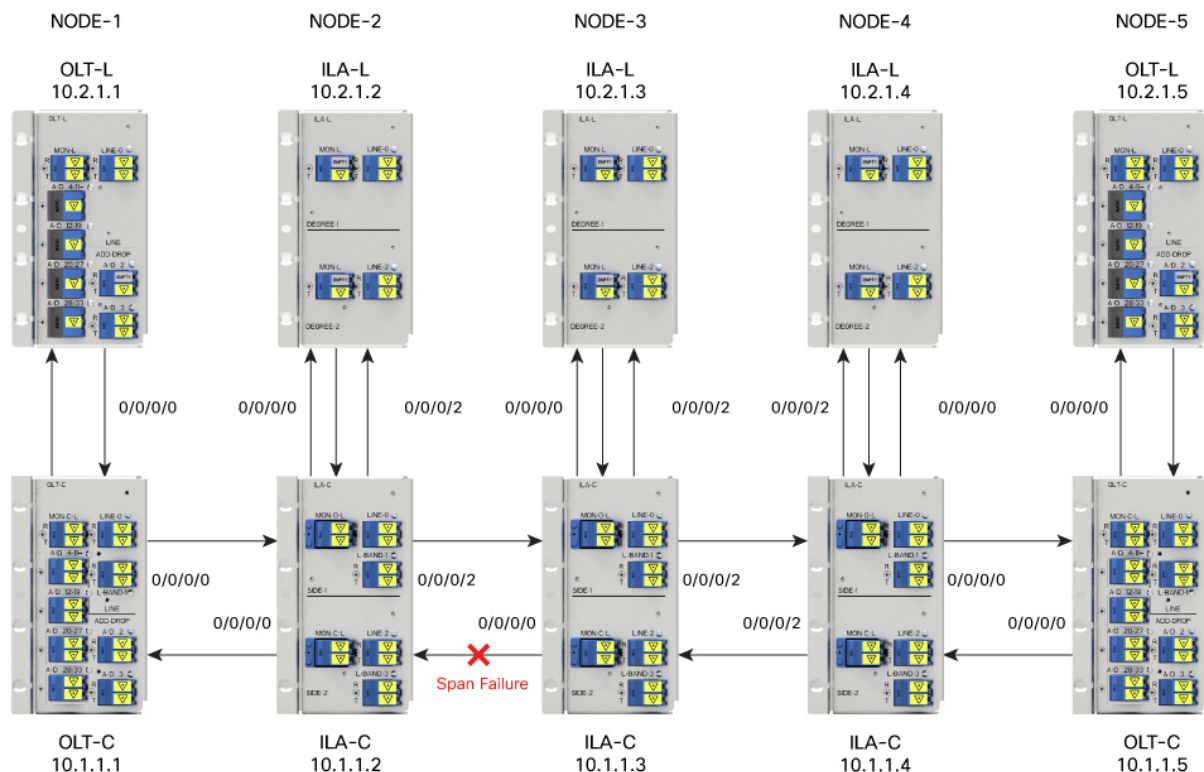
Figure 3: Example of Span Failure

To troubleshoot span failure on a C+L band network, start by running the following commands on the manager nodes in the same order:

**Step 1** Run the **show olc band-status** command on node 10.1.1.1.

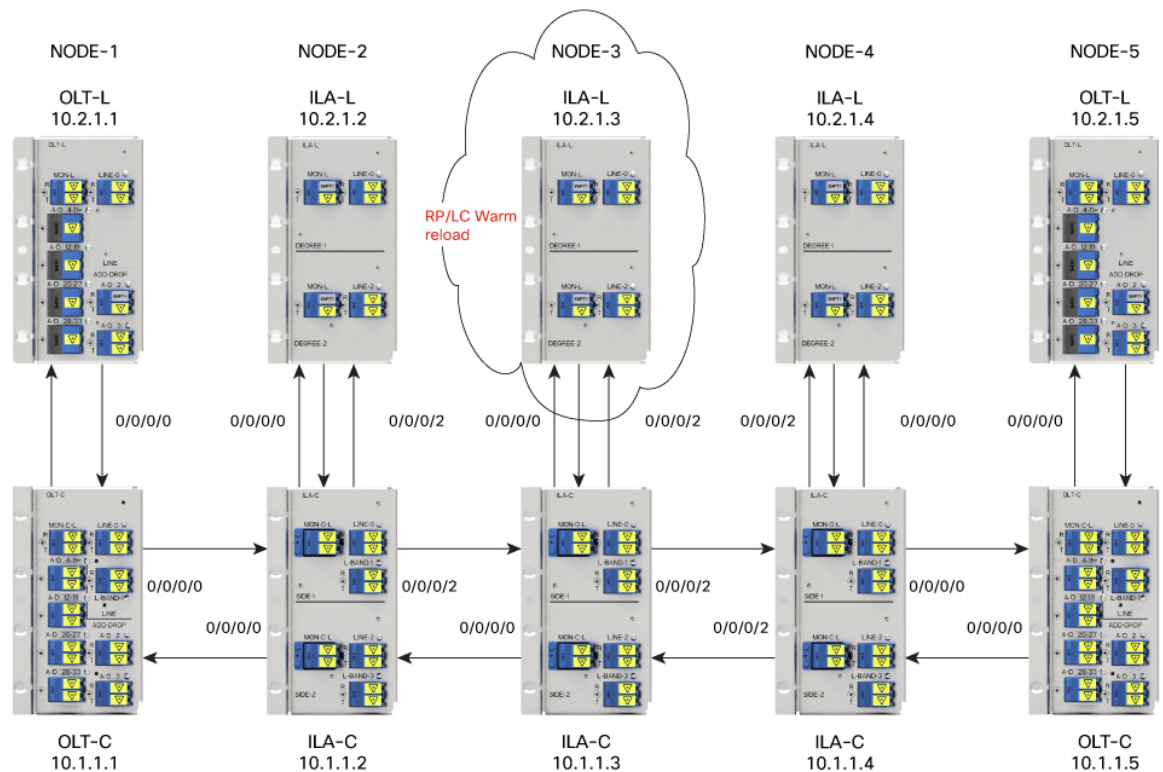
**Figure 4: Example RP or LC Warm Reload Troubleshooting on C+L Band Network**

On a C+L band network, RP or LC warm reload on a C or L band device might affect the partner band connectivity. In this case, traffic is not impacted. To troubleshoot a RP or LC warm reload on a C+L band network, following these steps:

**Step 1** Run the **show olc band-status** command on node 10.1.1.1.

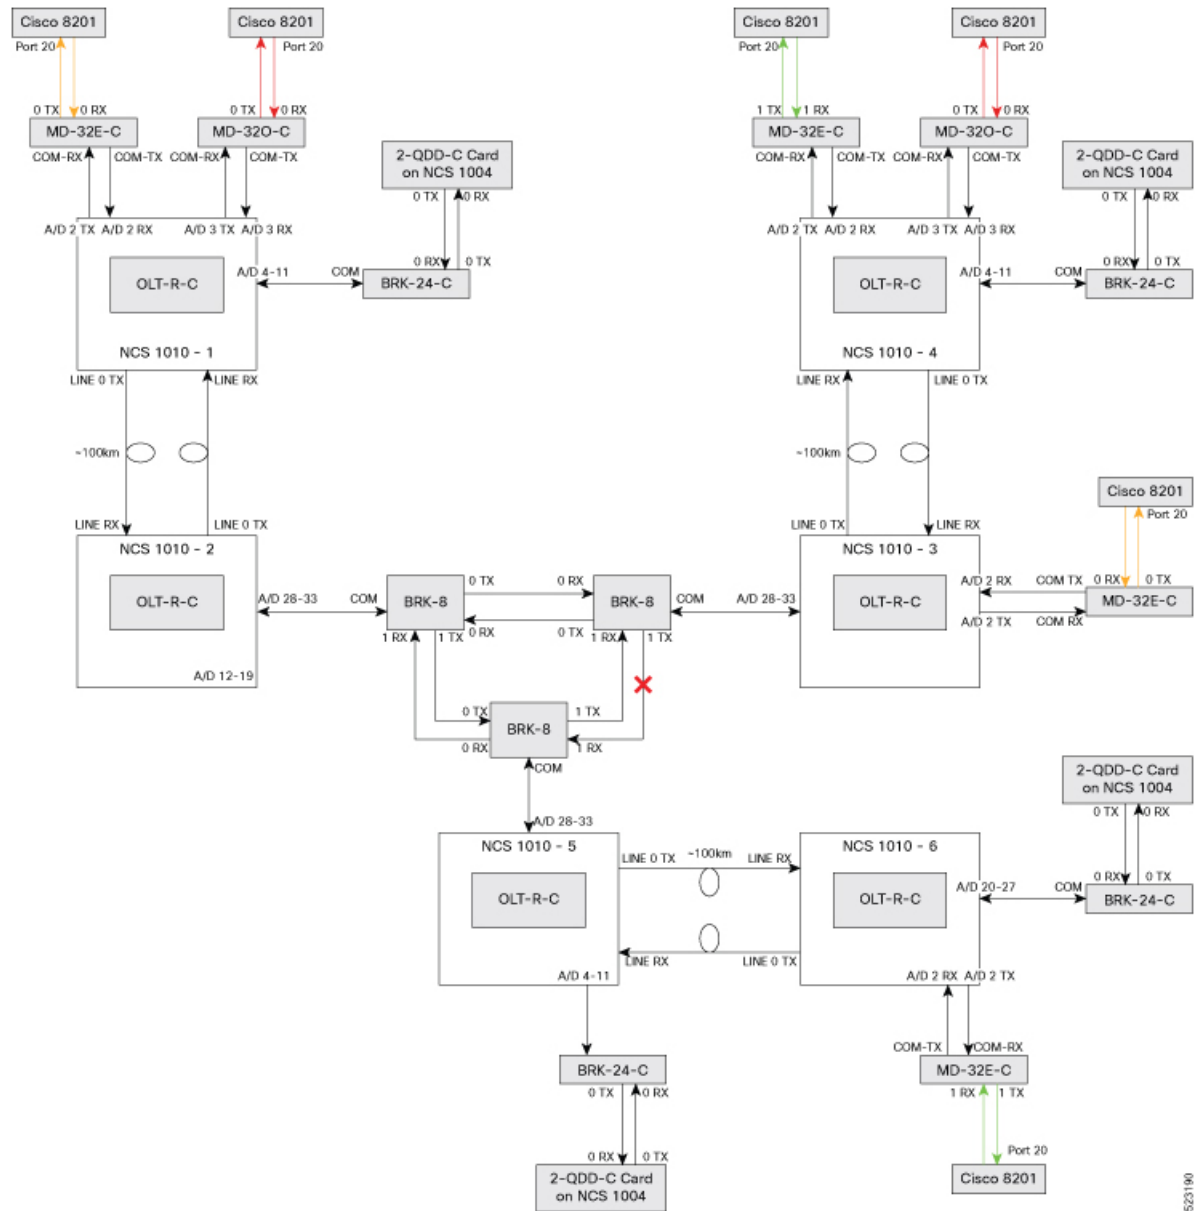
Figure 5: Fiber Cut Between Two Passive Devices

The following figure displays the fiber cut between two passive devices:

The following example shows how to determine the fiber cut between two passive devices:
