Troubleshooting Guide for Cisco NCS 1010, IOS XR Releases 7.9.x

First Published: 2023-02-03

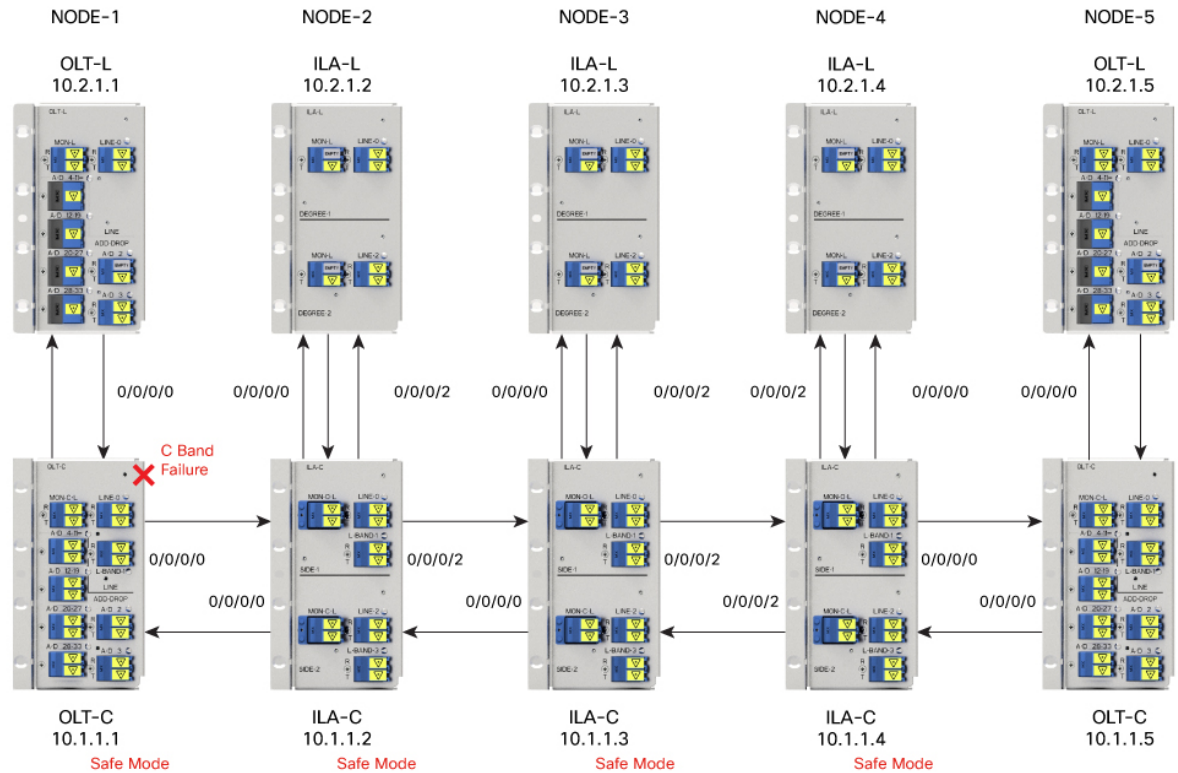
Figure 2: Example of C-band Failure on a C+L Band Network

In this section, we will troubleshoot C band failure due to amplifier shutdown or failure. To troubleshoot C-band failure on a C+L band network, start by running the following commands on the manager nodes in the same order:

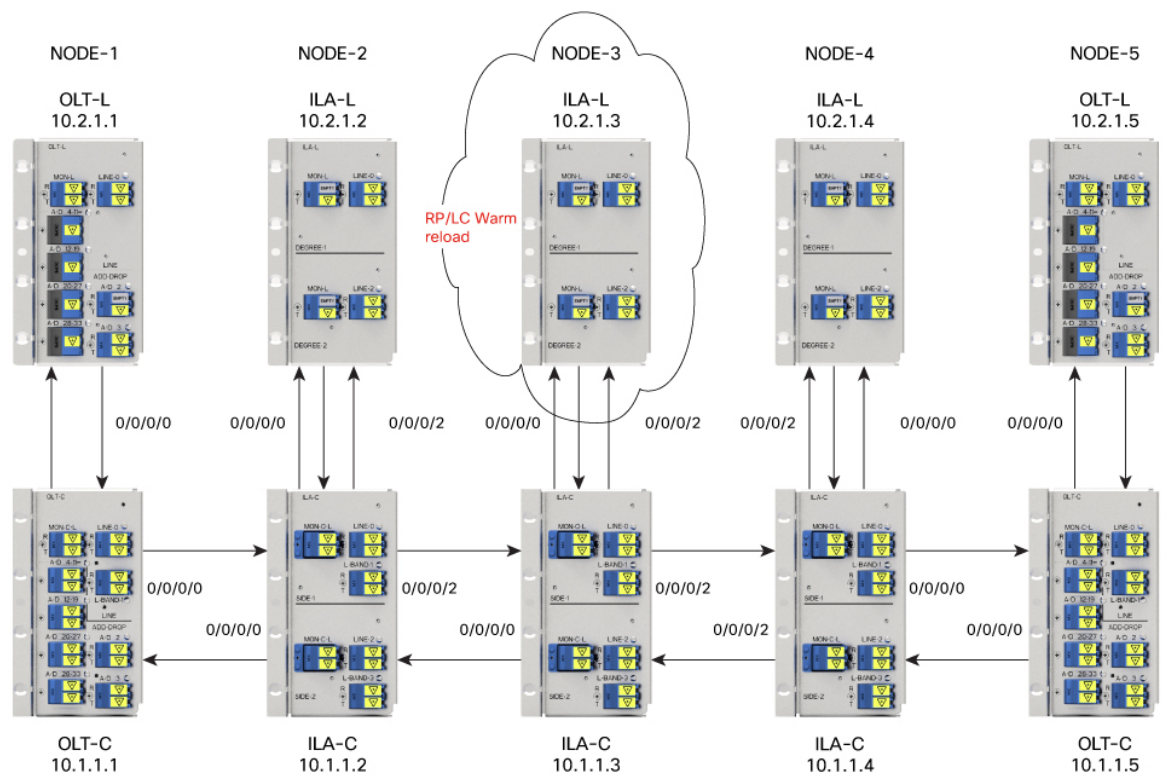
Figure 4: Example RP or LC Warm Reload Troubleshooting on C+L Band Network

On a C+L band network, RP or LC warm reload on a C or L band device might affect the partner band connectivity. In this case, traffic is not impacted. To troubleshoot a RP or LC warm reload on a C+L band network, following these steps:
