## **Troubleshooting Guide for Cisco NCS 1014, IOS XR Release 26.x.x**

## Alarm Troubleshooting

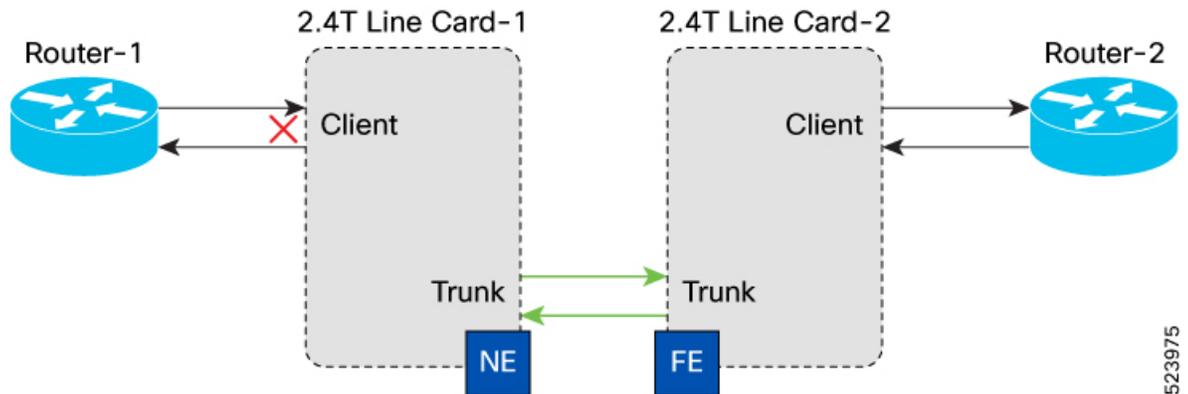
Figure 1: Client Unidirectional Receiver Fiber Cut

This figure displays a client unidirectional receiver fiber cut.

These tables list the alarms raised at the respective ports of each node.

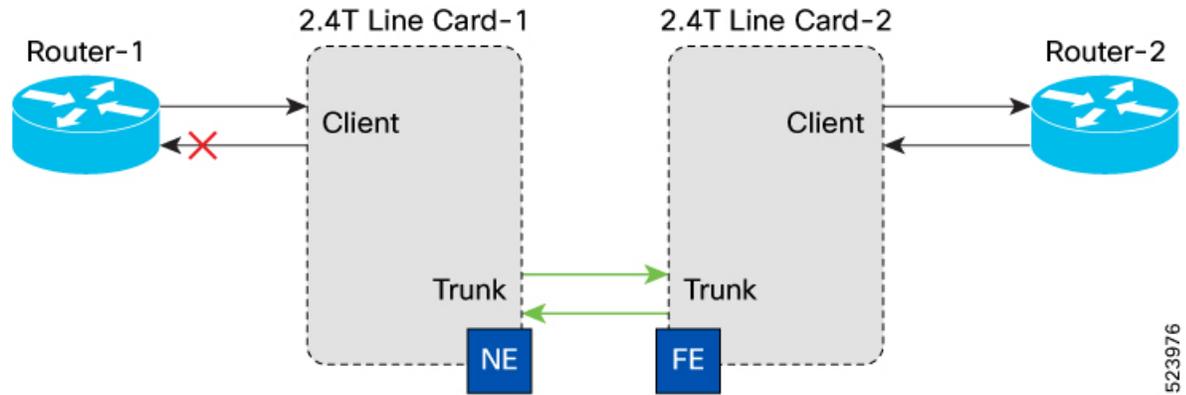
Figure 2: Client Unidirectional Transmitter Fiber Cut

This figure displays the client unidirectional transmitter fiber cut.

The following tables list the alarms that are raised at the respective ports of each node.

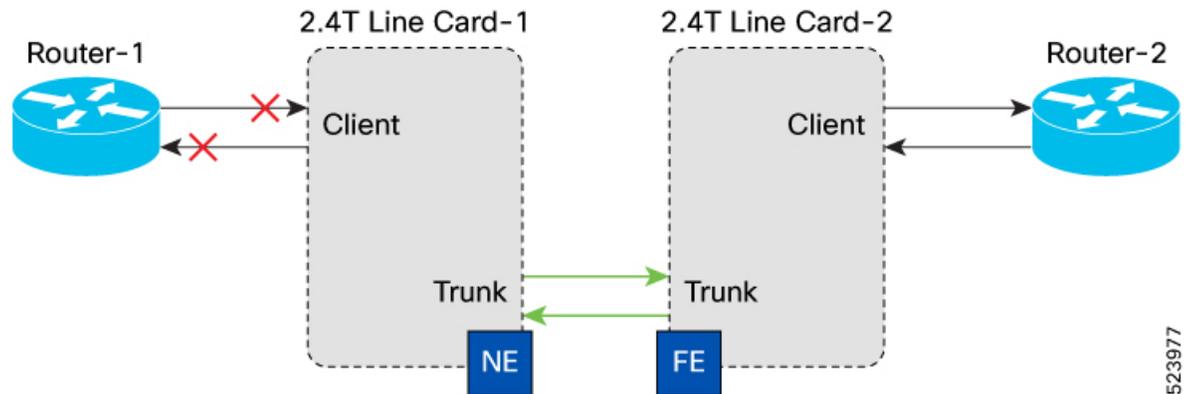
Figure 3: Client Bi-directional Fiber Cut

This figure displays a client bi-directional receiver fiber cut.

These tables list the alarms that are raised at the respective ports of each node.

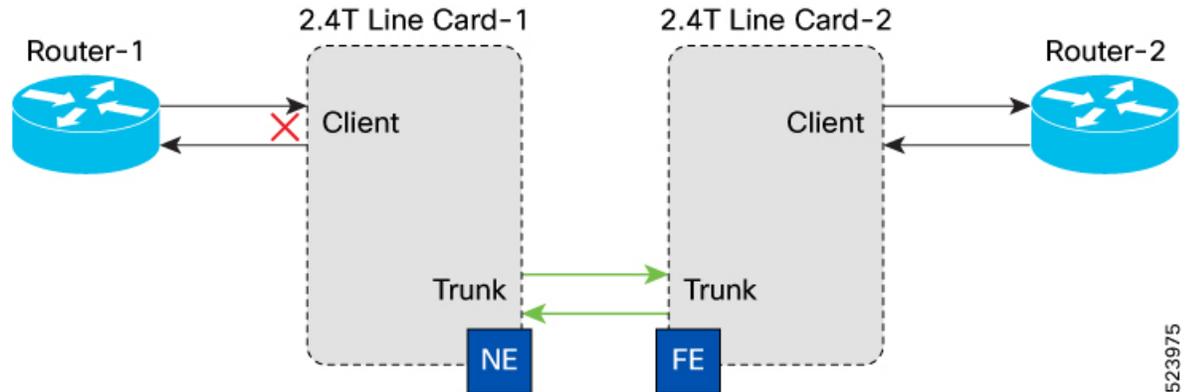
Figure 4: Client Unidirectional SYNCLOSS

This figure displays the unidirectional SYNCLOSS.

These tables list the alarms that are raised and suppressed at the respective ports of each node.

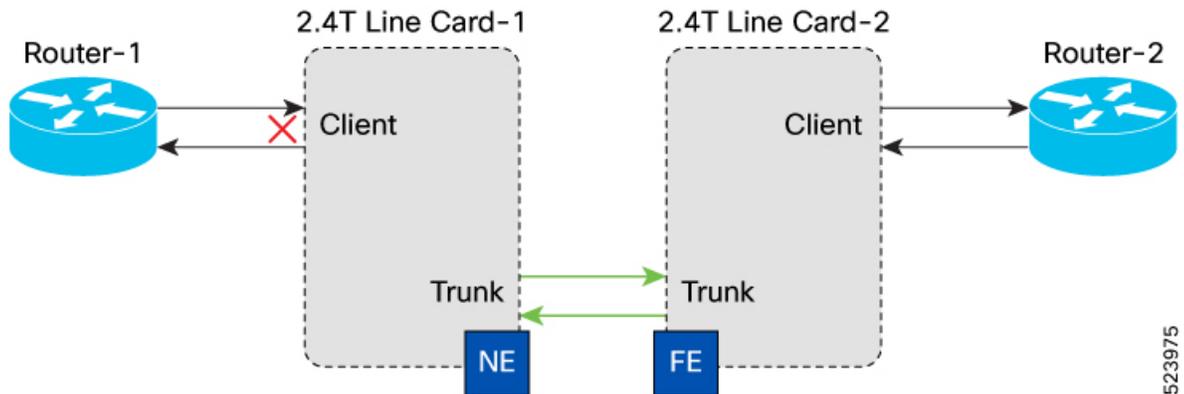
Figure 5: Client Unidirectional LF

This figure displays unidirectional LF.

These tables list the alarms that are raised and suppressed at the respective ports of each node.

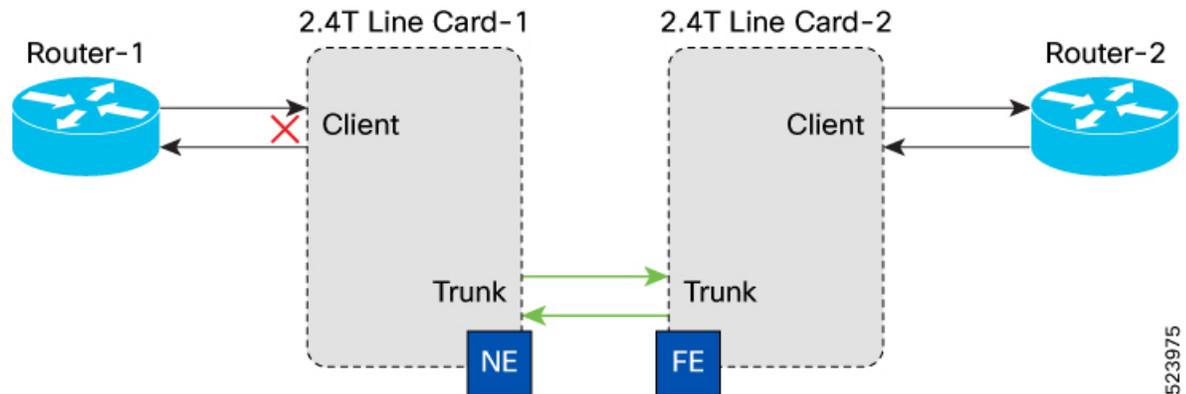
Figure 6: Client Unidirectional RF

This figure displays unidirectional RF.

These tables list the alarms that are raised and suppressed at the respective ports of each node:

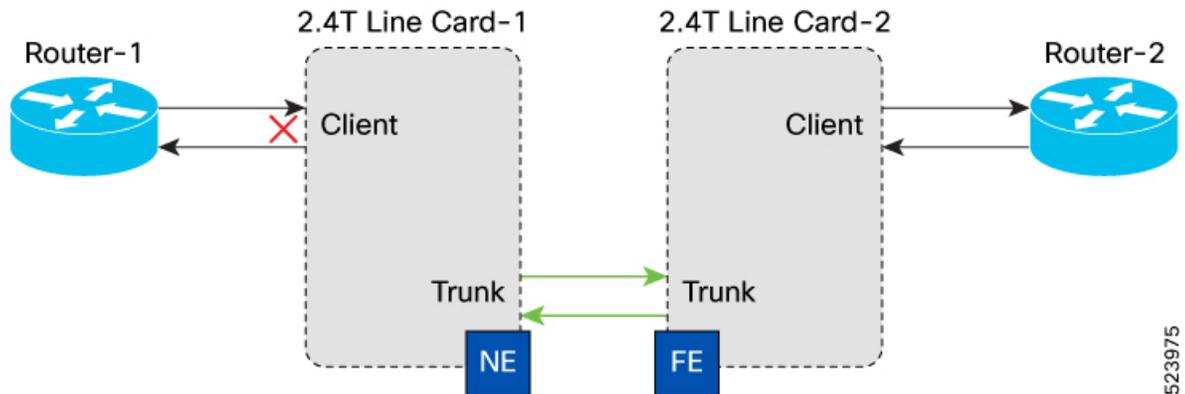
Figure 7: Client Unidirectional HI-SER

This figure displays client unidirectional Hi-SER fault.

These tables list the alarms that are raised at the respective ports of each node:

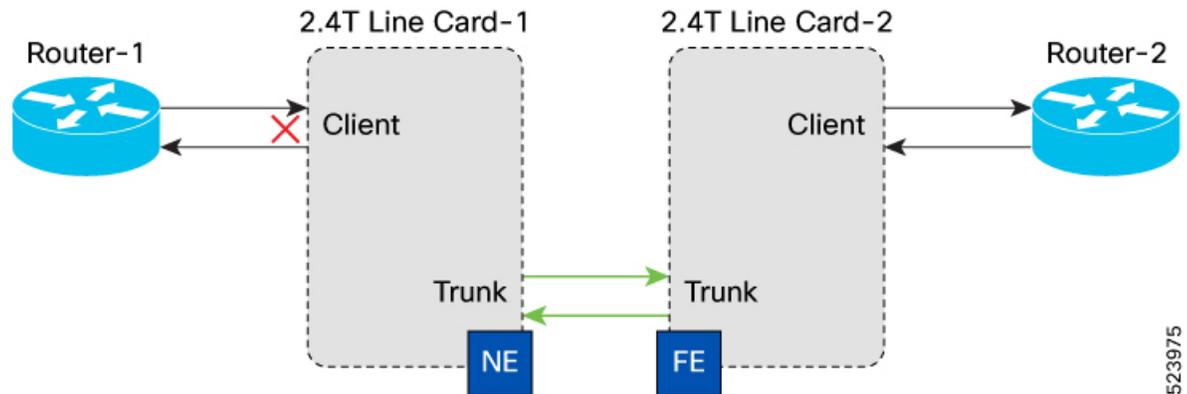
Figure 9: Client Unidirectional LD

This figure displays client unidirectional LD.

These tables list the alarms that are raised at the respective ports of each node.

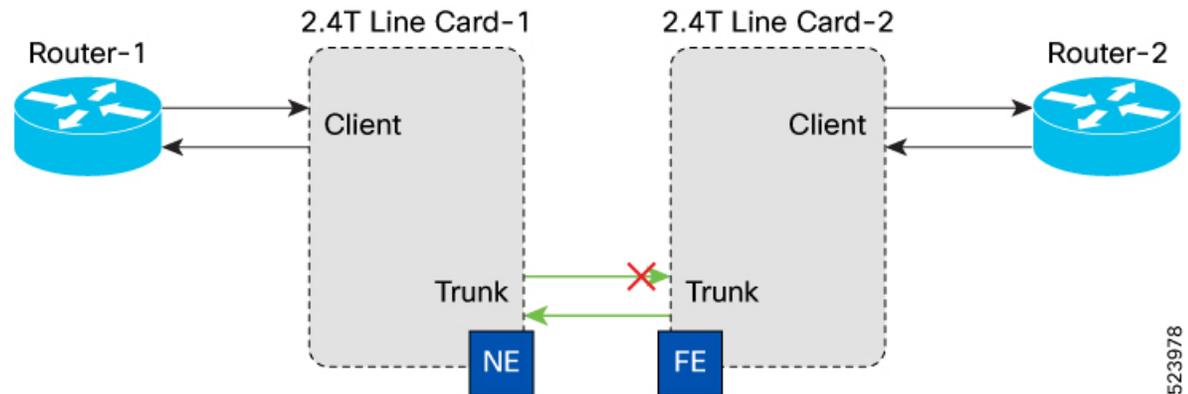
Figure 12: Trunk Unidirectional Fiber Cut

This figure displays trunk unidirectional fiber cut.

These tables list the alarms that are raised at the respective ports of each node.

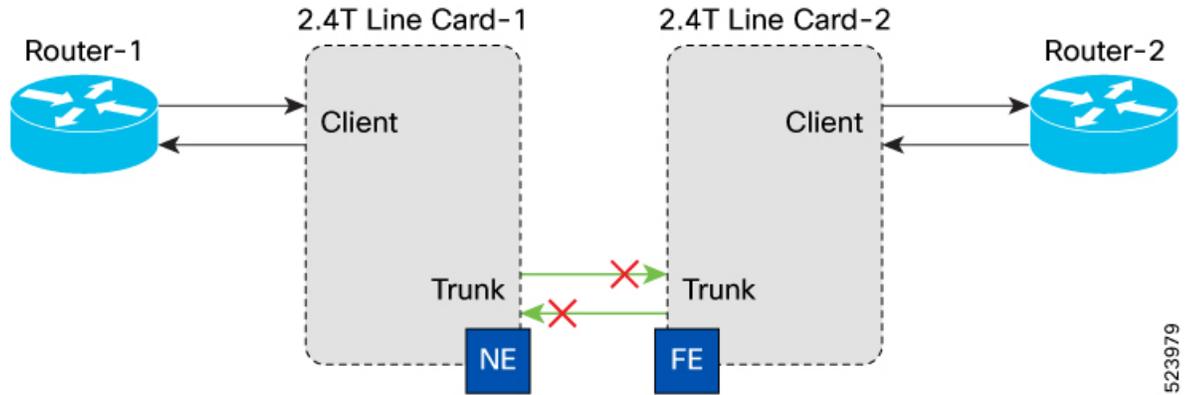
Figure 13: Trunk Bi-directional Fiber Cut

This figure displays trunk bidirectional fiber cut.

These tables list the alarms that are raised at the respective ports of each node.

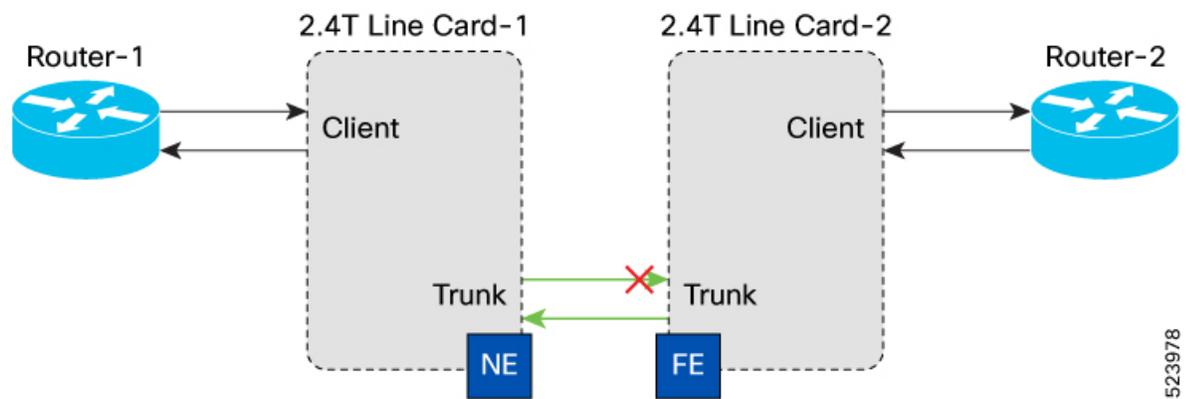
Figure 16: Trunk Unidirectional LOF

This figure displays trunk LOF.

These tables list the alarms that are raised at the respective ports of each node.

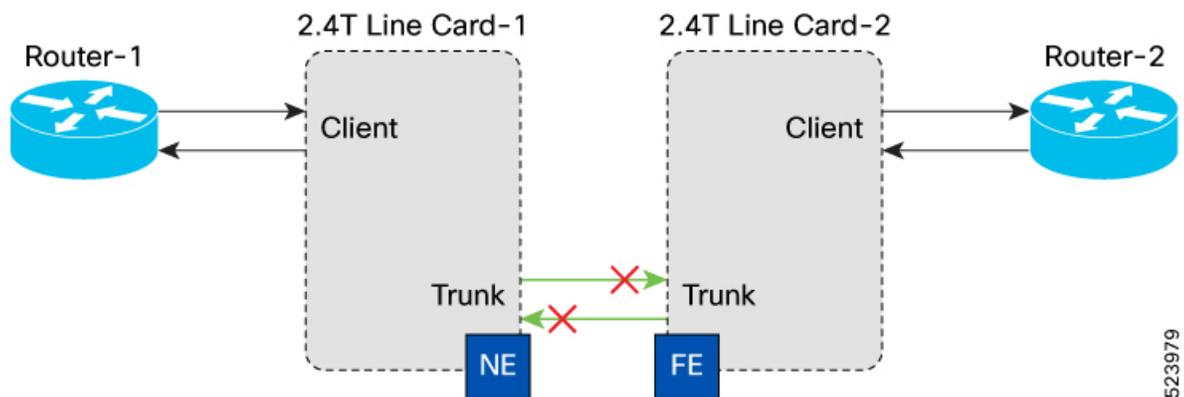
**Figure 17: Trunk GIDM**

The following figure displays trunk GIDM:

The following tables list the alarms that are raised at the respective ports of each node:

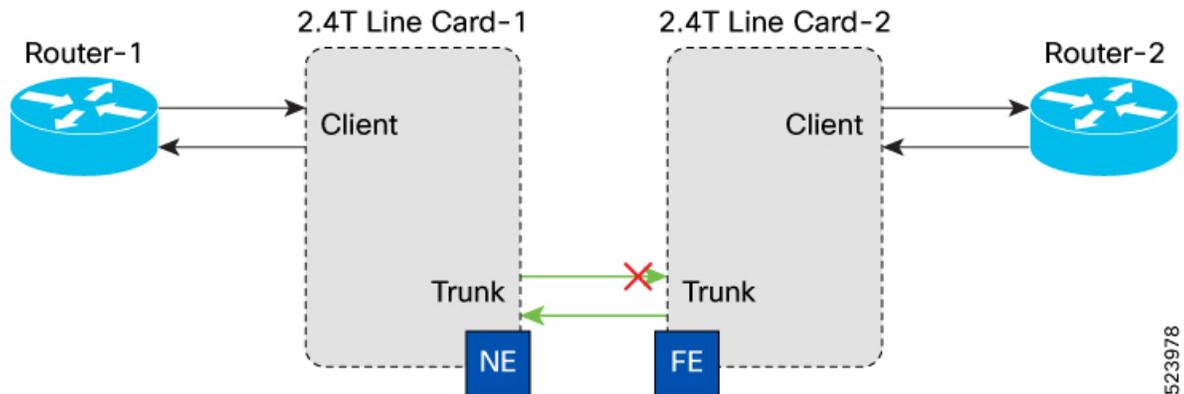
Figure 18: Trunk Unidirectional OTUK-TIM

This figure displays trunk unidirectional OTUK-TIM.

These tables list the alarms that are raised at the respective ports of each node.

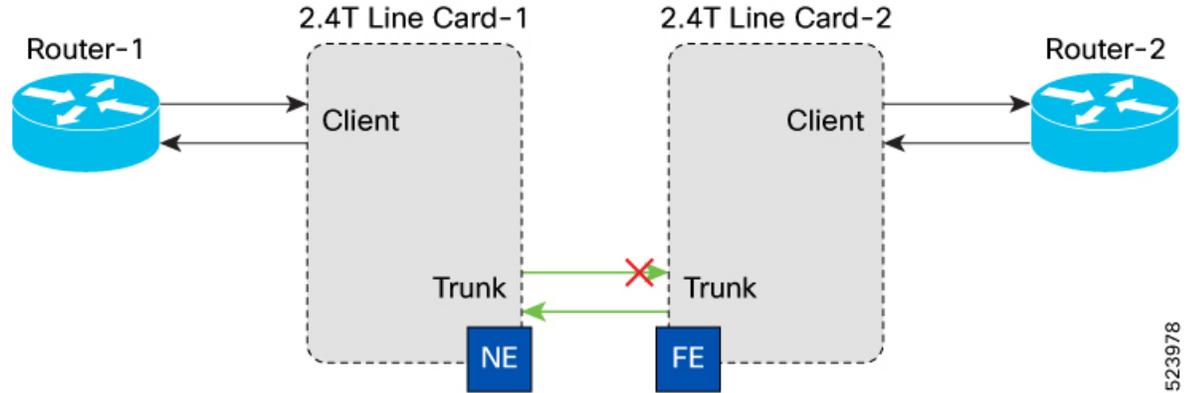
Figure 19: Trunk Unidirectional IMPROPRMVL

This figure displays trunk optics IMPROPRMVL.

These tables list the alarms that are raised at the respective ports of each node.
