Troubleshooting Guide for Cisco NCS 1020, IOS XR Release 24.3.x

First Published: 2024-09-04

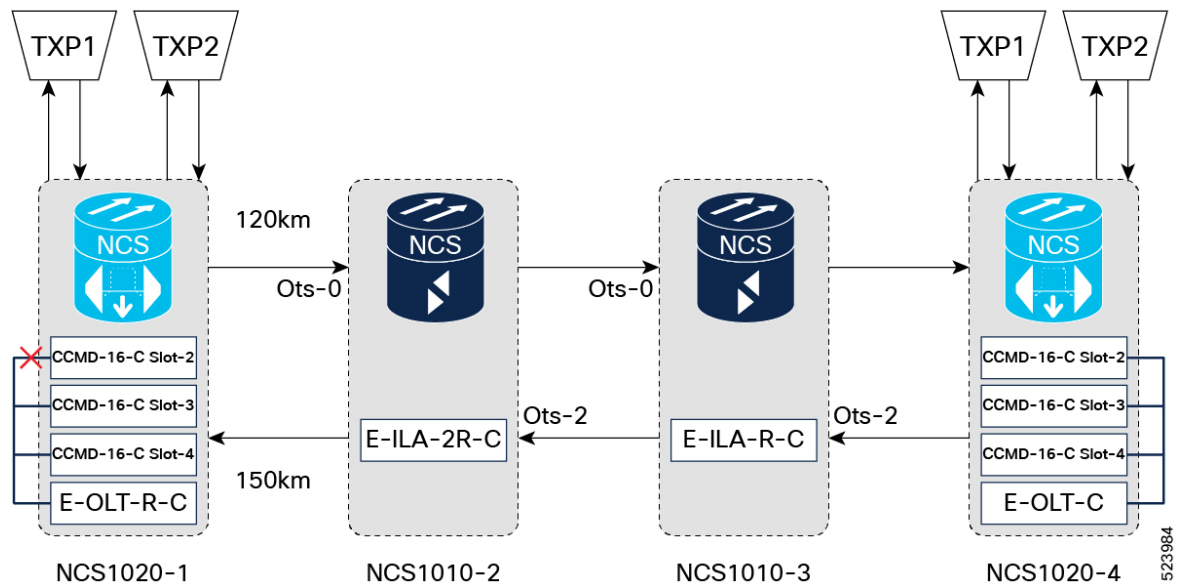
Figure 1: Fiber Cut on Line

The following figure displays client-side failure due to fiber cut:

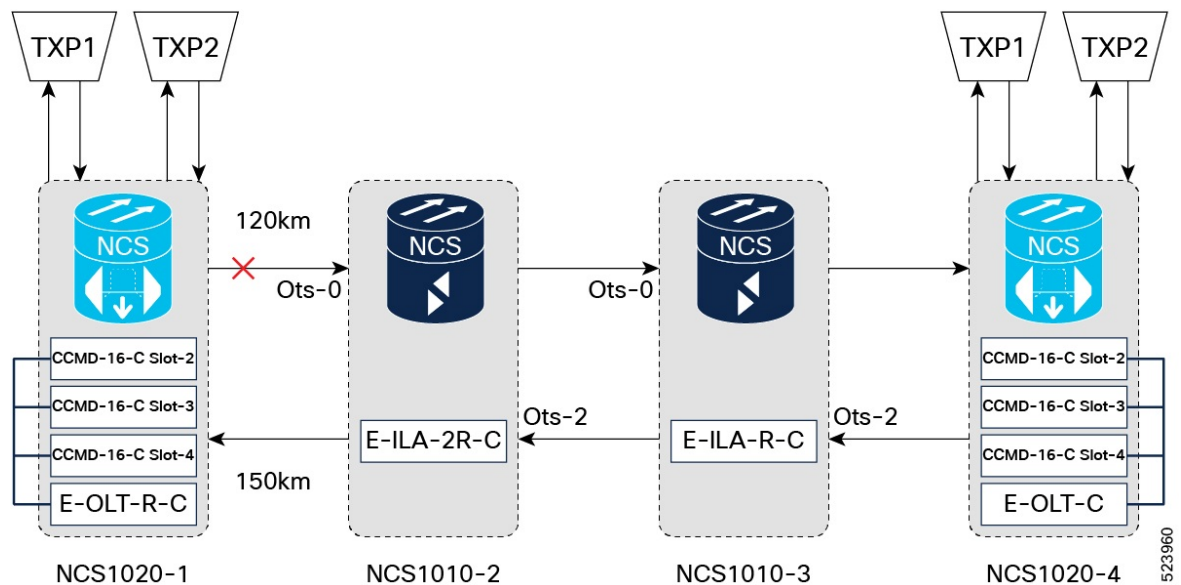
Figure 2: Fiber Cut at the Line OTS Controller

The following figure shows loss of fiber connection continuity at the Line port:

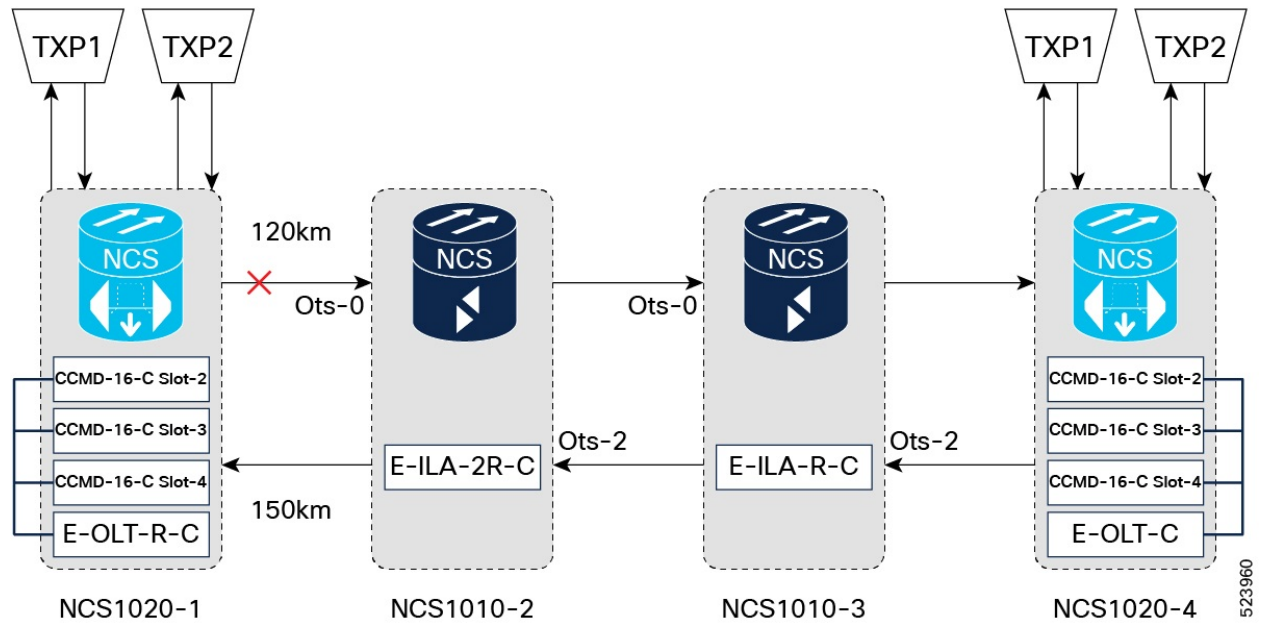
Figure 3: Unidirectional Fiber Cut on Line

The following figure displays line unidirectional fiber cut on a NCS 1020:

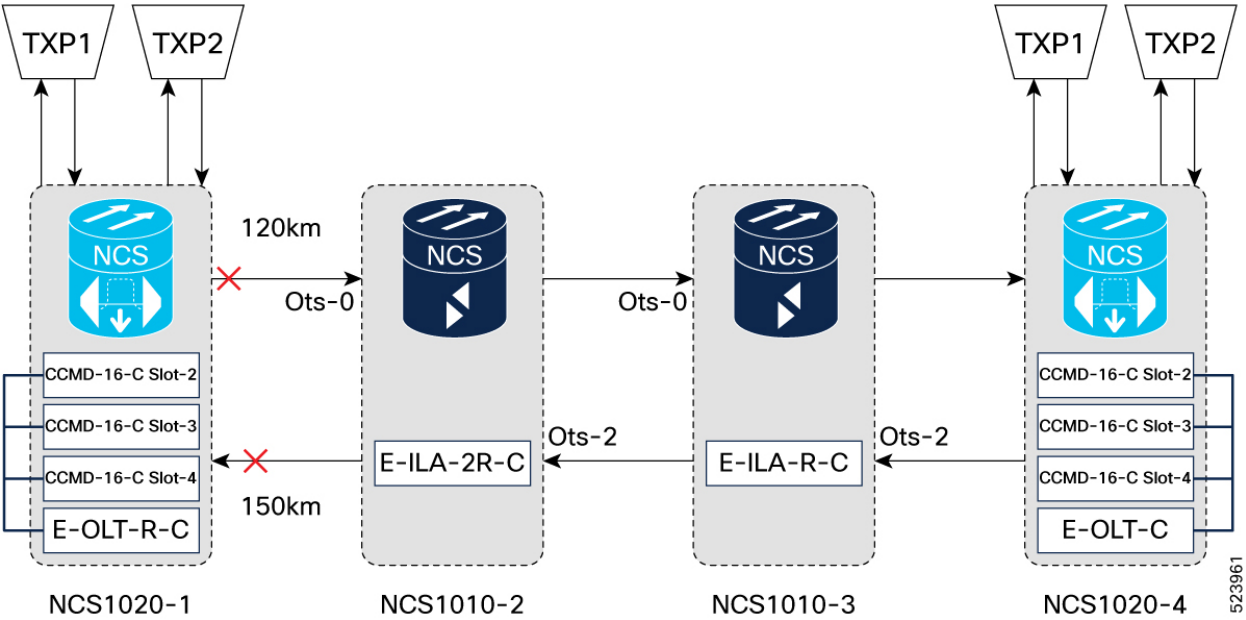
Figure 4: Bidirectional Fiber Cut on Line

The following figure displays line bidirectional fiber cut on a NCS 1020 network:

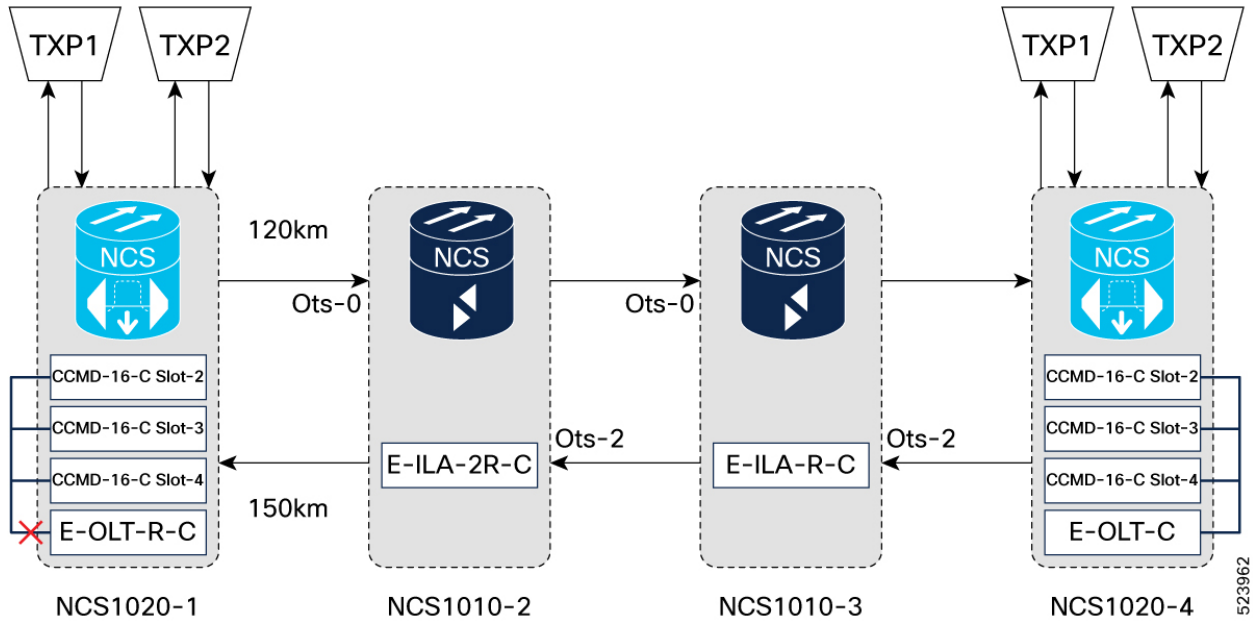
Figure 5: Fiber Cut Between CCMD and OLT

The following figure displays fiber cut between CCMD and OLT:

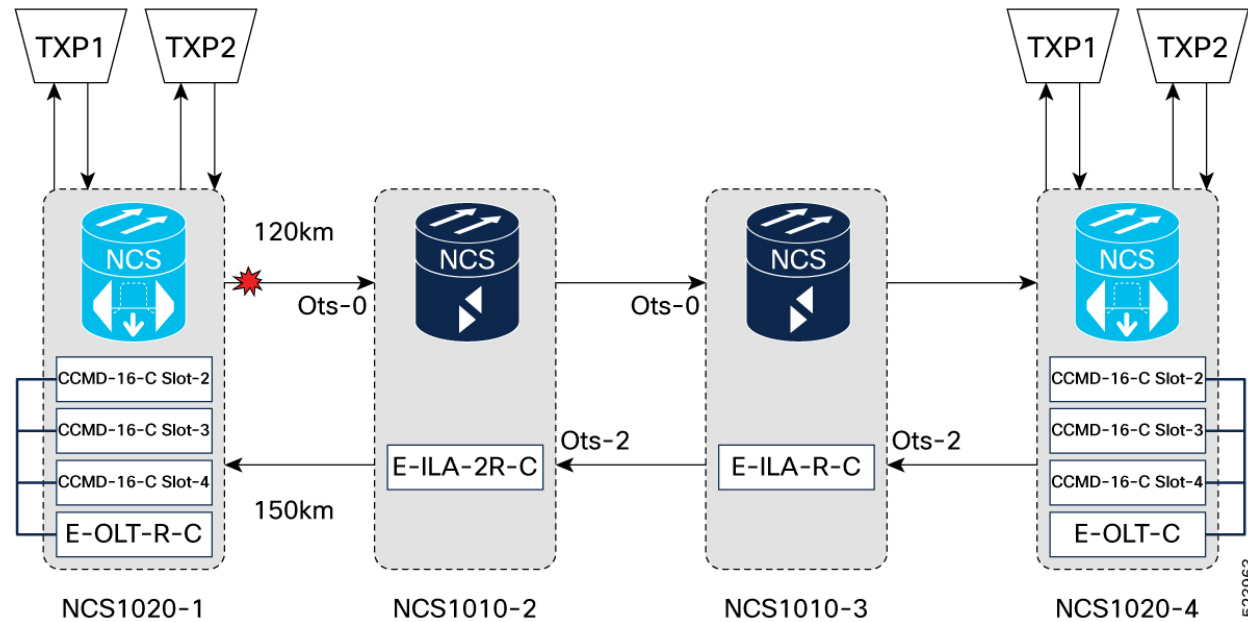
Figure 6: High Back Reflection Condition on the Line Tx port

The following figure displays high back reflection condition on the line Tx port:

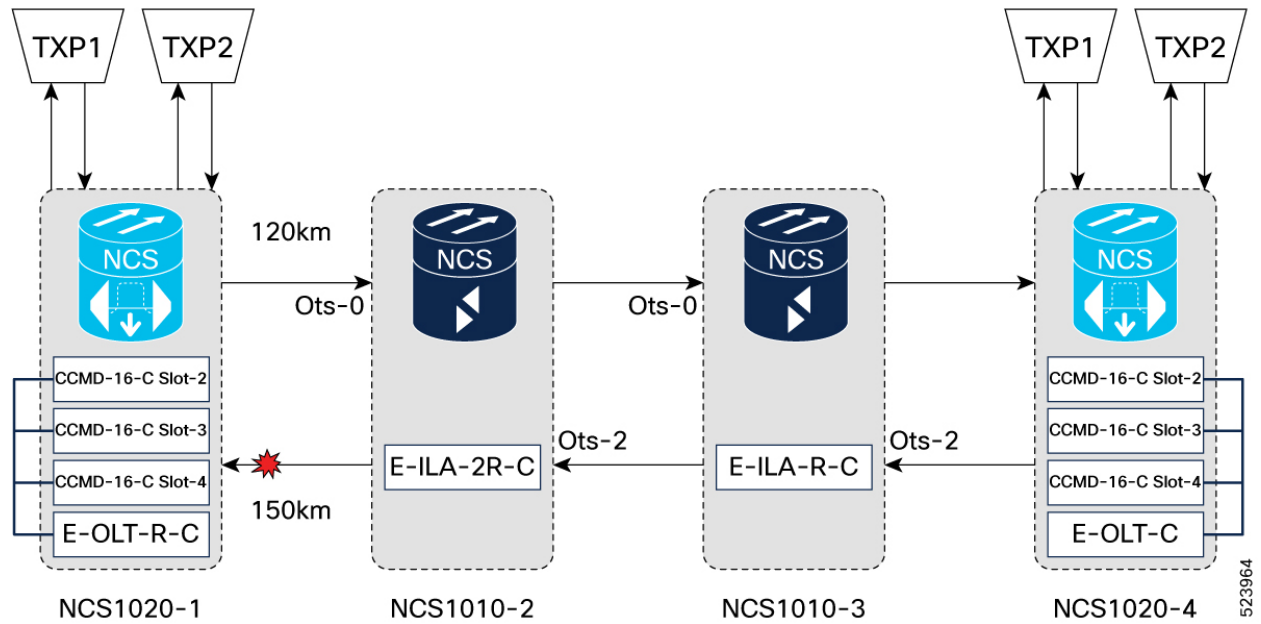
Figure 7: High Back Reflection Condition on the Line Rx RAMAN Port

The following figure displays high back reflection condition on the line Rx RAMAN port:

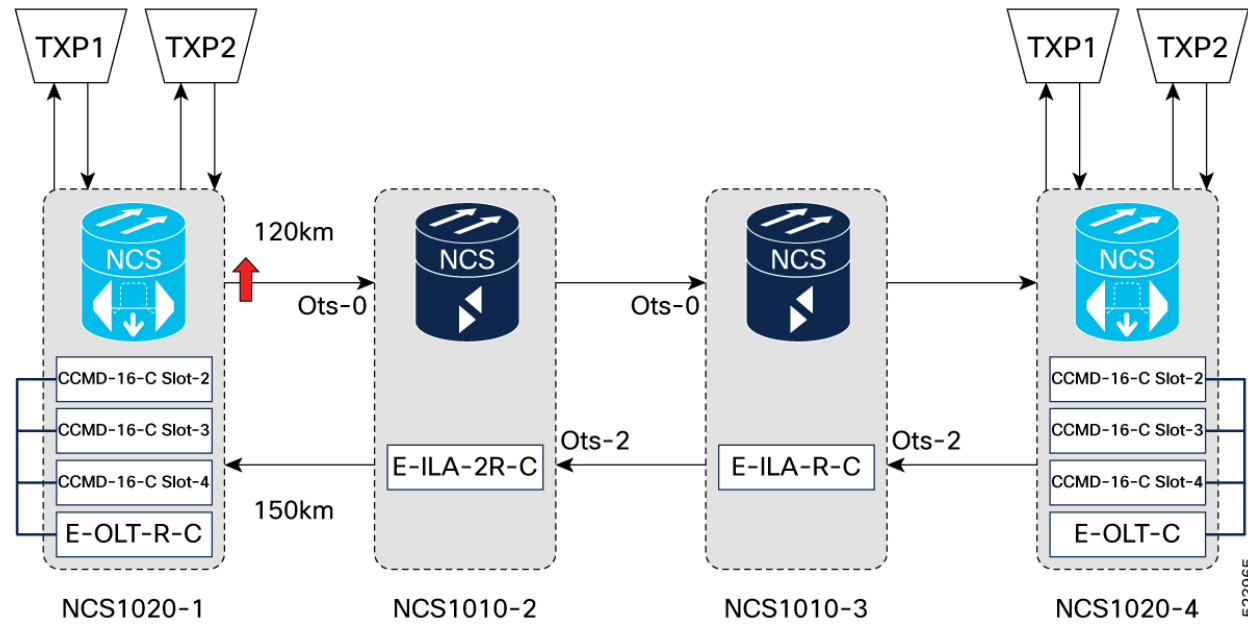
Figure 8: High span loss on Line Tx Port

The following figure displays high span loss on line Tx port:

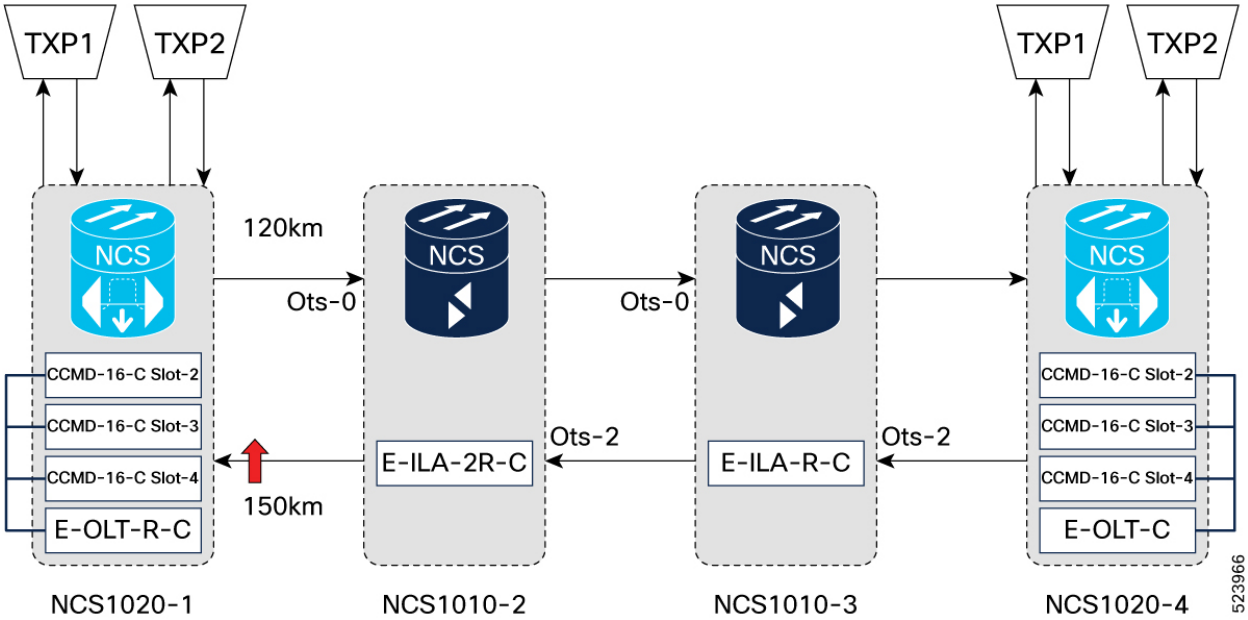
Figure 9: High span loss on Line Rx port

The following figure displays high span loss on the line Rx port:

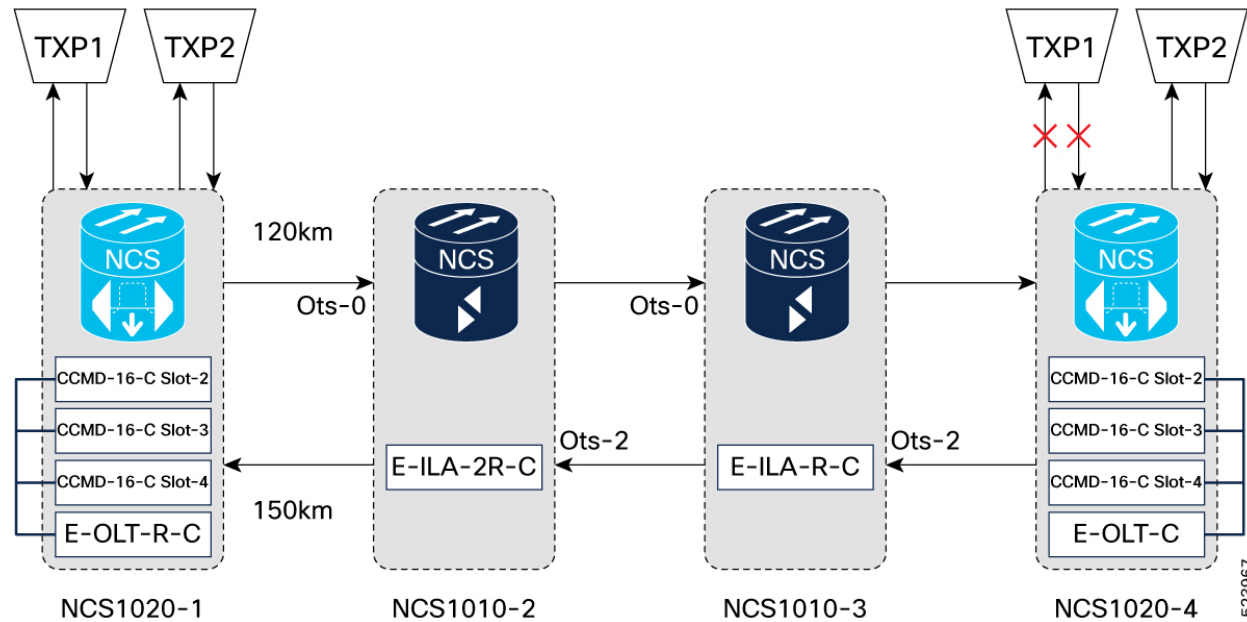
Figure 10: Single Channel Failure due to Bidirectional Fiber Cut on Line

The following figure displays single channel failure due to bidirectional fiber cut on line:

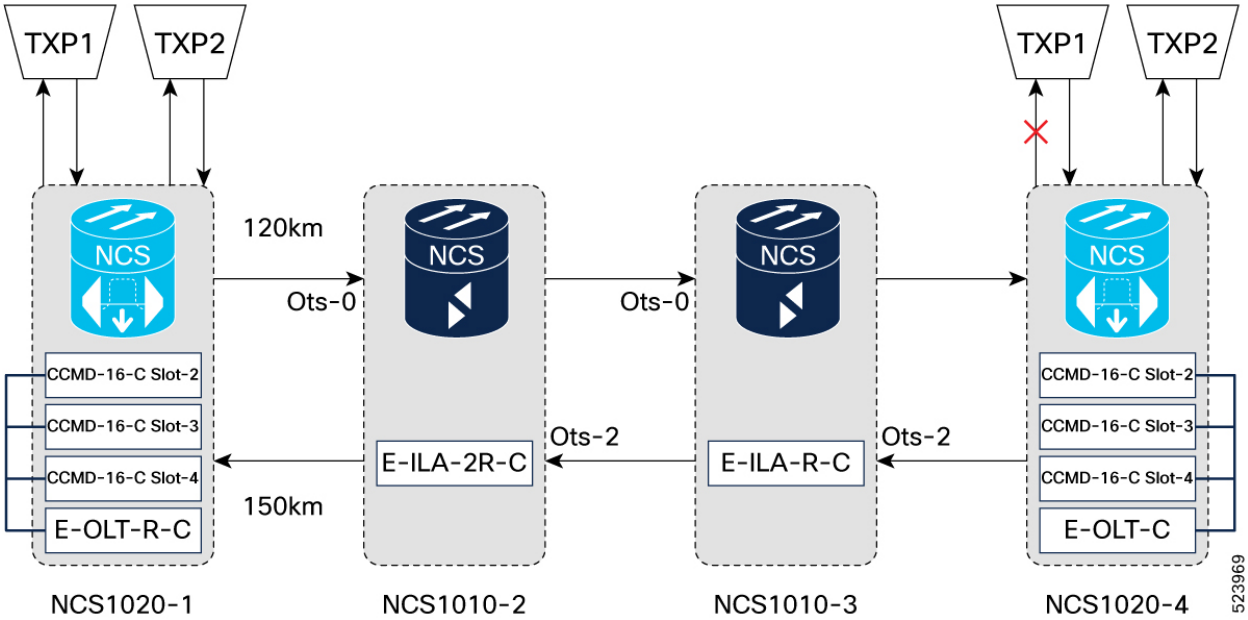
Figure 11: Single Channel Failure due to Unidirectional Fiber Cut at TXP-Tx

The following figure displays single channel failure due to unidirectional fiber cut at TXP-Tx:
