Troubleshooting Guide for Cisco NCS 1020, IOS XR Release 26.x.x

Troubleshooting of Infrastructure Alarms

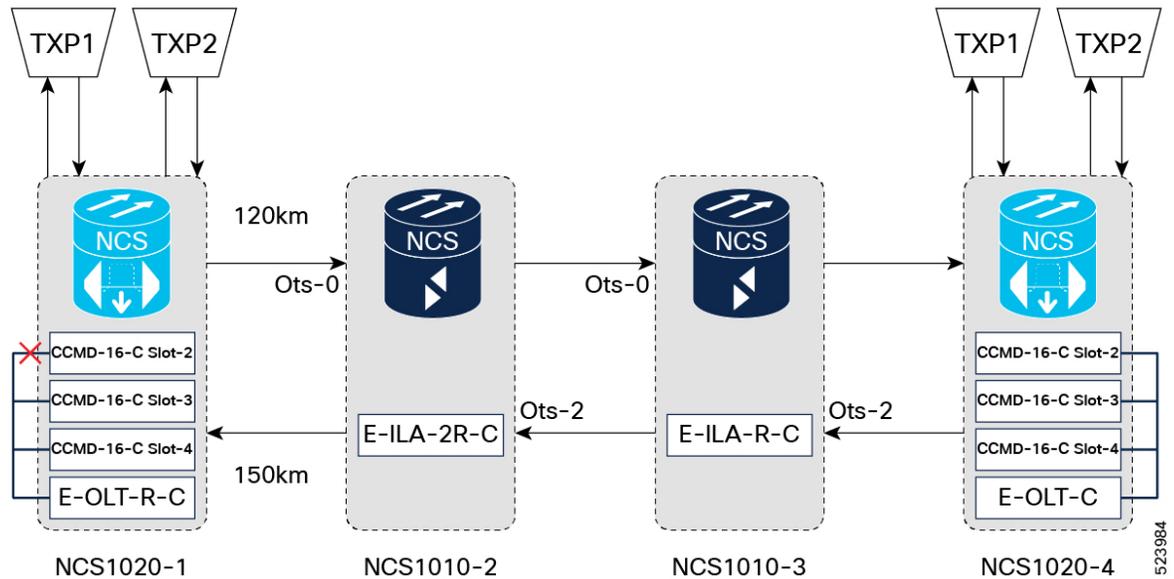
Figure 1: Fiber Cut on Line

The following figure displays client-side failure due to fiber cut:

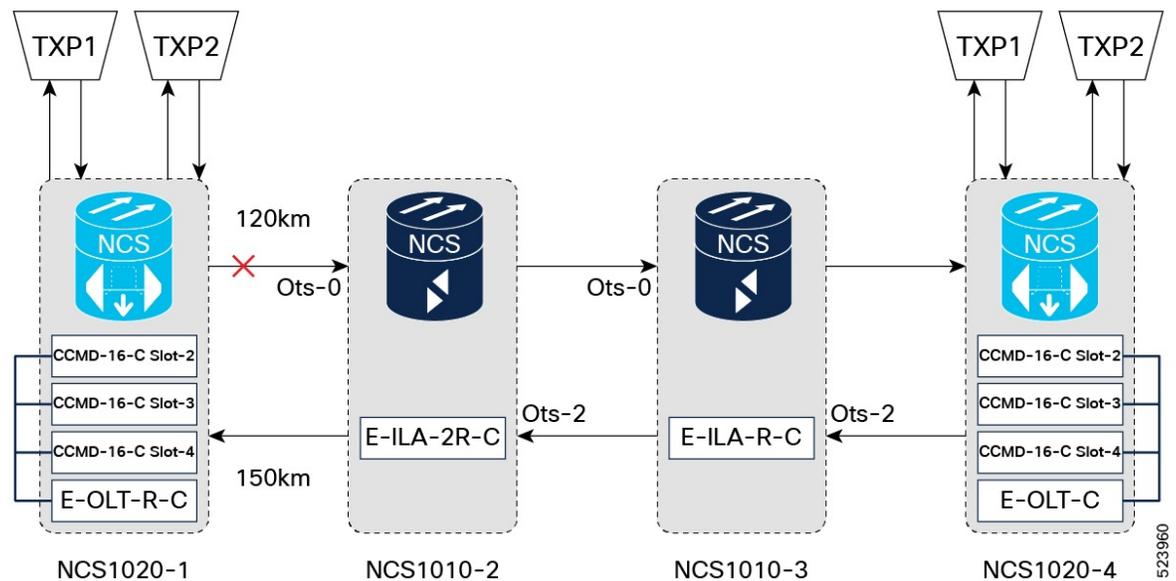
Figure 2: Fiber Cut at the Line OTS Controller

The following figure shows loss of fiber connection continuity at the Line port:

In this scenario, the following alarms are raised on the OLT (node 1):

- RX-LOS-P
- EGRESS-AUTO-LASER-SHUT
- INGRESS-AMPLI-LASER-OFF
- FEFI

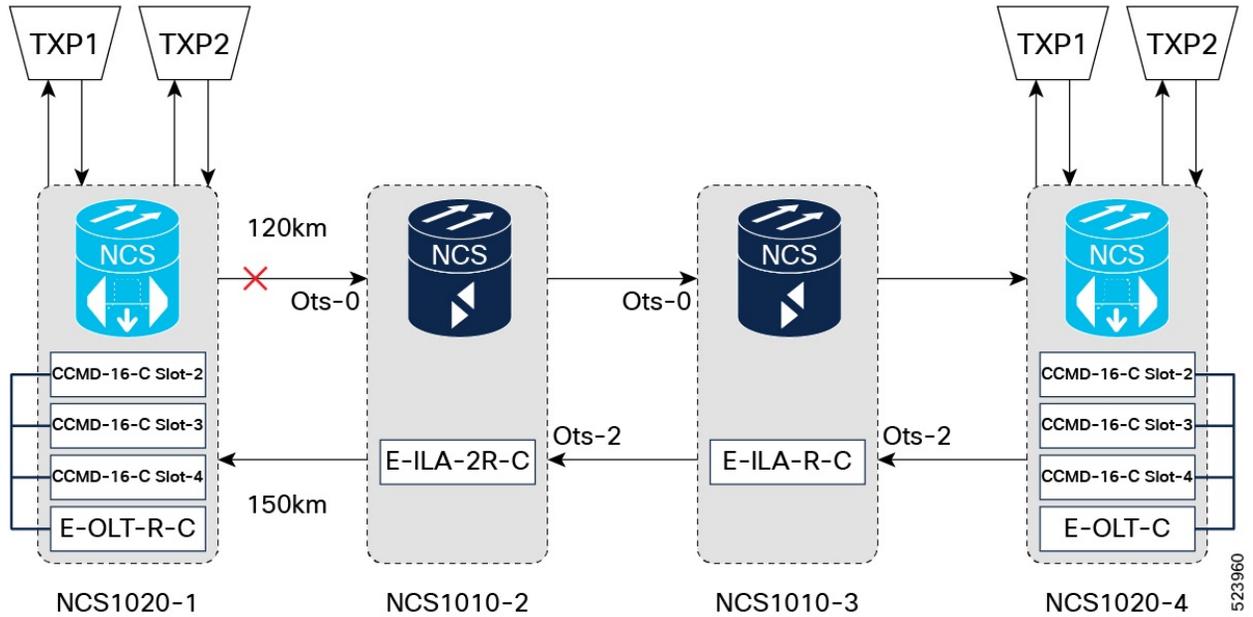
Figure 3: Unidirectional Fiber Cut on Line

The following figure displays line unidirectional fiber cut on a NCS 1020:

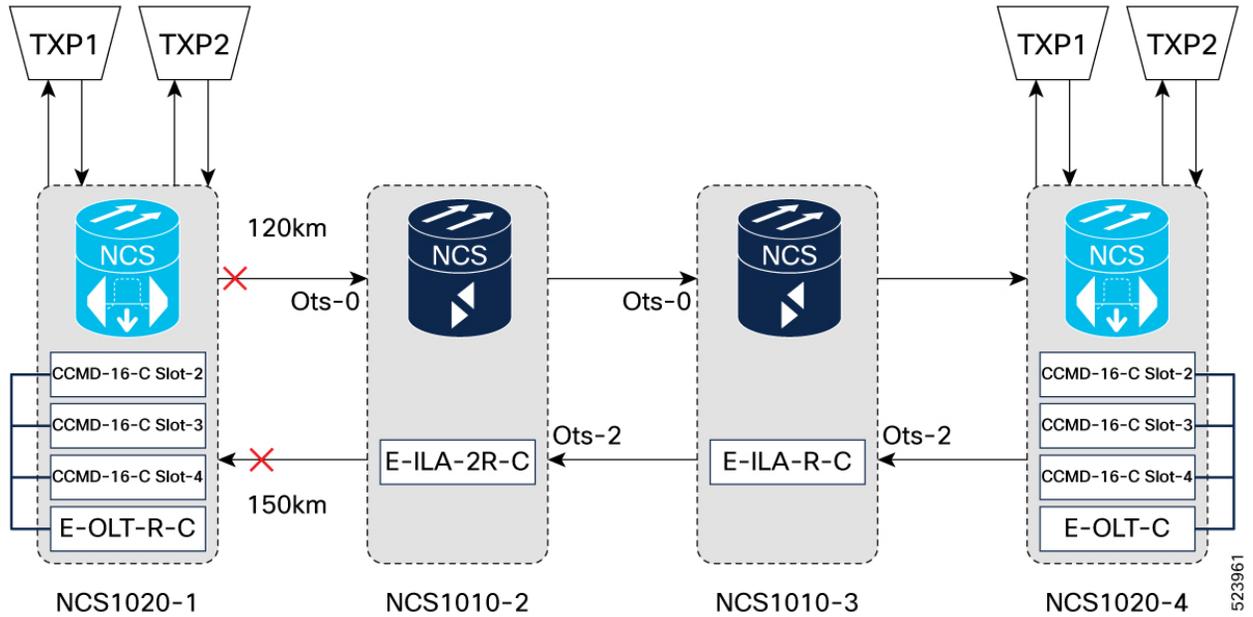
Figure 4: Bidirectional Fiber Cut on Line

The following figure displays line bidirectional fiber cut on a NCS 1020 network:

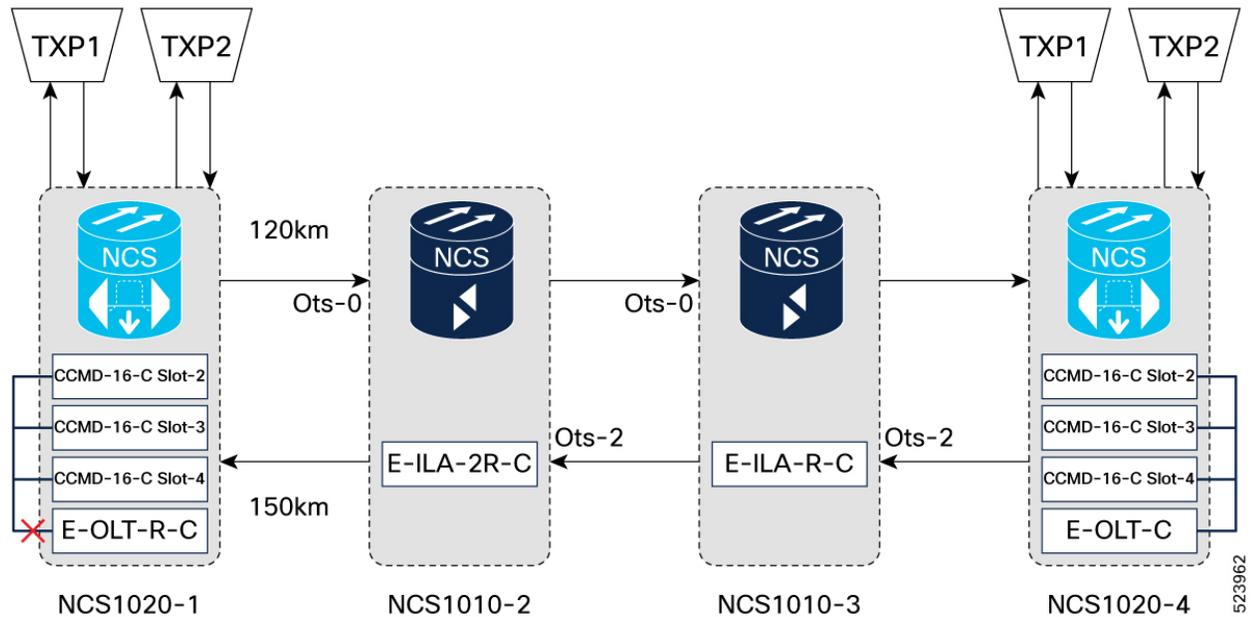
Figure 5: Fiber Cut Between CCMD and OLT

The following figure displays fiber cut between CCMD and OLT:

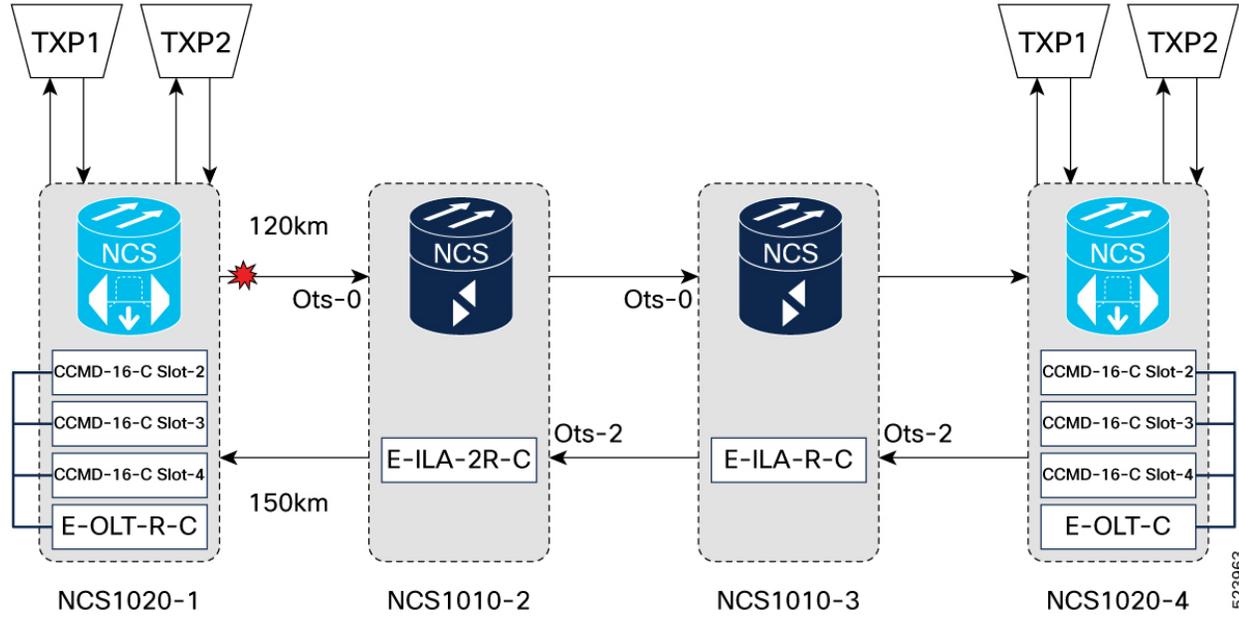
Figure 6: High Back Reflection Condition on the Line Tx port

The following figure displays high back reflection condition on the line Tx port:

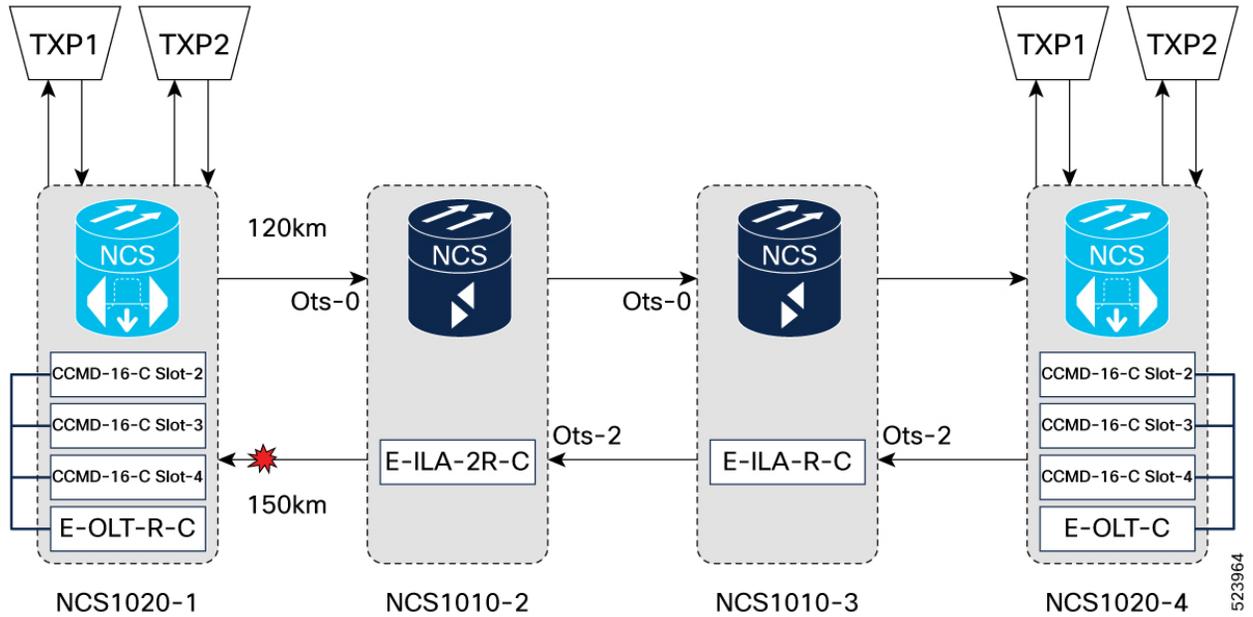
Figure 7: High Back Reflection Condition on the Line Rx RAMAN Port

The following figure displays high back reflection condition on the line Rx RAMAN port:

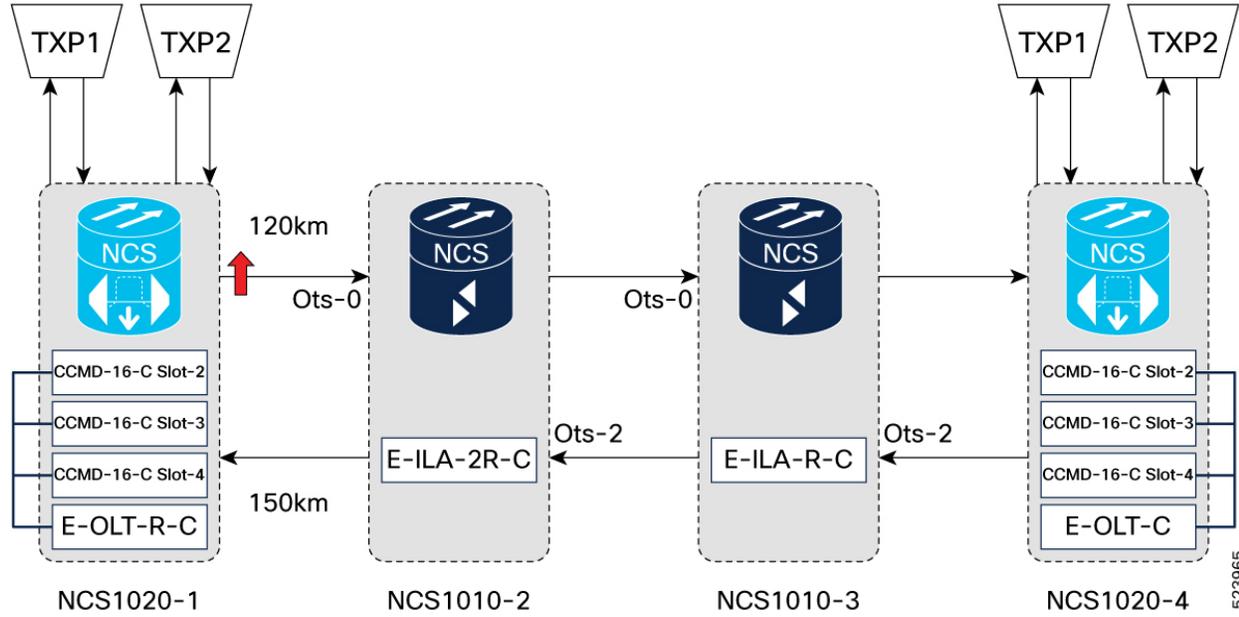
Figure 8: High span loss on Line Tx Port

The following figure displays high span loss on line Tx port:

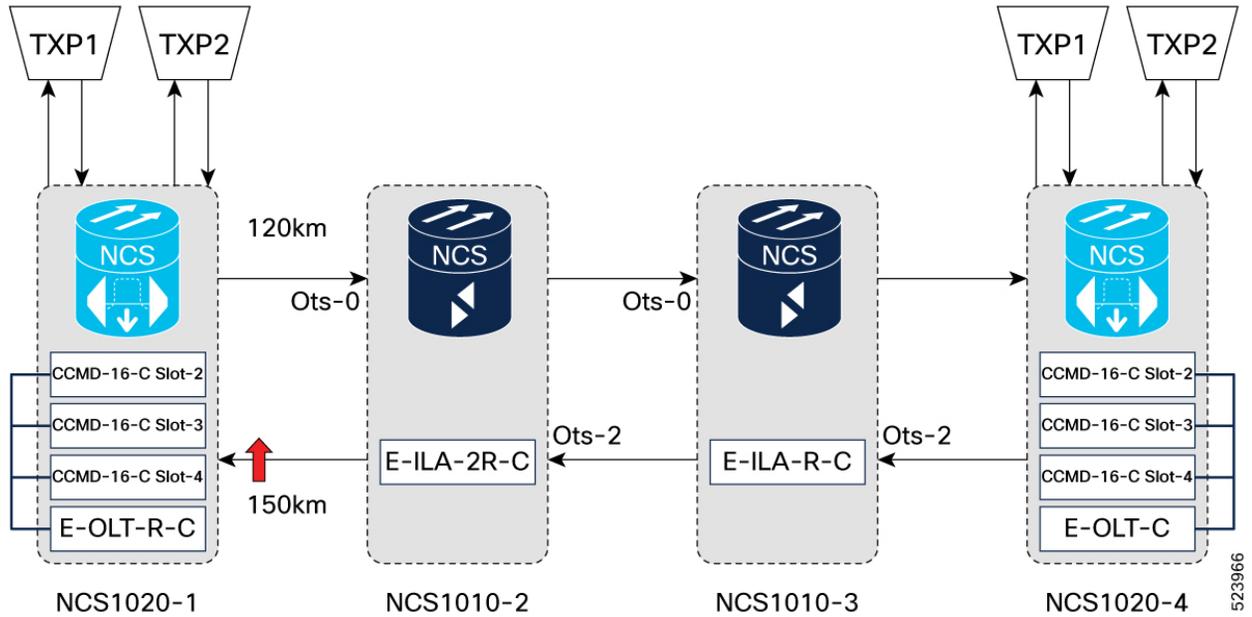
Figure 9: High span loss on Line Rx port

The following figure displays high span loss on the line Rx port:

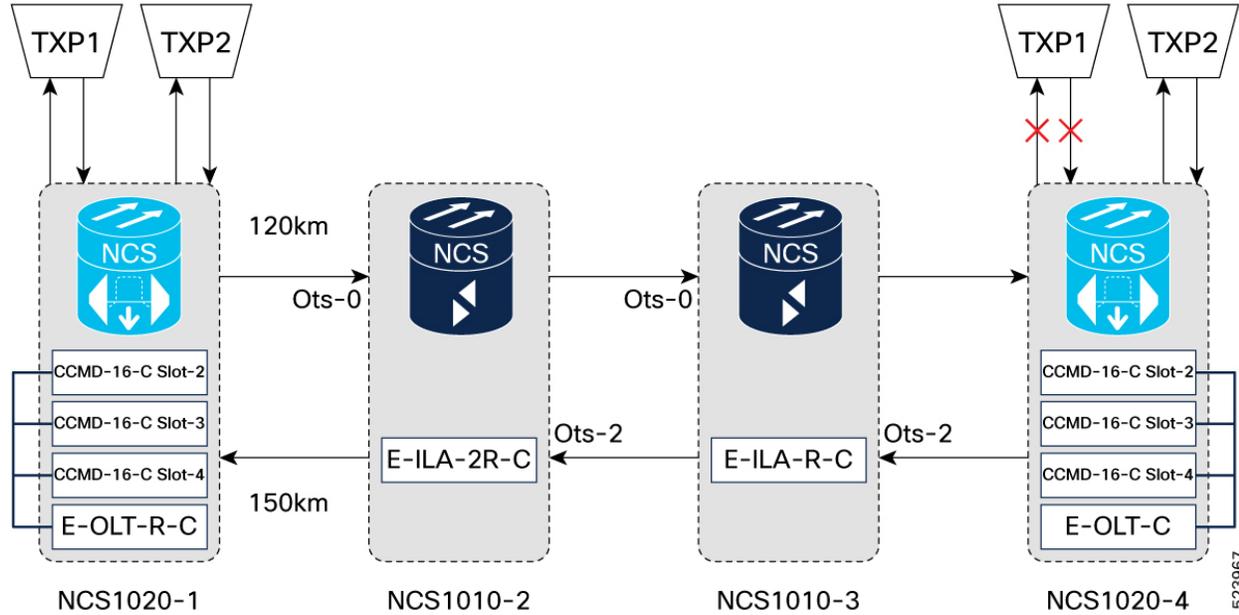
Figure 10: Single Channel Failure due to Bidirectional Fiber Cut on Line

The following figure displays single channel failure due to bidirectional fiber cut on line:

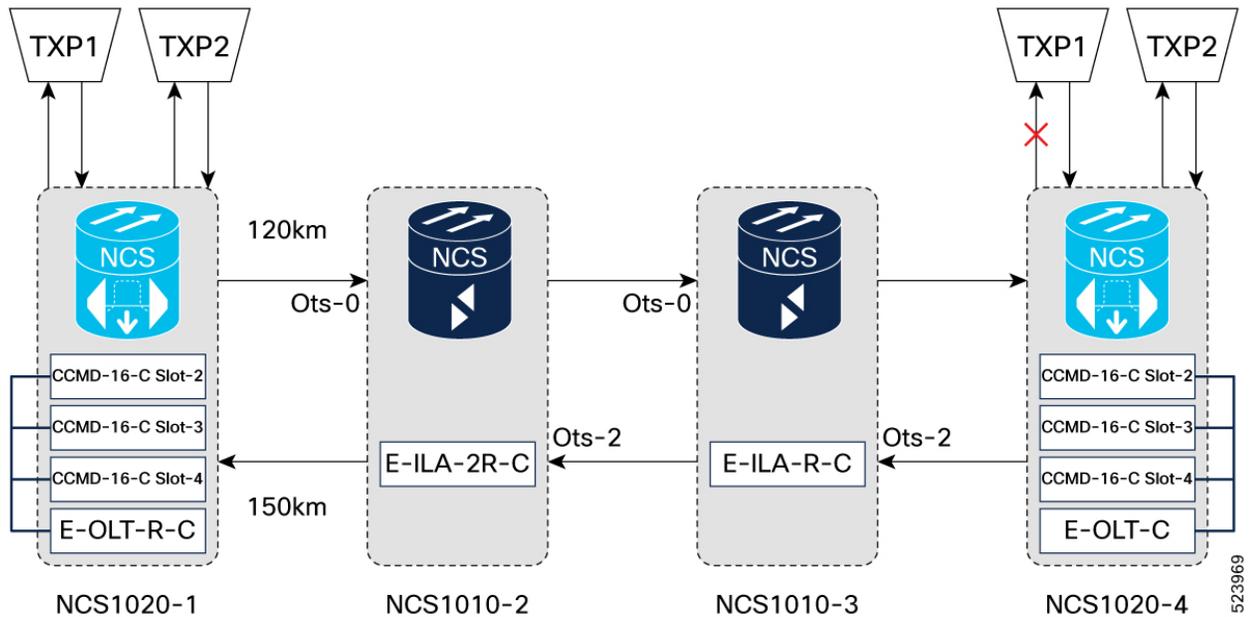
Figure 11: Single Channel Failure due to Unidirectional Fiber Cut at TXP-Tx

The following figure displays single channel failure due to unidirectional fiber cut at TXP-Tx:

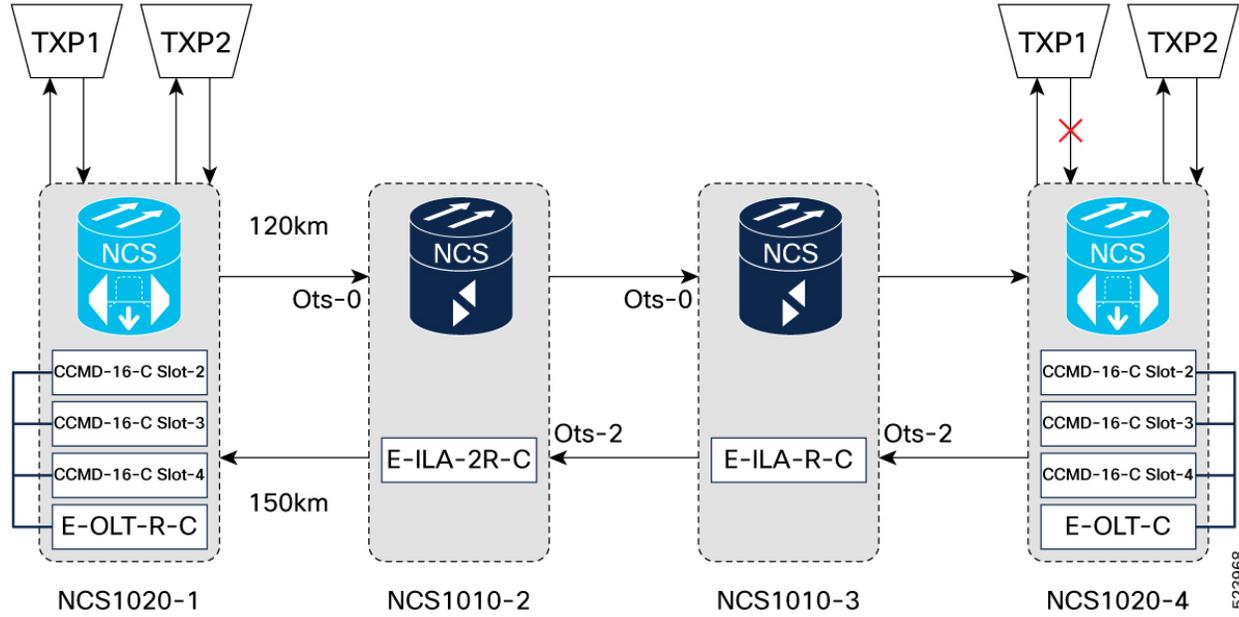
Figure 12: Single Channel Failure due to Unidirectional Fiber Cut at TXP-Tx

The following figure displays single channel failure due to unidirectional fiber cut at TXP-Rx:
