General Troubleshooting

This chapter provides procedures for troubleshooting the most common problems encountered when operating the NCS 1020 chassis.

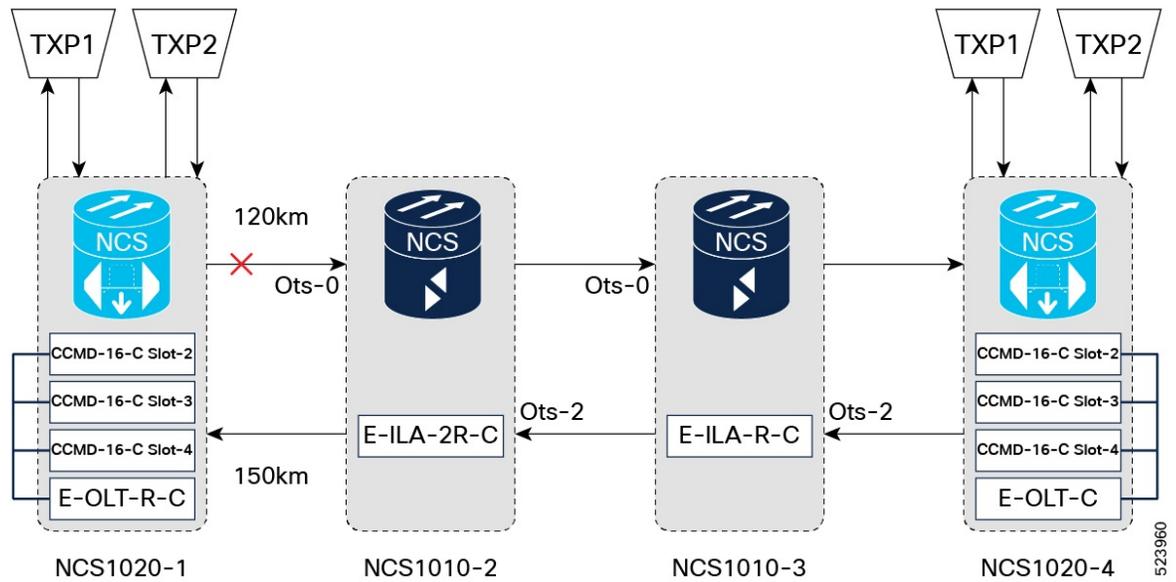
Figure 2: Fiber Cut at the Line OTS Controller

The following figure shows loss of fiber connection continuity at the Line port:

In this scenario, the following alarms are raised on the OLT (node 1):

- RX-LOS-P
- EGRESS-AUTO-LASER-SHUT
- INGRESS-AMPLI-LASER-OFF
- FEFI
