# Release Notes for the Cisco Catalyst Blade Switch 3020 for HP, Cisco IOS Release 12.2(46)SE

August 28, 2008

Cisco IOS Release 12.2(46)SE and later runs on the Cisco Catalyst Blade Switch 3020 for HP, referred to as the *switch*. Unless otherwise noted, the term *switch* refers to a standalone switch.

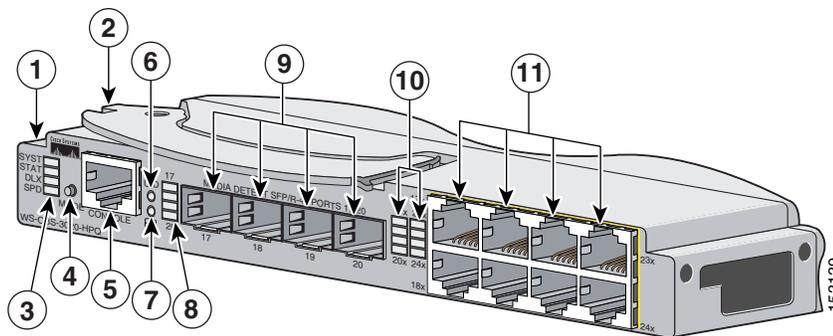
**Figure 1** The Catalyst Blade Switch 3020 for HP

This illustration in the *Cisco Catalyst Blade Switch 3020 for HP Getting Started Guide* has been updated:

1	Switch module	7	Health LED
2	Release latch	8	SFP module port LEDs for ports 17 to 20
3	System status LEDs	9	SFP module ports 17 to 20
4	Mode button	10	Gigabit Ethernet ports LEDs for ports 17x to 24x
5	Console port	11	Gigabit Ethernet ports 17x to 24x
6	UID <sup>1</sup> LED
