Release Notes for the Cisco Catalyst Blade Switch 3020 for HP, Cisco IOS Release 12.2(46)SE

Cisco IOS Release 12.2(46)SE and later runs on the Cisco Catalyst Blade Switch 3020 for HP, referred to as the *switch*. Unless otherwise noted, the term *switch* refers to a standalone switch.

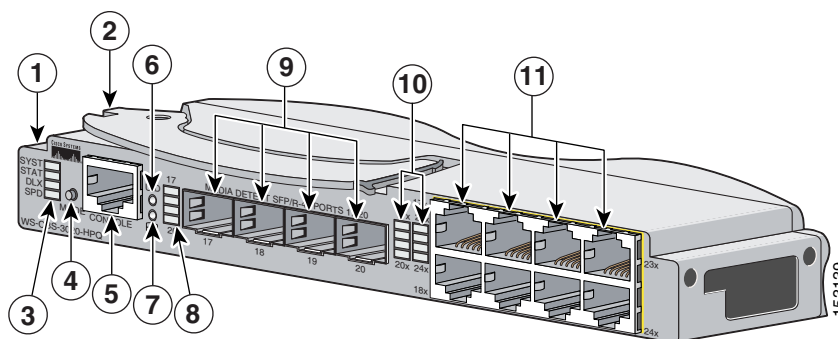
Figure 1 The Catalyst Blade Switch 3020 for HP

1	Switch module	7	Health LED
2	Release latch	8	SFP module port LEDs for ports 17 to 20
3	System status LEDs	9	SFP module ports 17 to 20
4	Mode button	10	Gigabit Ethernet ports LEDs for ports 17x to 24x
5	Console port	11	Gigabit Ethernet ports 17x to 24x
6	UID ¹ LED

1. UID: unit identifier.

This illustration in the *Cisco Catalyst Blade Switch 3020 for HP Getting Started Guide* has been updated:
