Release Notes for the Cisco Catalyst Blade Switch 3020 for HP, Cisco IOS Release 12.2(50)SE and Later

Revised October 5, 2010

Cisco IOS Release 12.2(50)SE and later runs on the Cisco Catalyst Blade Switch 3020 for HP, referred to as the *switch*. Unless otherwise noted, the term *switch* refers to a standalone switch.

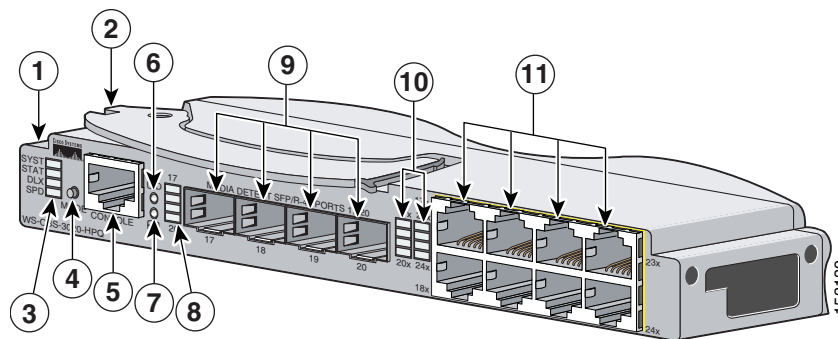
Figure 1 The Catalyst Blade Switch 3020 for HP

1	Switch module	7	Health LED
2	Release latch	8	SFP module port LEDs for ports 17 to 20
3	System status LEDs	9	SFP module ports 17 to 20
4	Mode button	10	Gigabit Ethernet ports LEDs for ports 17x to 24x
5	Console port	11	Gigabit Ethernet ports 17x to 24x
6	UID ¹ LED

1. UID: unit identifier.

This illustration in the *Cisco Catalyst Blade Switch 3020 for HP Getting Started Guide* has been updated:
