Release Notes for the Cisco Catalyst Blade Switch 3020 for HP, Cisco IOS Release 12.2(53)SE and Later

Cisco IOS Release 12.2(53)SE and later runs on the Cisco Catalyst Blade Switch 3020 for HP, referred to as the *switch*. If you wish to use Device Manager to upgrade the switch from Cisco IOS Release 12.2(35)SE through Cisco IOS Release 12.2(40)SE1 (the LAN Base image) to Cisco IOS Release 12.2(50)SE or later (the IP base image), you must first upgrade to Cisco IOS Release 12.2(40)SE2.

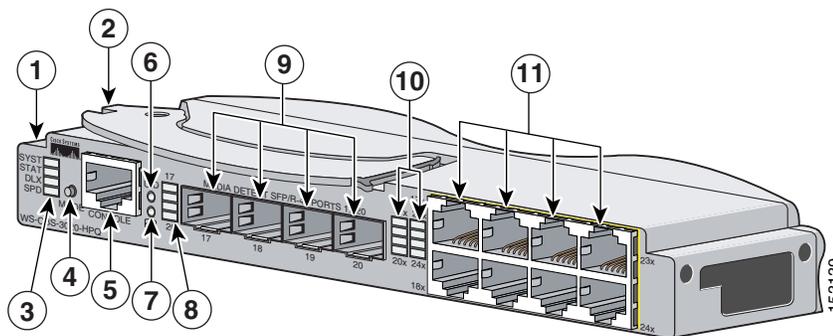
Figure 1 The Catalyst Blade Switch 3020 for HP

1	Switch module	7	Health LED
2	Release latch	8	SFP module port LEDs for ports 17 to 20
3	System status LEDs	9	SFP module ports 17 to 20
4	Mode button	10	Gigabit Ethernet ports LEDs for ports 17x to 24x
5	Console port	11	Gigabit Ethernet ports 17x to 24x
6	UID ¹ LED

1. UID: unit identifier.

This illustration in the *Cisco Catalyst Blade Switch 3020 for HP Getting Started Guide* has been updated:
