Cisco Nexus 5000 Series and Cisco Nexus 2000 Series Release Notes, Releases 4.1(3)N1(1), 4.1(3)N1(1a), 4.1(3)N2(1) and 4.1(3)N2(1a)

Current Release: 4.1(3)N2(1a) - December 15, 2009
Part Number: OL-16601-01 Q0

This document describes the features, caveats, and limitations for Cisco Nexus 5000 Series switches and the Cisco Necus 2000 Series Fabric Extenders. Use this document in combination with documents listed in the “[Related Documentation](#)” section on page 35.

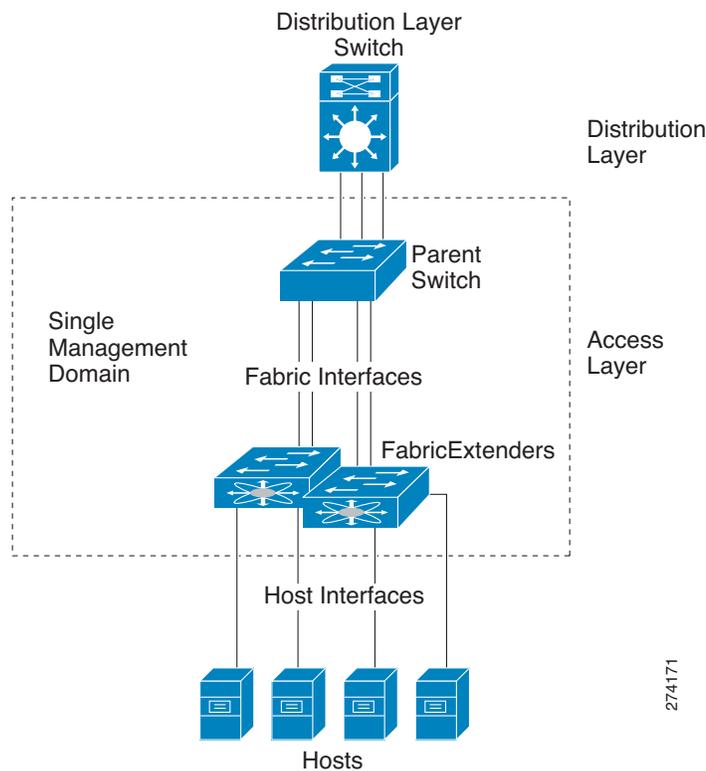
Figure 1-1 Single Management Domain

The Fabric Extender integrates with its parent switch, allowing zero-touch provisioning as well as automatic configuration. This integration allows large numbers of servers and hosts to be supported using the same feature set as the parent Nexus 5000 Series switch, including security and quality of service (QoS) configuration parameters, with a single point of management as shown in [Figure 1-1](#). Spanning Tree Protocol (STP) is not required between the Fabric Extender and its parent switch, because the Fabric Extender and its parent switch allow you to enable a large multi-path, loop-free, active-active topology.
